# Your Inspection Report

Tuesday, October 22, 2024

Leonardo Betancor, CMI, 24GI00182600, HOI.0001093

Smart Choice Inspections LLC  
173 Ridge Road, Suite H1  
Cedar Grove, NJ 07009

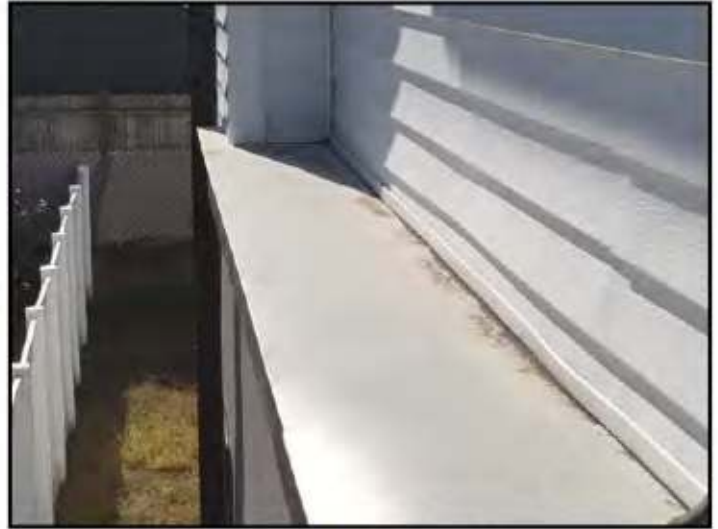
1. Possible water infiltration behind EIFS

**Condition:** • Possible water infiltration behind EIFS

It appears that the small roof section above the front EIFS facade has an improper slope, pitched downward towards the building instead of away from it. This is causing water to seep into the wall cavity, as confirmed by thermal imaging and moisture readings. The first step in correcting this issue will be to rebuild the small roof sections with the correct pitch and open the wall cavity to inspect for water damage and mold.

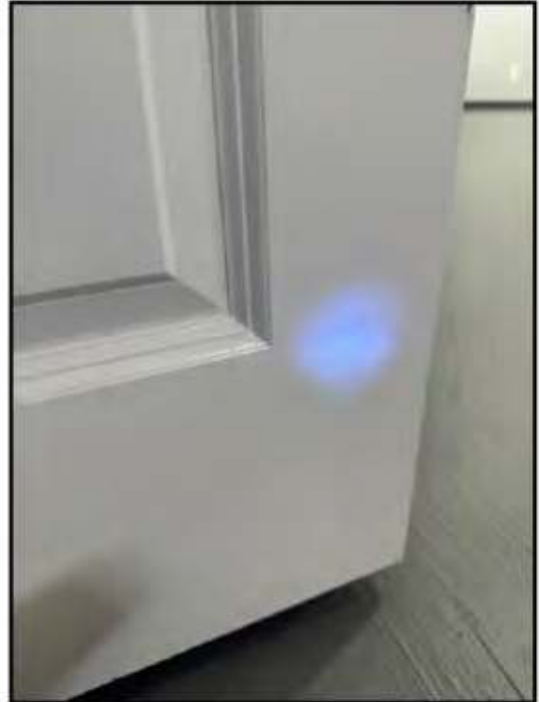
23. Questionable installation

**Condition:** • Questionable installation

A lower section of the basement appears to be missing a French drain and sump pump system. Water marks can be seen on the door, approximately 8-10 inches high.

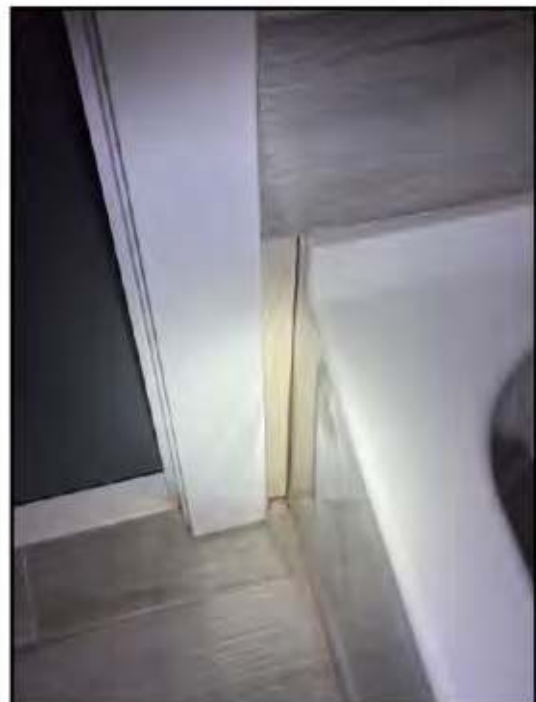
**27.** Tile loose, broken or missing

**FIXTURES AND FAUCETS \ Bathtub enclosure****Condition:** • [Tile loose, broken or missing](#)**Implication(s):** Chance of water damage to structure, finishes and contents**Location:** Basement Bathroom

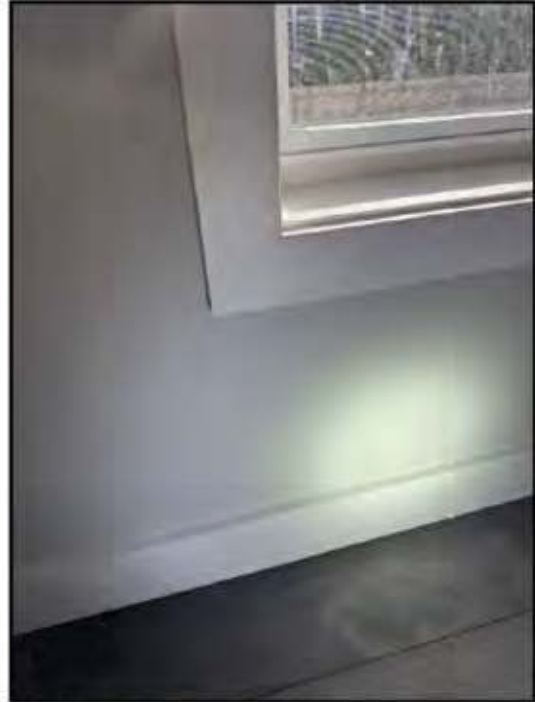
29. Active water leak detected

**Condition:** • Active water leak detected

**Implication(s):** Chance of movement, Rot, Leakage

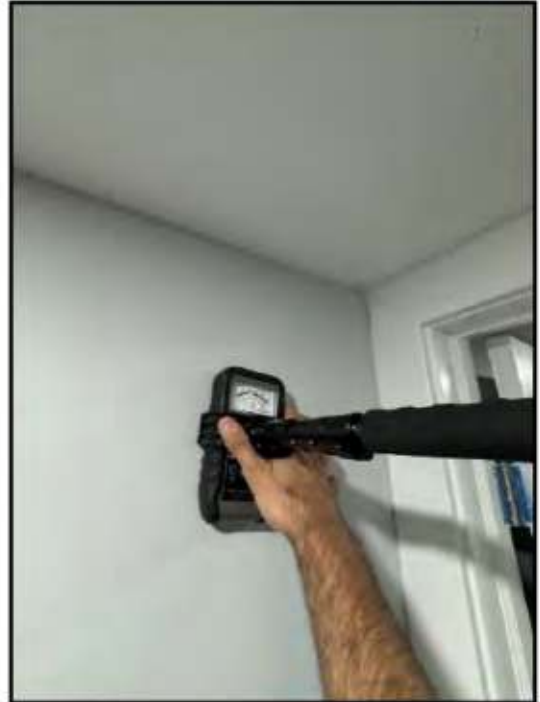
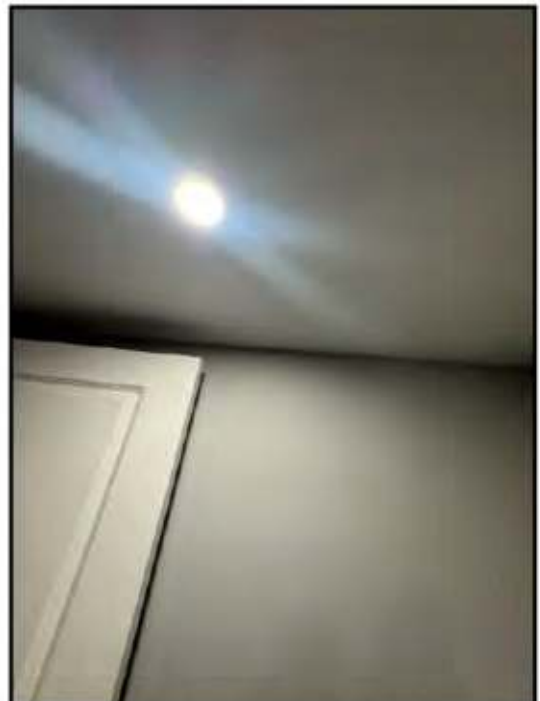
**Condition:** • Active water leak detected

The area appears to be located below the EIFS water infiltration point.

**Implication(s):** Chance of movement, Rot, Leakage

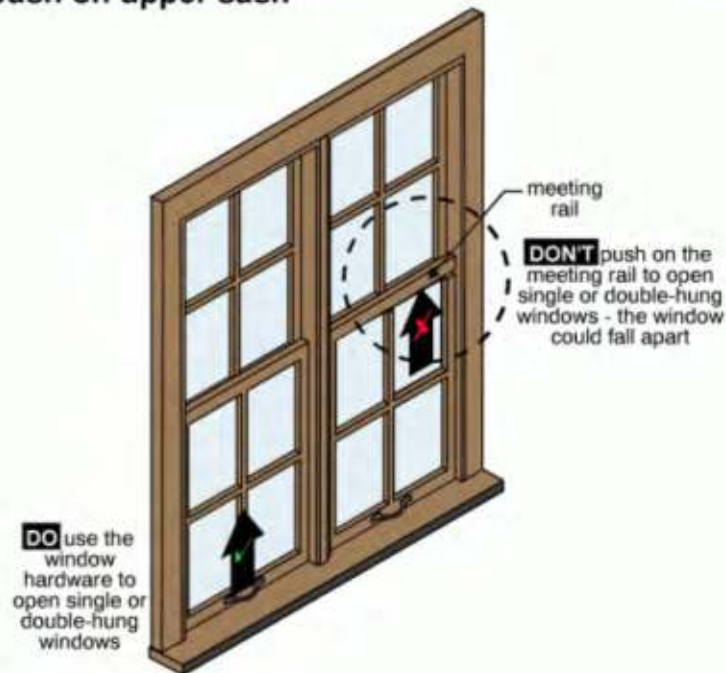
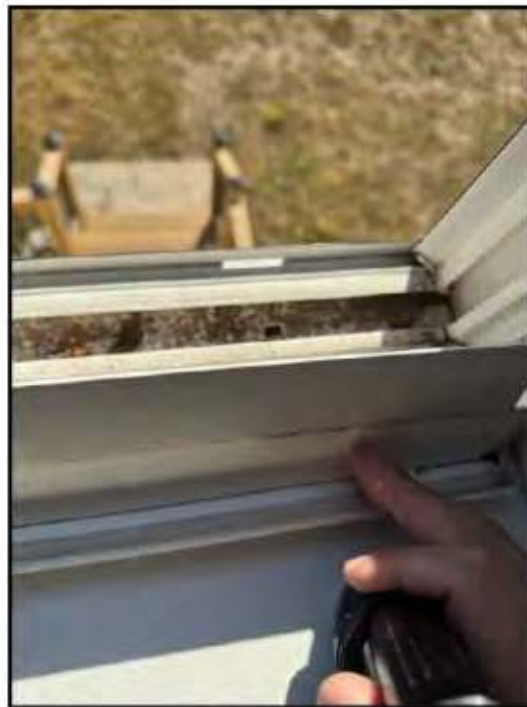
36. Sash coming apart

**Condition:** • [Sash coming apart](#)

**Implication(s):** Chance of damage to finishes and structure | Glass breaking

**Task:** Further evaluation

**Don't push on upper sash**

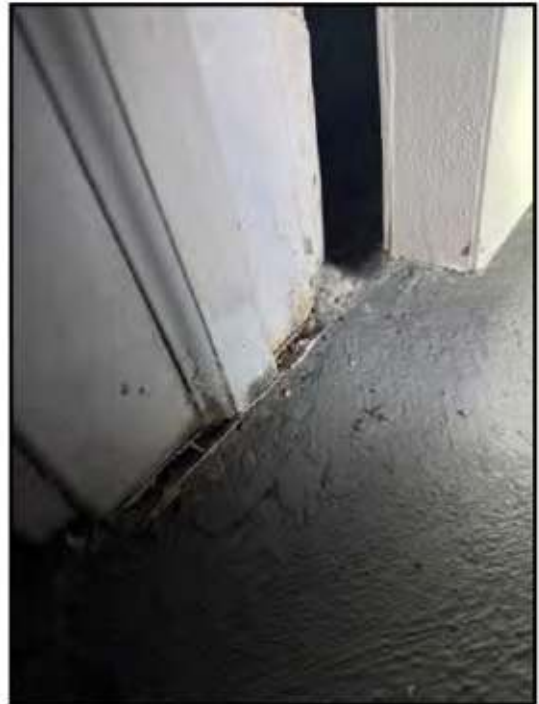
46. Water marks

Condition: • [Water marks](#)

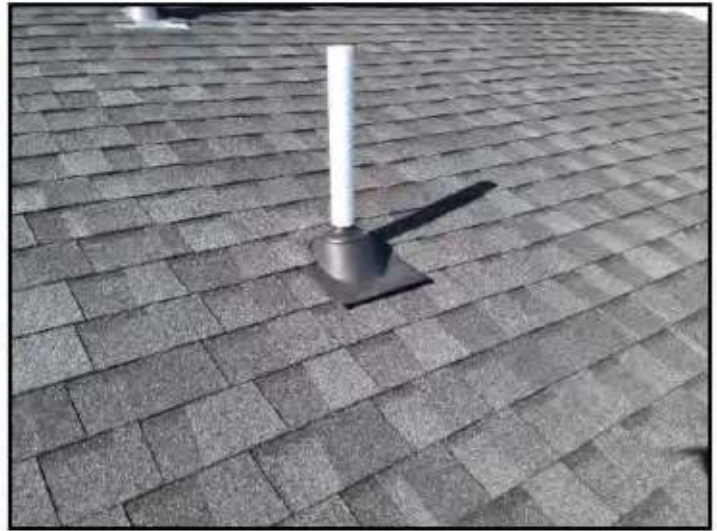
63. Loose

2. Condition: • Loose

Recommend nailing flashing down and sealing over nails

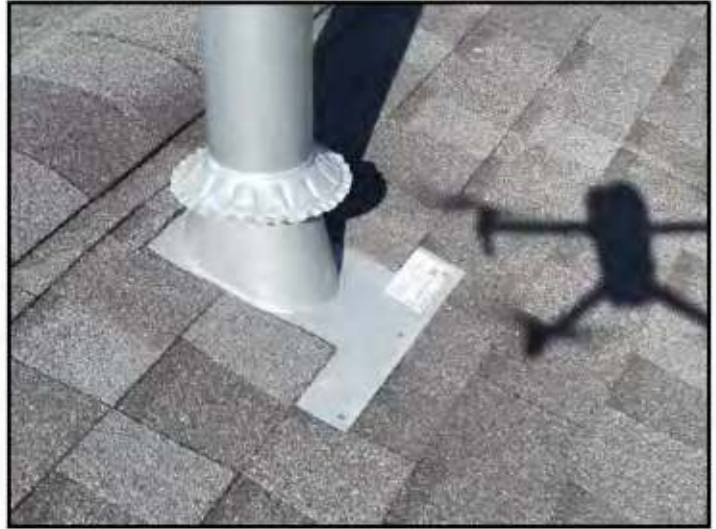
65. Fasteners - exposed / missing

3. Condition: • [Fasteners - exposed / missing](#)

Implication(s): Chance of water damage to structure, finishes and contents

Recommend sealing over fasteners

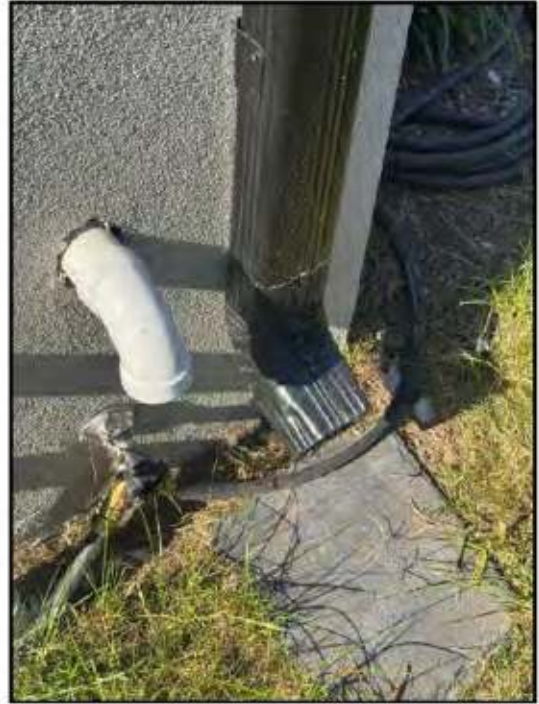
69. Discharge too close to building

4. Condition: • [Discharge too close to building](#)

Implication(s): Chance of water damage to structure, finishes and contents

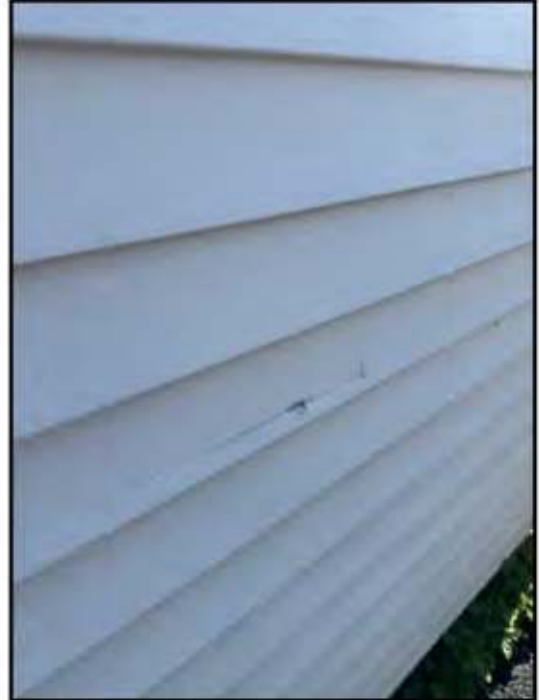
**72. Mechanical damage**

**WALLS \ Vinyl siding****6. Condition:** • [Mechanical damage](#)**Implication(s):** Chance of water damage to structure, finishes and contents

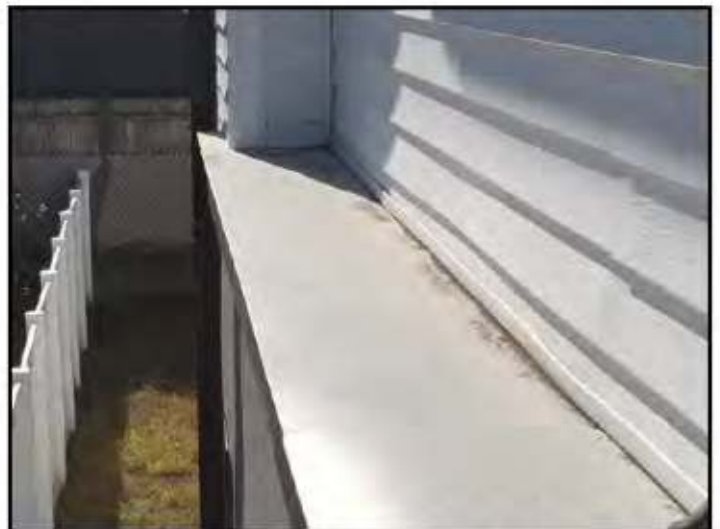
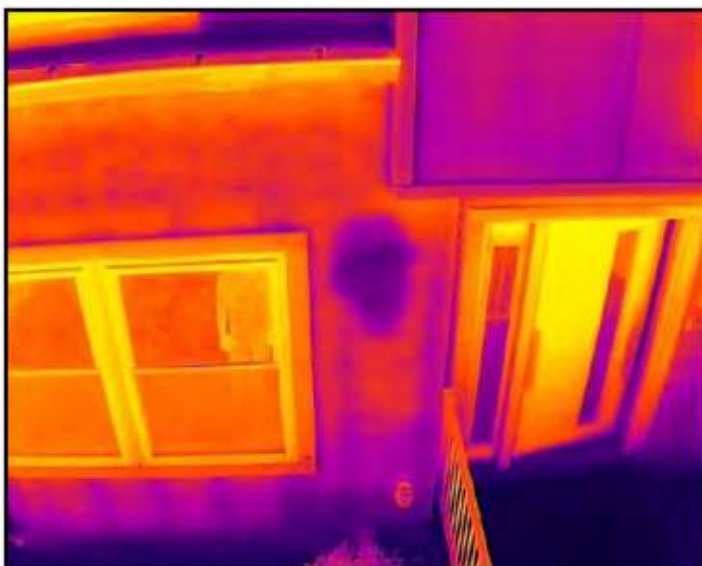
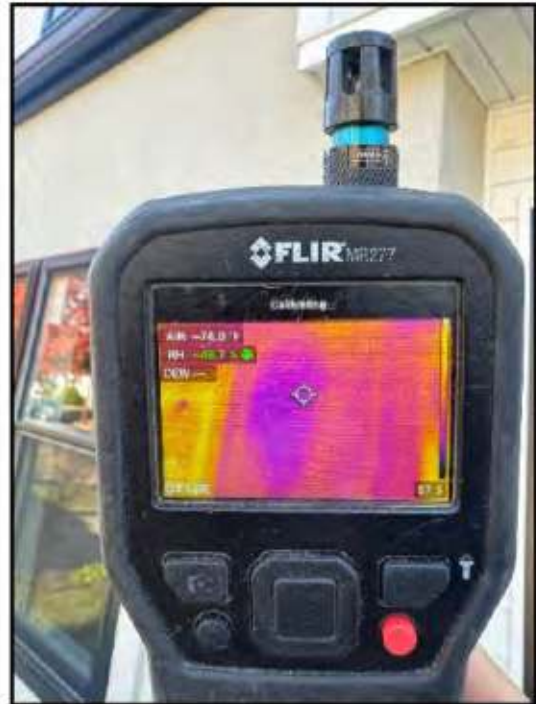
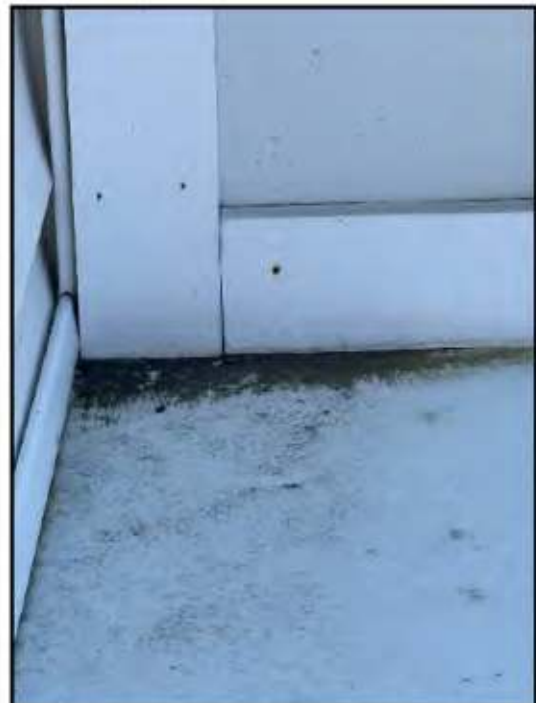
**76. Unsealed openings****10. Condition:** • Possible water infiltration behind EIFS

It appears that the small roof section above the front EIFS facade has an improper slope, pitched downward towards the building instead of away from it. This is causing water to seep into the wall cavity, as confirmed by thermal imaging and moisture readings. The first step in correcting this issue will be to rebuild the small roof sections with the correct pitch and open the wall cavity to inspect for water damage and mold.

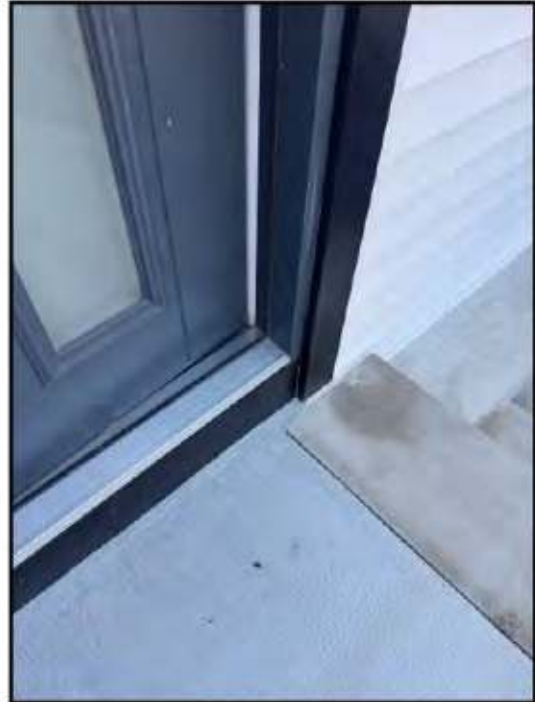
94. Damaged, cracked or loose

18. Condition: • [Damaged, cracked or loose](#)

Implication(s): Chance of damage to finishes and structure

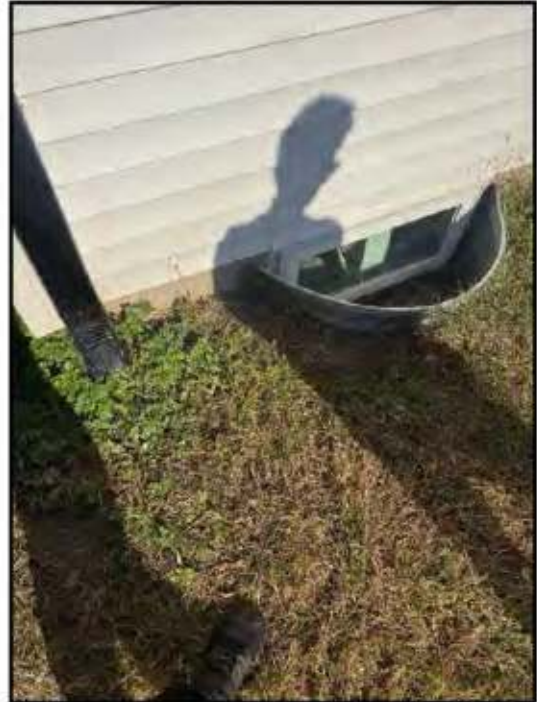
102. Improper slope or drainage

24. Condition: • [Improper slope or drainage](#)

Implication(s): Chance of water damage to structure, finishes and contents

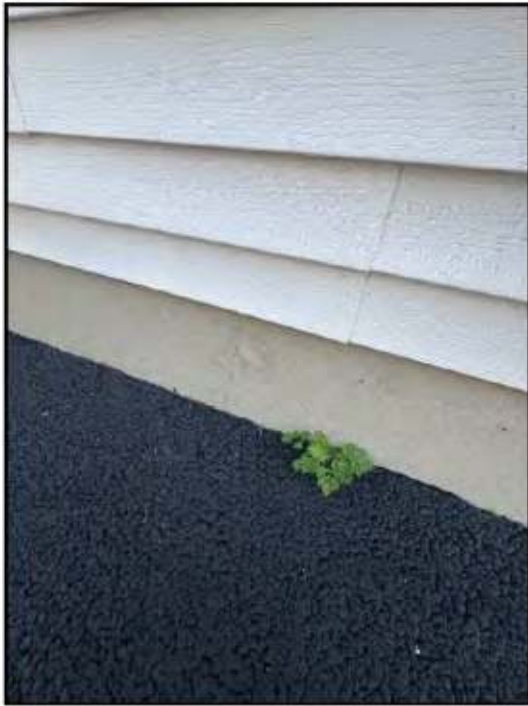
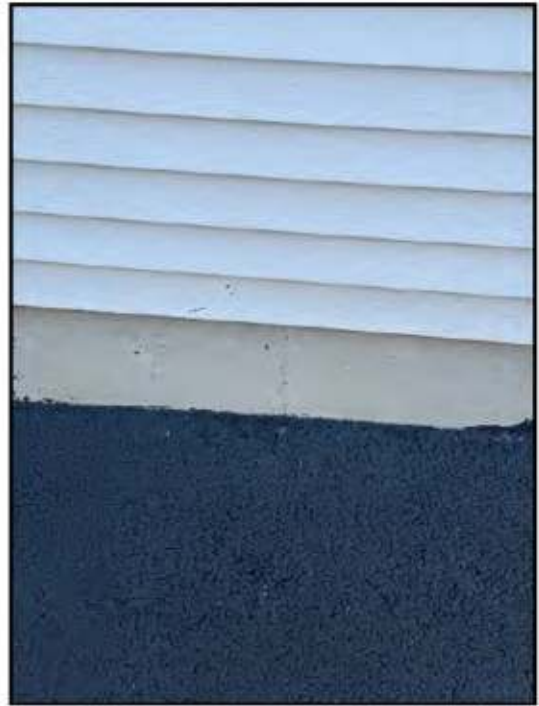
29. Condition: • [Cracked](#)

Implication(s): Chance of water damage to structure, finishes and contents | Weakened structure

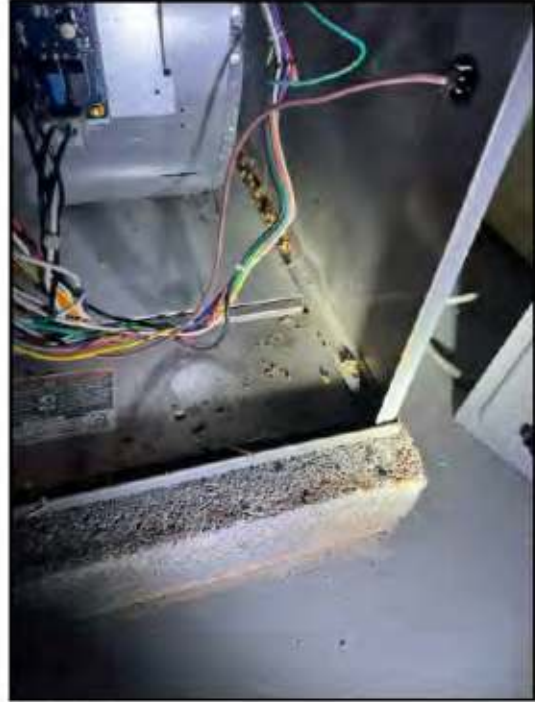
128. Dirty

**FURNACE \ Ducts, registers and grilles****44. Condition:** • [Dirty](#)**Implication(s):** Increased heating and cooling costs | Reduced comfort

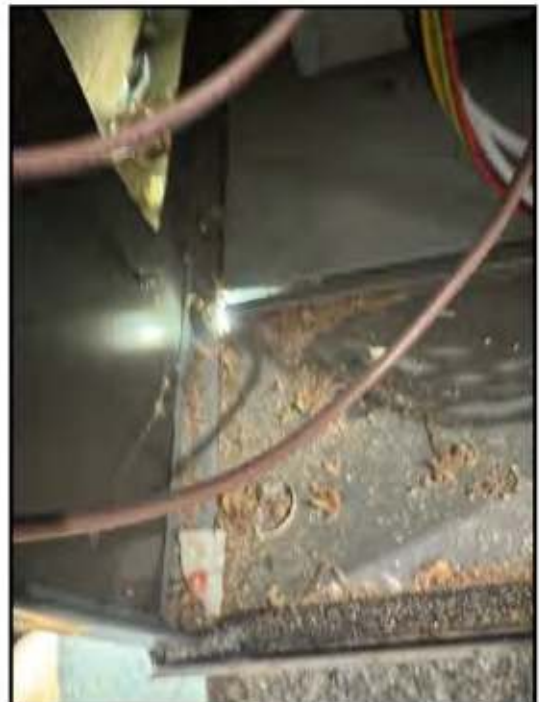
131. Air leakage entering from return side

**46. Condition:** • Air leakage entering from return side

**Implication(s):** Openings found on the return side (before the blower) can pull back gases and pollutants from the utility area, INTO the supply side. These pollutants can include carbon monoxide.

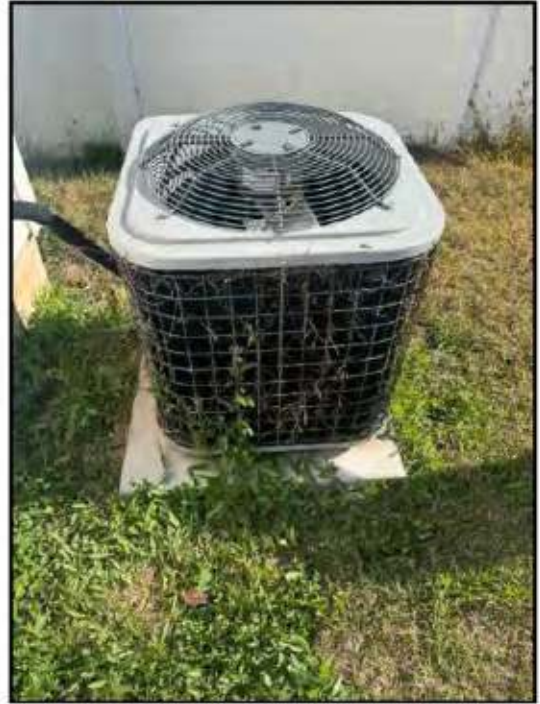
142. Vegetation around compressor

**51. Condition:** • Vegetation around compressor

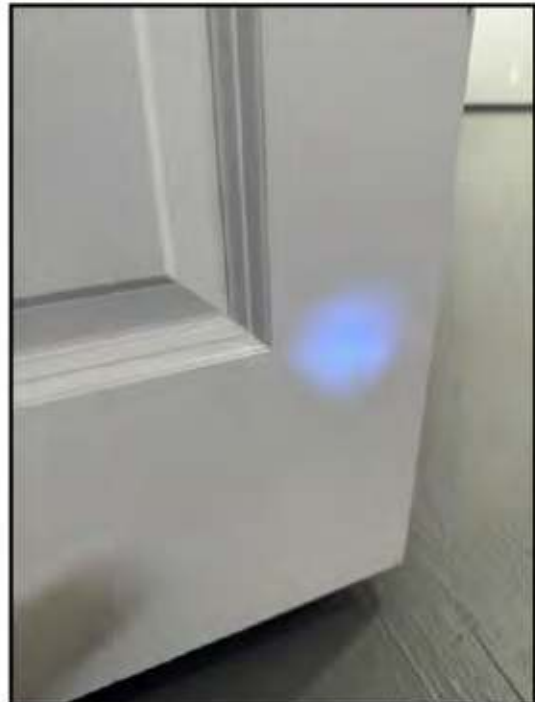
157. Questionable installation

## 63. Condition: • Questionable installation

A lower section of the basement appears to be missing a French drain and sump pump system. Water marks can be seen on the door, approximately 8-10 inches high.

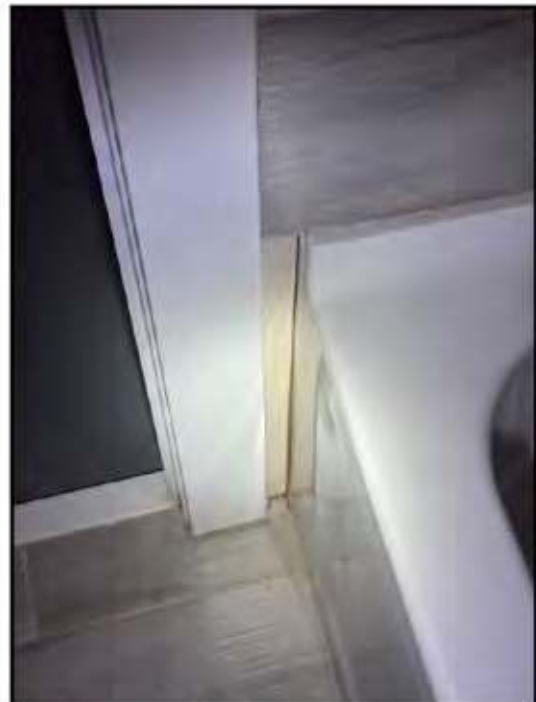
169. Tile loose, broken or missing

## 72. Condition: • [Tile loose, broken or missing](#)

Implication(s): Chance of water damage to structure, finishes and contents

Location: Basement Bathroom

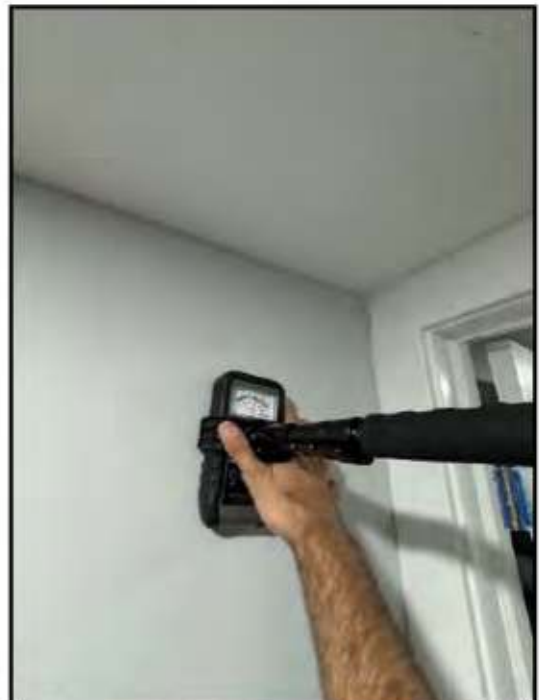
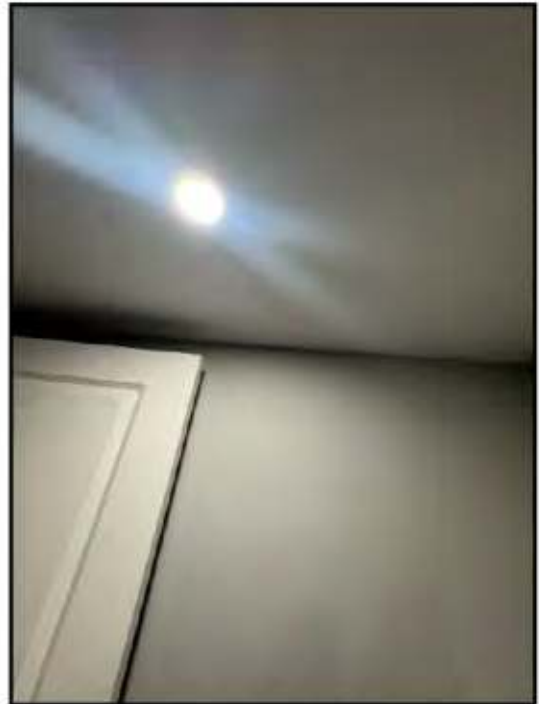
**86. Condition:** • Active water leak detected

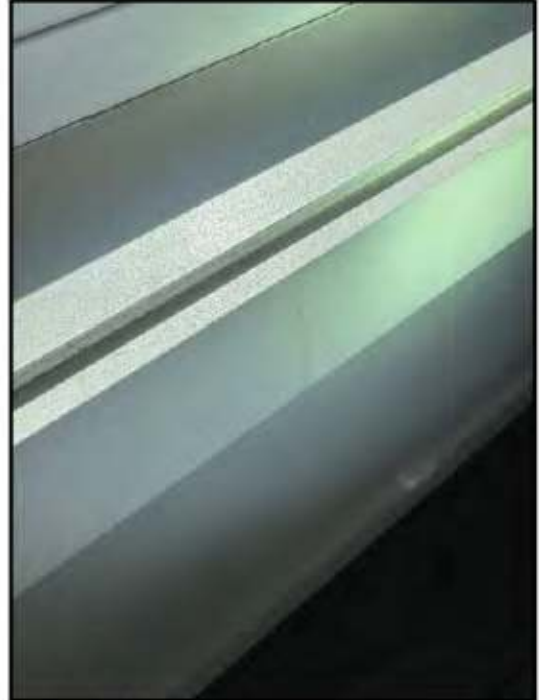
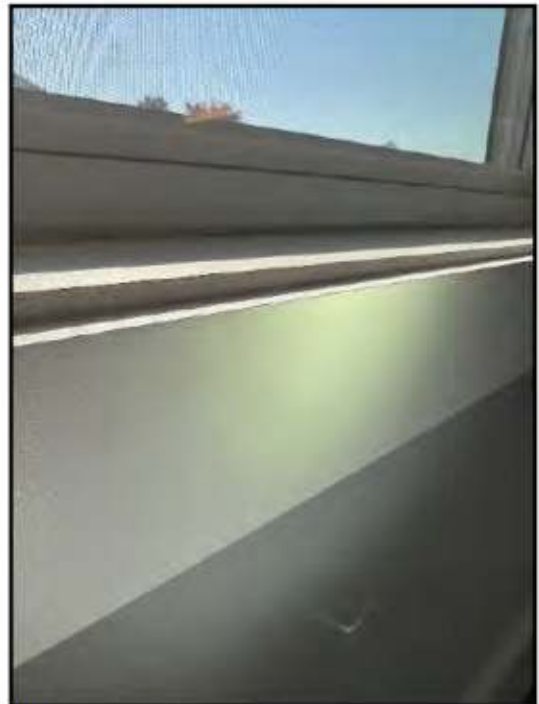
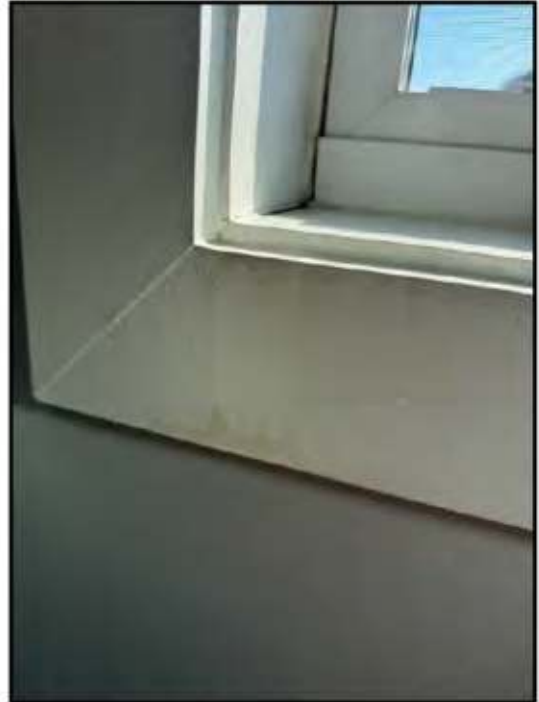
**96. Condition:** • Water stains
