# Your Inspection Report

Tuesday, November 5, 2024

Leonardo Betancor, CMI, 24GI00182600, HOI.0001093

Smart Choice Inspections LLC  
173 Ridge Road, Suite H1  
Cedar Grove, NJ 07009

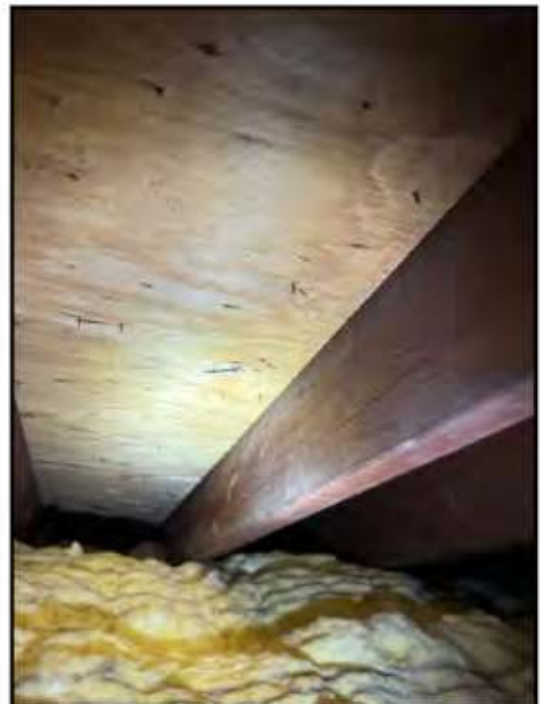
1. Split or damage

**Condition:** • Split or damage

**Implication(s):** Weakened structure | Chance of structural movement

**Location:** Attic Garage

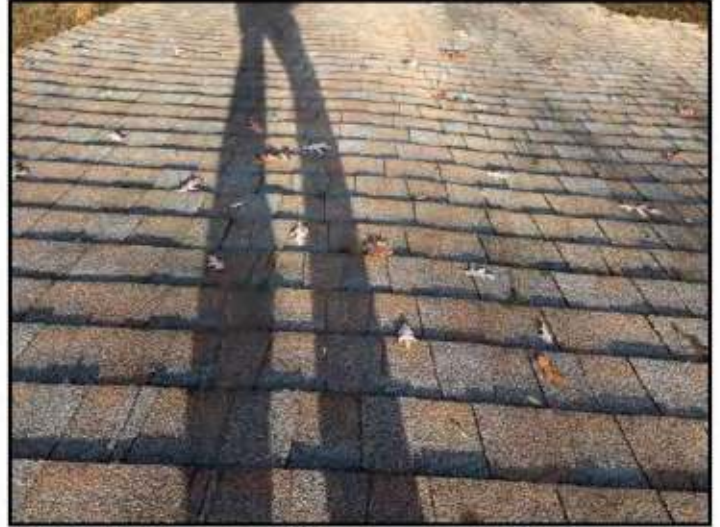
5. Buckled

Condition: • [Buckled](#)

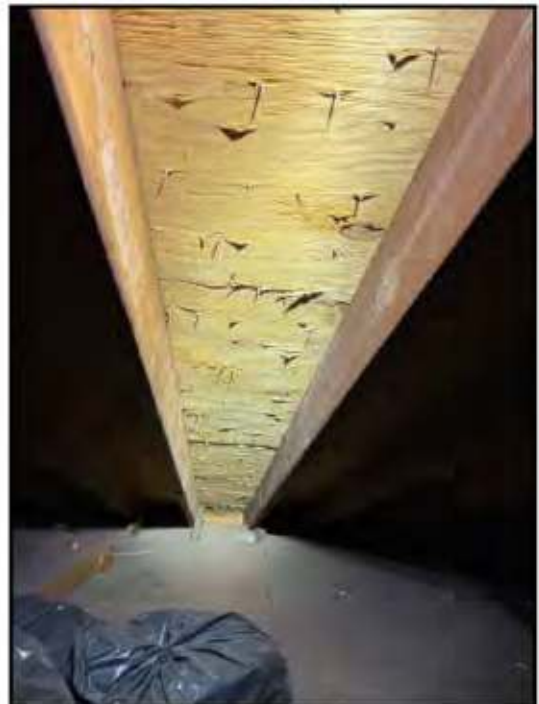
7. Damage

Condition: • Damage

Implication(s): Chance of water damage to structure, finishes and contents | Weakened structure

Task: Further evaluation and repair

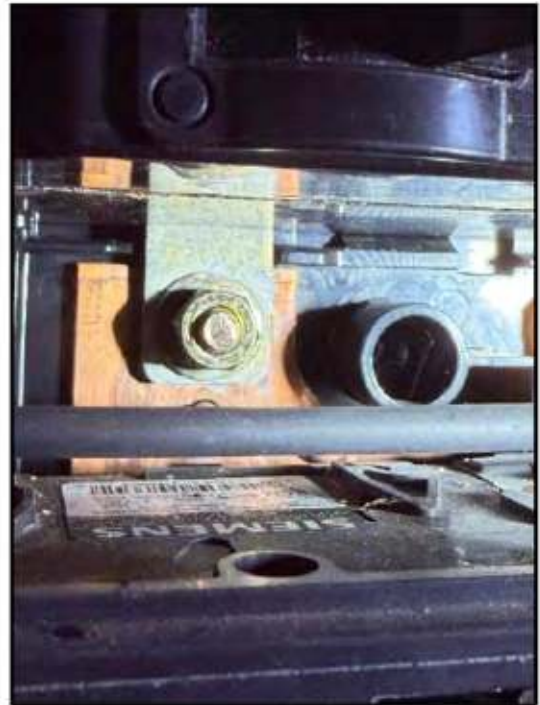
14. Rust or water in panel

Condition: • [Rust or water in panel](#)

Implication(s): Electric shock | Fire hazard

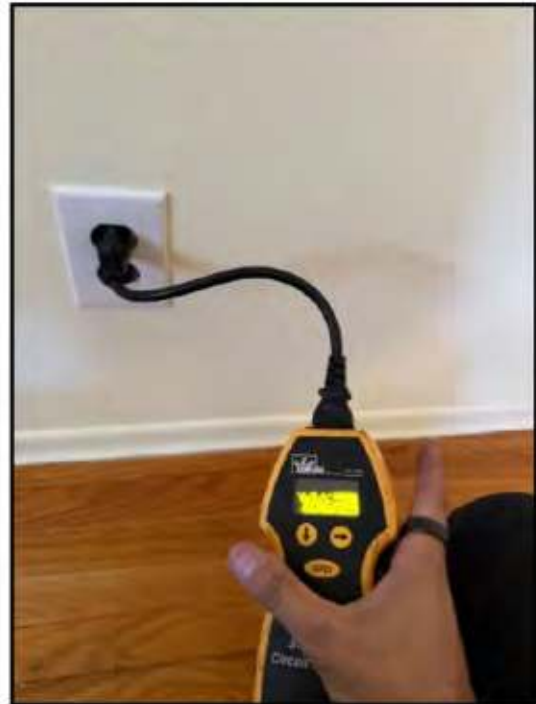
19. Loose

**DISTRIBUTION SYSTEM \ Outlets (receptacles)**Condition: • Loose

Implication(s): Electric shock | Fire hazard

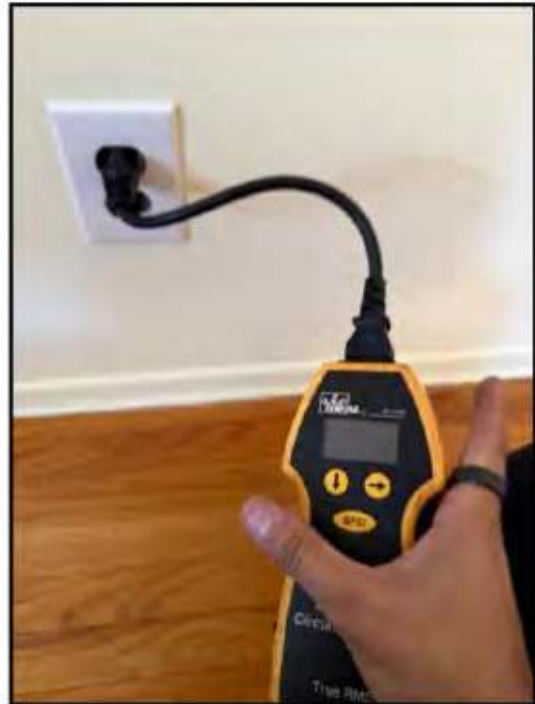
22. Loose connections

**Condition:** • Loose connections

**Implication(s):** Electric shock, Fire hazard

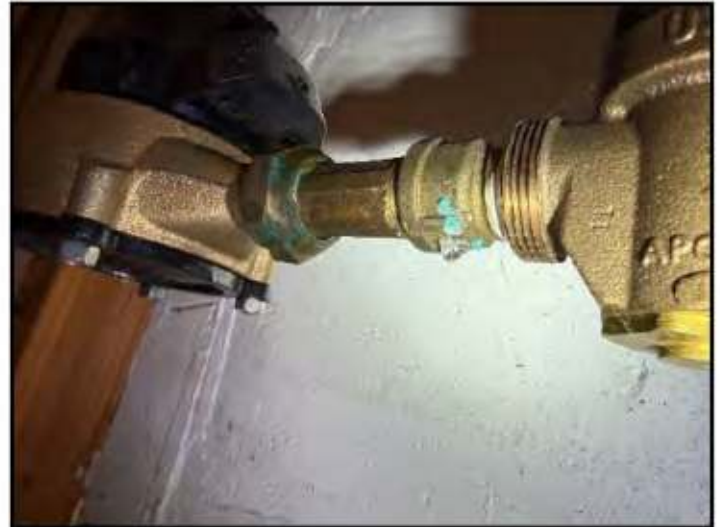
29. Leak

Condition: • [Leak](#)

Implication(s): Chance of water damage to structure, finishes and contents | Damage to equipment

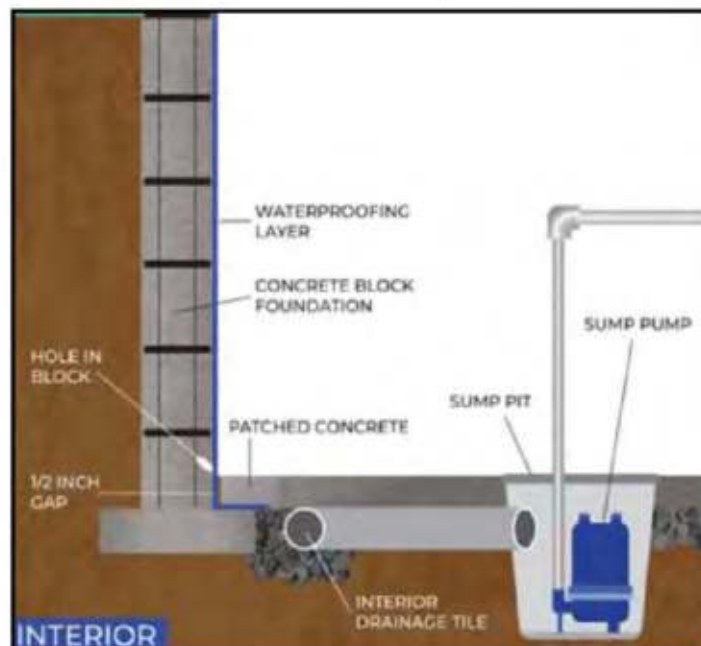
35. Questionable installation

**Condition:** • Questionable installation

A section of chimney flue liner has been repurposed as a makeshift sump pump basin. This approach was sometimes used in the 1950s-1970s but is not as effective as a modern sump basin. The sump pump in this setup is intended to remove any water that rises from the water table beneath the slab, helping to reduce water pressure under the foundation. It appears that a French drain may have been installed along portions of the basement perimeter (although we cannot confirm if perforated pipe is present, as it is not visible), but it does not connect to this sump basin, which limits the drainage system's effectiveness.

For optimal performance, it is recommended to replace this flue liner with a properly sized polyethylene basin (16x22 inches) and connect it directly to the French drain piping. This setup would improve water collection and ensure efficient drainage. Additionally, the sump pump discharge should be directed to an exterior point at least 6-10 feet away from the home, rather than into the sewer system, to prevent rainwater from overloading the sewer infrastructure.

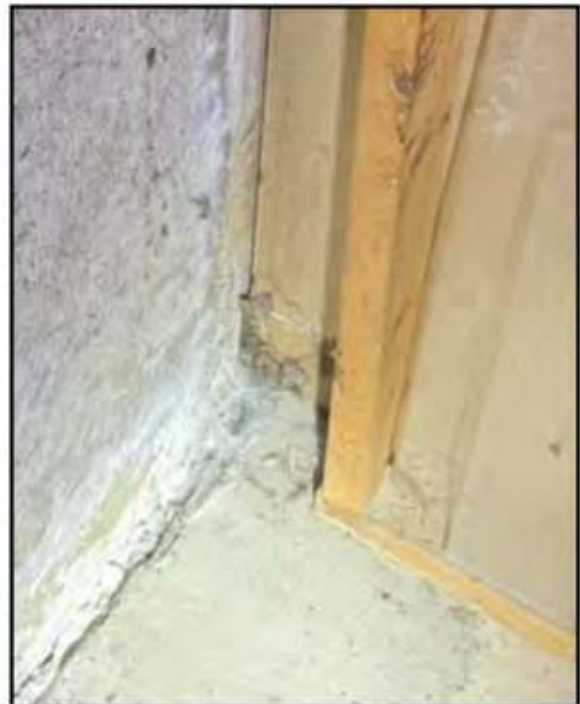
44. Mold

Condition: • [Mold](#)

Implication(s): Chance of water damage to structure, finishes and contents | Contaminants may enter building air

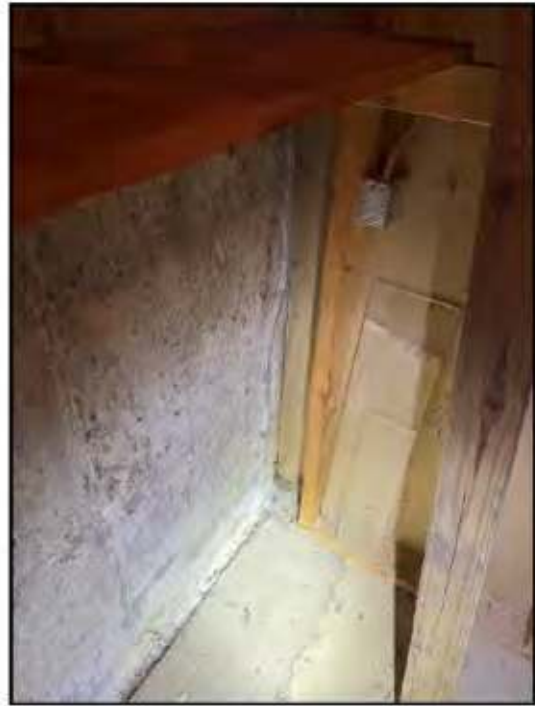
48. Water marks

Condition: • [Water marks](#)

Implication(s): Chance of water damage to structure, finishes and contents

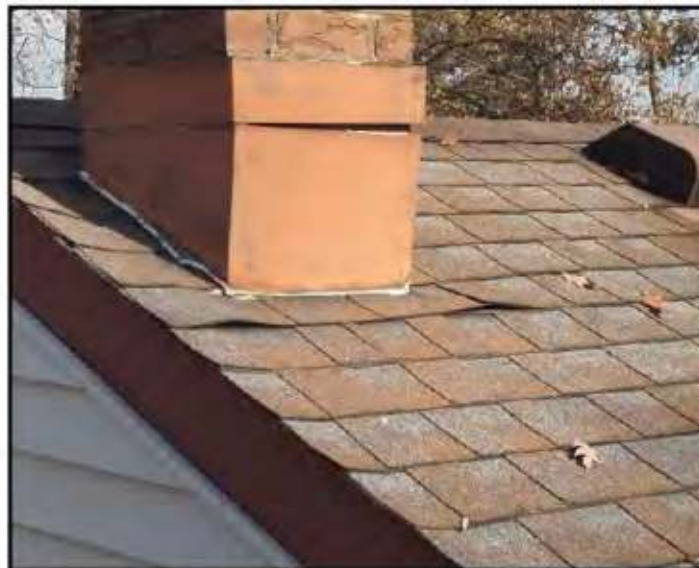
57. Cupping, curling, clawing

2. Condition: • [Cupping, curling, clawing](#)

Implication(s): Chance of water damage to structure, finishes and contents

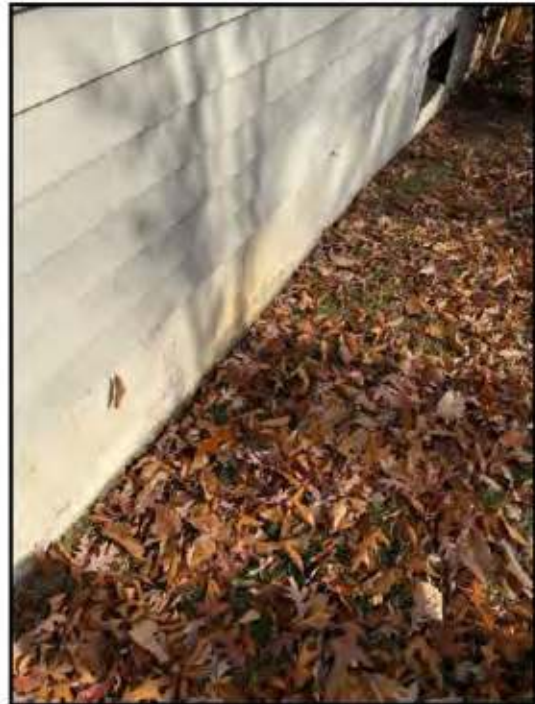
90. Improper slope or drainage

27. Condition: • [Improper slope or drainage](#)

Implication(s): Chance of water damage to structure, finishes and contents

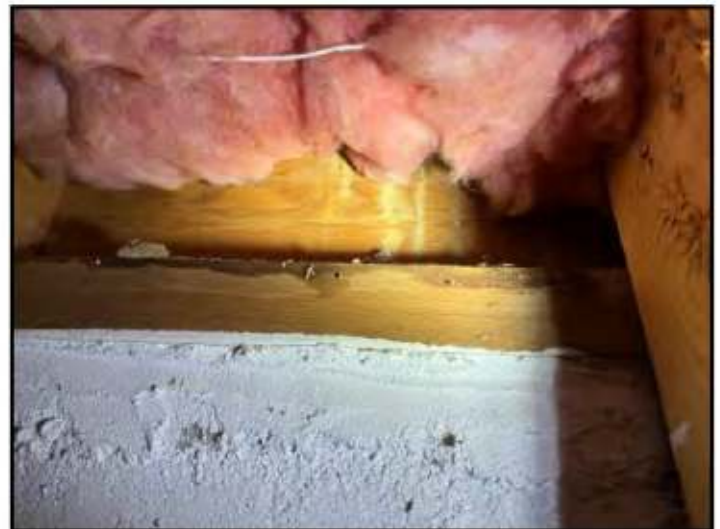
98. Water Stains

**33. Condition:** • Water Stains

**Implication(s):** Chance of water damage to structure, finishes and contents. Weakened structure, Chance of structural movement.

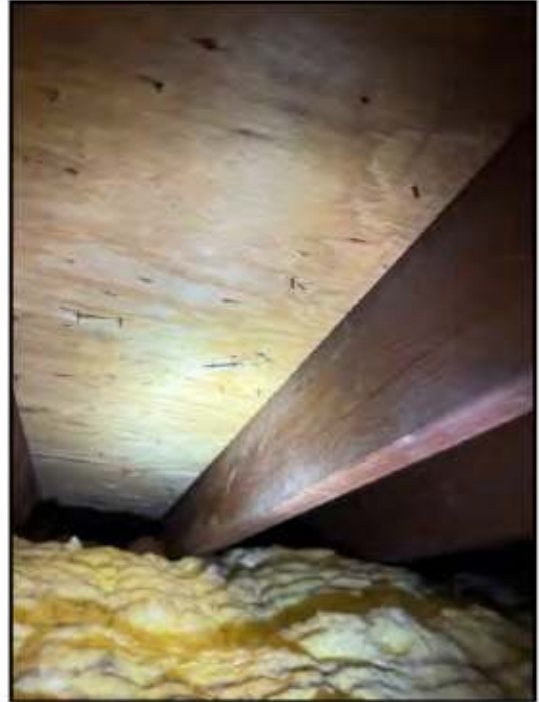
**106.** *Split or damage*

**ROOF FRAMING \ Rafter/trusses****36. Condition:** • Split or damage**Implication(s):** Weakened structure | Chance of structural movement**Location:** Attic Garage

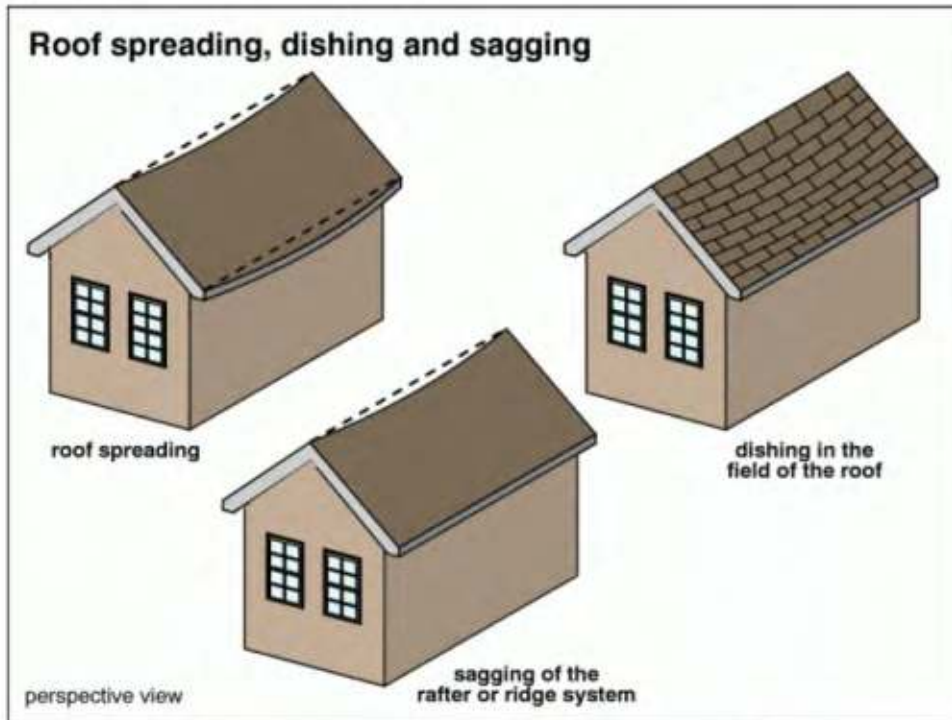
**109. Rafter spread**

**37. Condition:** • [Rafter spread](#)**Implication(s):** Weakened structure | Chance of structural movement

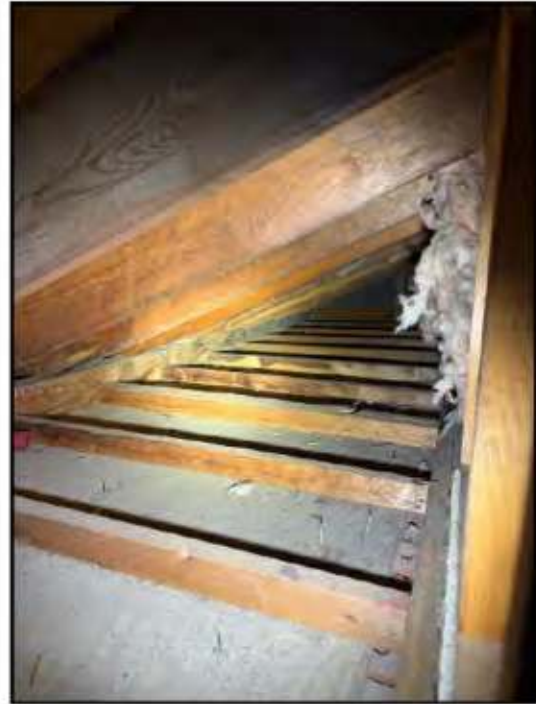
110. Water Stains

**38. Condition:** • Water Stains**Implication(s):** Chance of water damage to structure, finishes and contents

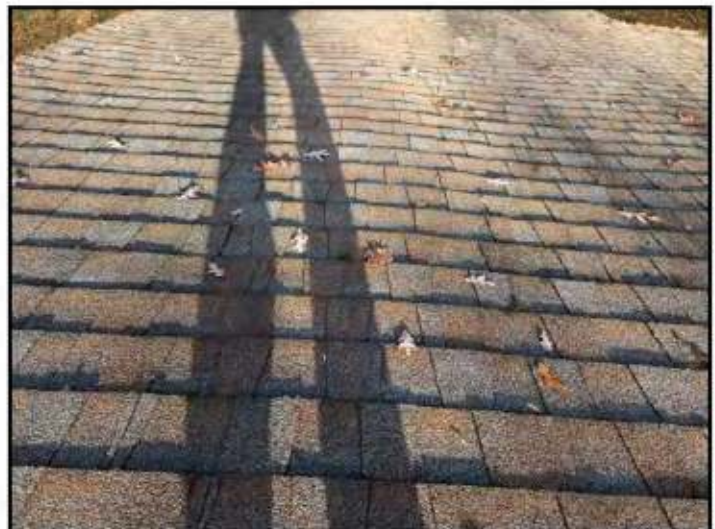
112. Buckled

**ROOF FRAMING \ Sheathing (roof/attic)****39. Condition:** • [Buckled](#)**Implication(s):** Weakened structure | Chance of structural movement**Task:** Further evaluation

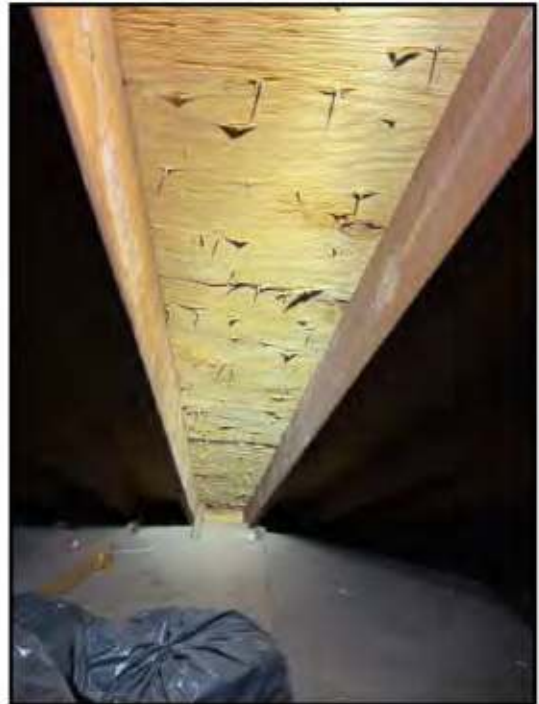
115. Damage

**114.** *Buckled***41. Condition:** • Damage**Implication(s):** Chance of water damage to structure, finishes and contents | Weakened structure**Task:** Further evaluation and repair

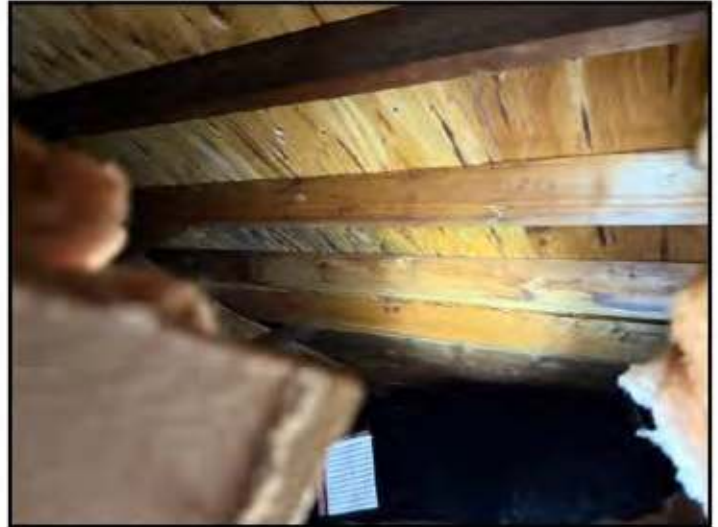
120. Water damage

43. Condition: • Water damage

Implication(s): Chance of water damage to structure, finishes and contents | Weakened structure

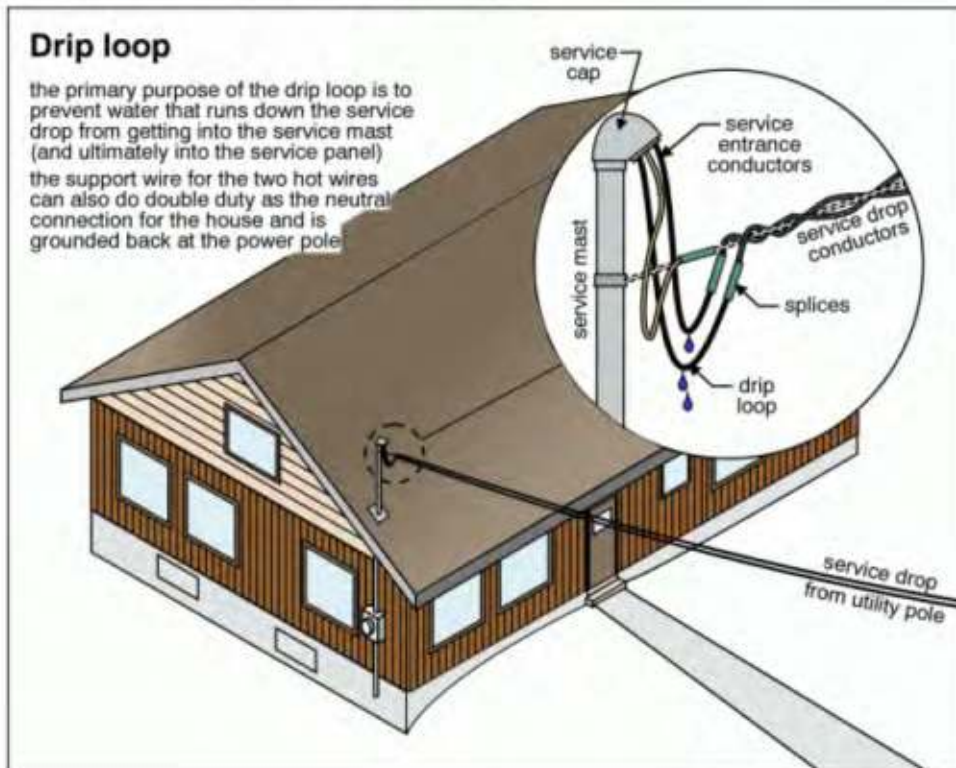
124. Poorly installed drip loop

45. Condition: • Poorly installed drip loop

Implication(s): Shock hazard or interruption of electrical service

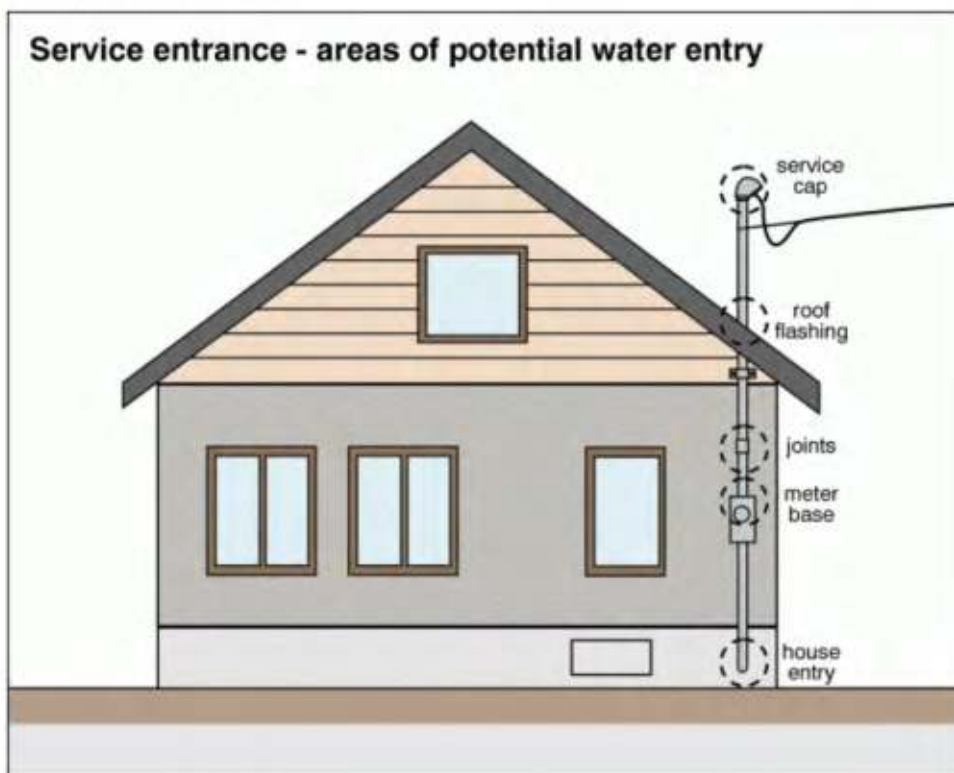
125. Rust or water in panel

46. Condition: • [Rust or water in panel](#)

Implication(s): Electric shock | Fire hazard

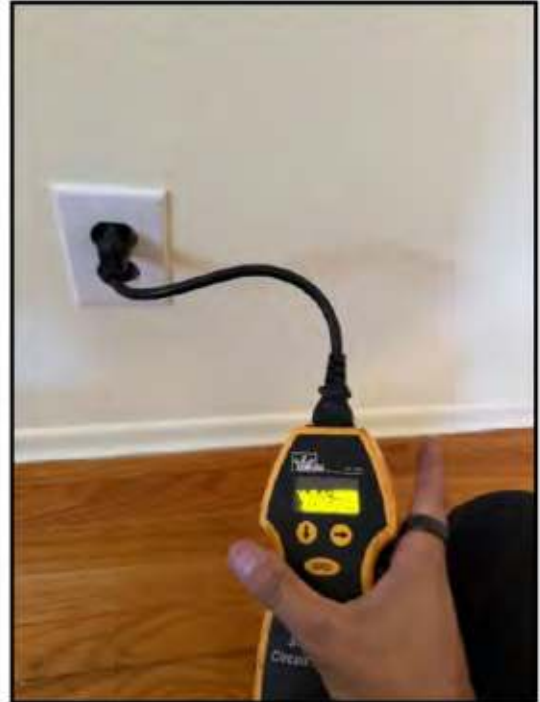
133. Loose

50. Condition: • [Loose](#)

Implication(s): Electric shock | Fire hazard

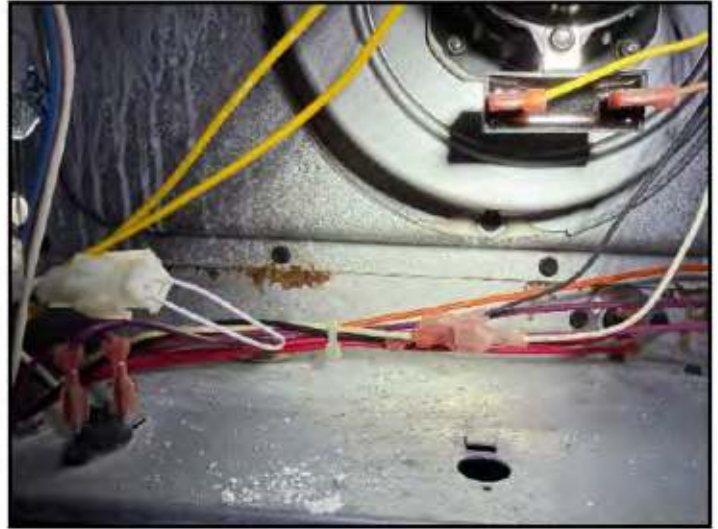
149. Rust, dirty, obstructed

62. Condition: • [Rust, dirty, obstructed](#)

Implication(s): Equipment not operating properly | Hazardous combustion products entering home

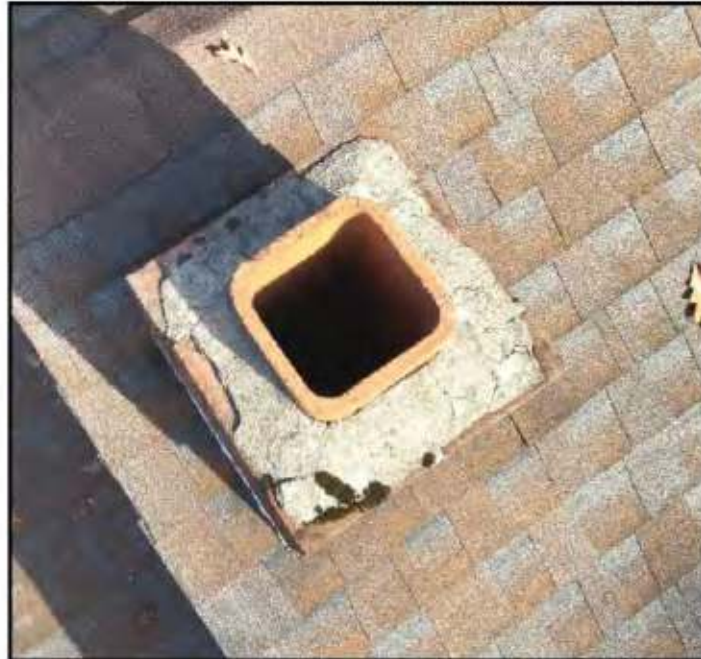
157. Rain cap missing or damaged

68. Condition: • [Rain cap missing or damaged](#)

Implication(s): Chance of water entering building | Chance of pests entering building

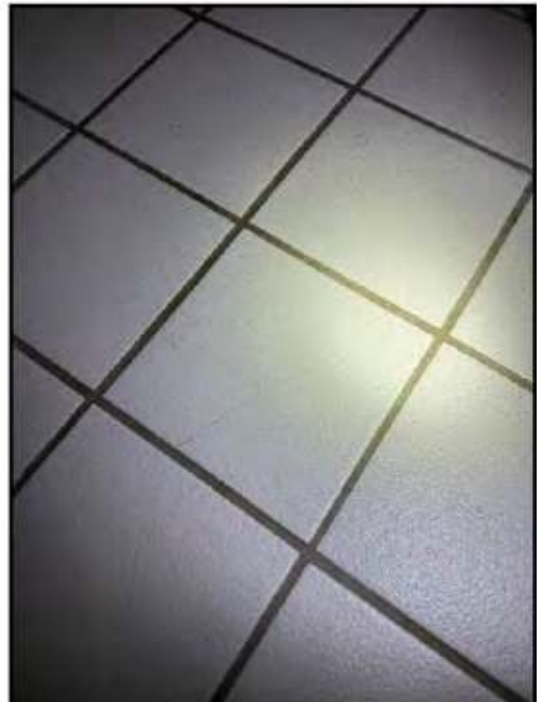
200. Tiles cracked

102. Condition: • [Tiles cracked](#)

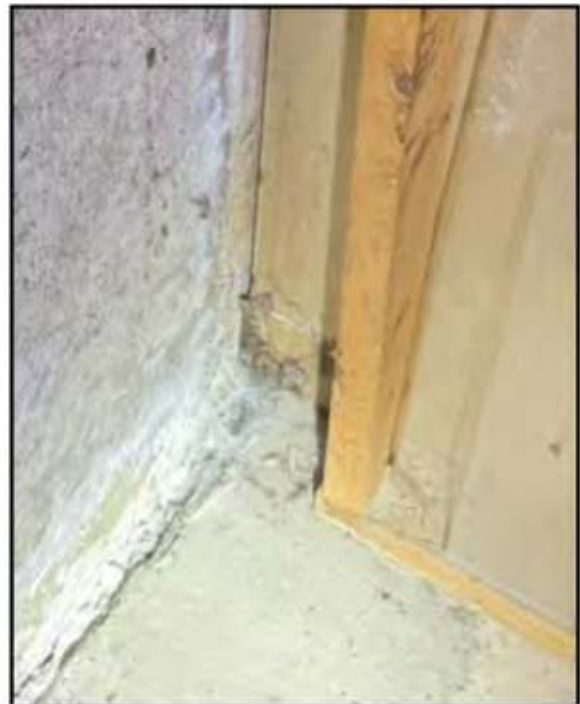
222. Mold

118. Condition: • **Mold**

Implication(s): Chance of water damage to structure, finishes and contents | Contaminants may enter building air

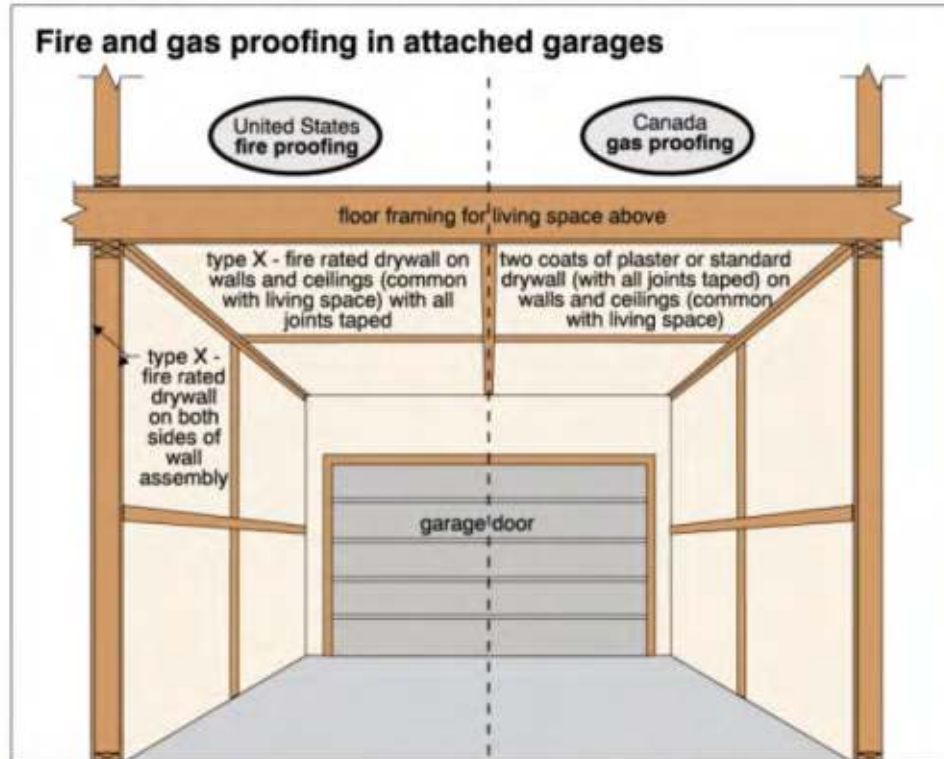
230. Missing sections of fire rated wall/ceiling...

121. Condition: • Missing sections of fire rated wall/ceiling assembly

Implication(s): Hazardous combustion products entering home

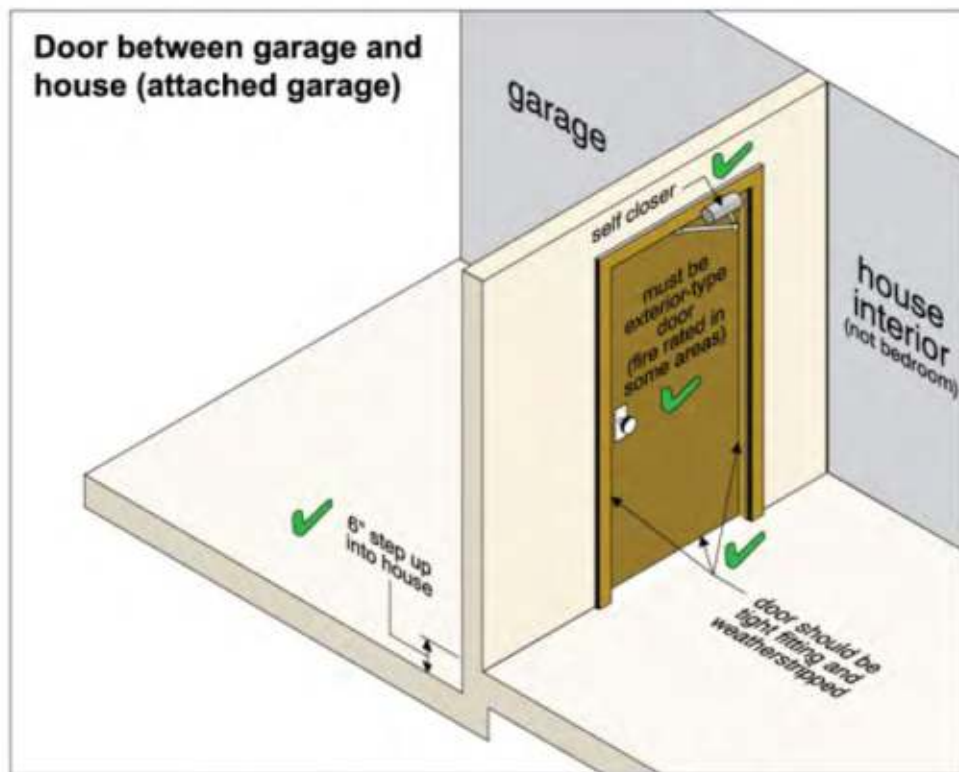
234. No self closer

Implication(s): Hazardous combustion products entering home

Location: Garage
