# Your Inspection Report

Tuesday, October 22, 2024

Leonardo Betancor, CMI, 24GI00182600, HOI.0001093

Smart Choice Inspections LLC  
173 Ridge Road, Suite H1  
Cedar Grove, NJ 07009

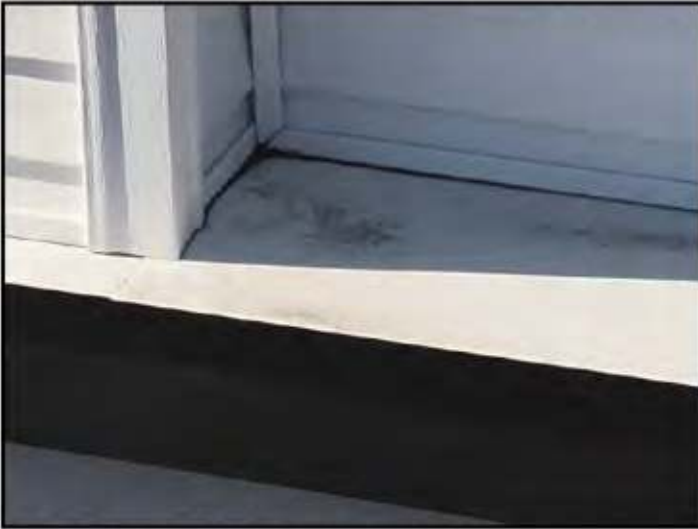
**Condition:** • Possible water infiltration behind EIFS

It appears that the small roof section above the front EIFS facade has an improper slope, pitched downward towards the building instead of away from it. This is causing water to seep into the wall cavity, as confirmed by thermal imaging and moisture readings. The first step in correcting this issue will be to rebuild the small roof sections with the correct pitch and open the wall cavity to inspect for water damage and mold.

1. Possible water infiltration behind EIFS

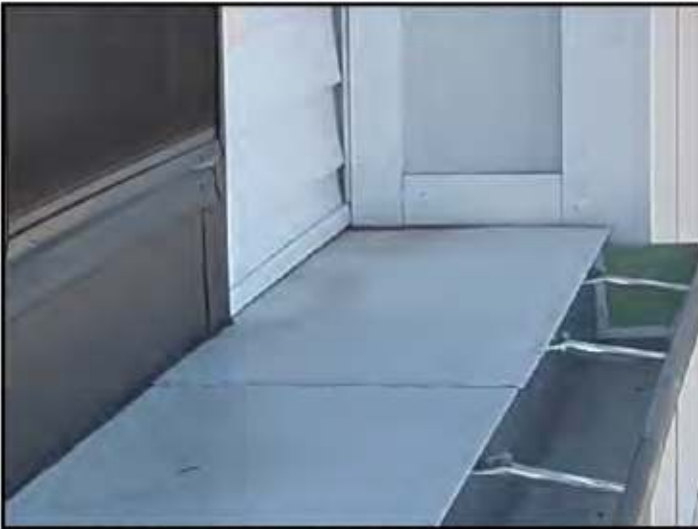
3. Possible water infiltration behind EIFS

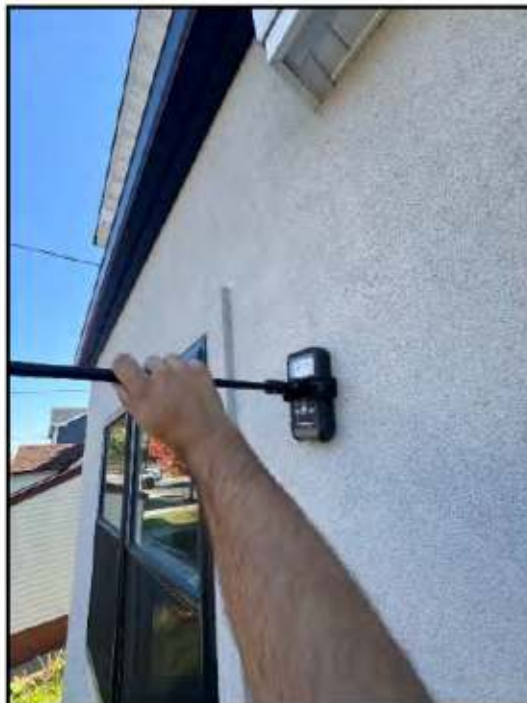
7. Possible water infiltration behind EIFS

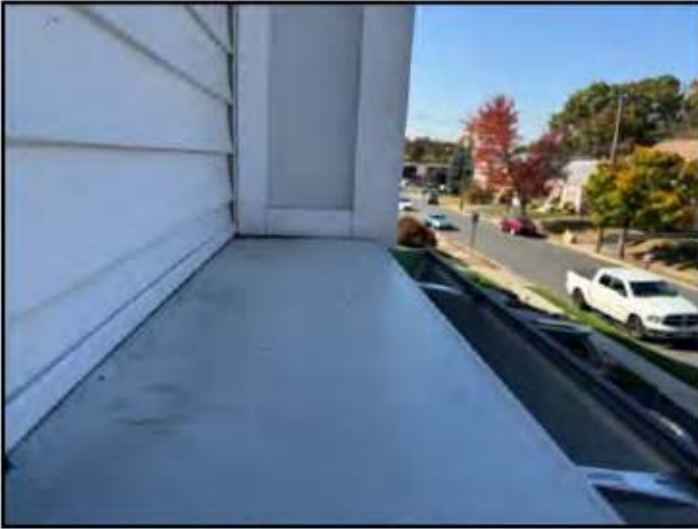
9. Possible water infiltration behind EIFS

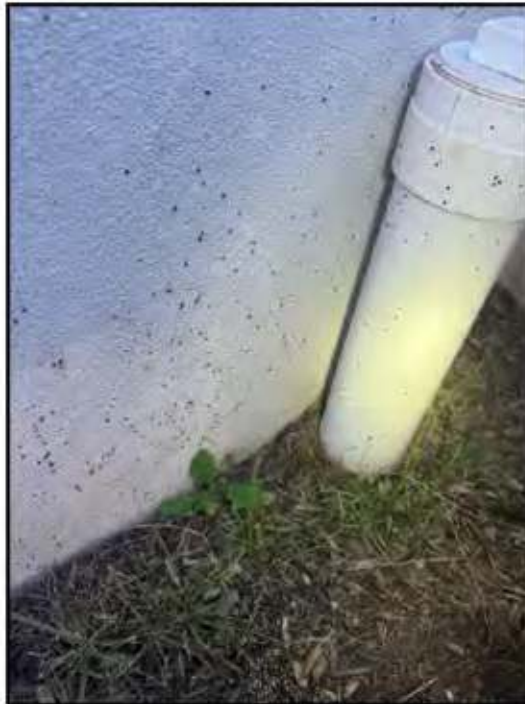
**Condition:** • Possible water infiltration behind EIFS

It appears that artillery fungus is growing in the mulch near the EIFS siding, possibly due to a moisture issue behind the siding. This type of fungus thrives in moist, decaying organic matter and shoots tiny black spores onto nearby surfaces, creating small, tar-like specks that stick to walls and siding. The suspected water issue behind the EIFS could be contributing to the favorable conditions for this fungus. To address this, it's essential to investigate and resolve any water intrusion issues behind the siding, and consider replacing the mulch with non-organic alternatives, such as stones, or refreshing it regularly to discourage fungal growth.

11. Possible water infiltration behind EIFS

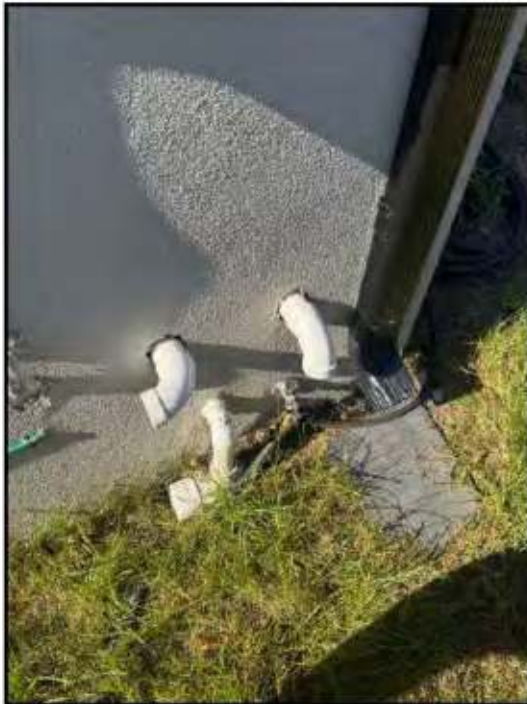
#### **Condition:** • [Poor vent location, arrangement](#)

**Implication(s):** Equipment not operating properly | Equipment inoperative | Hazardous combustion products entering home

12. Poor vent location, arrangement

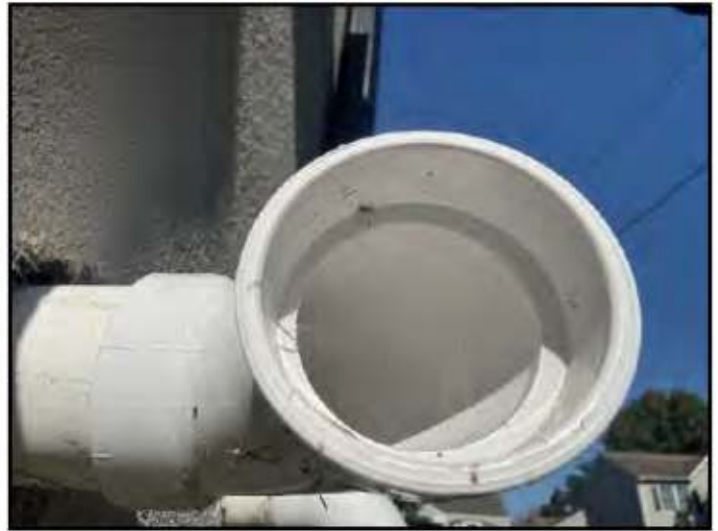
13. Poor vent location, arrangement

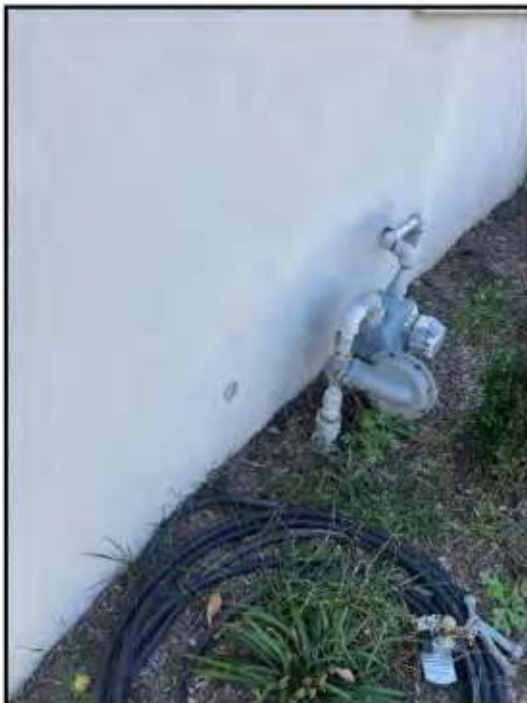
14. Poor vent location, arrangement

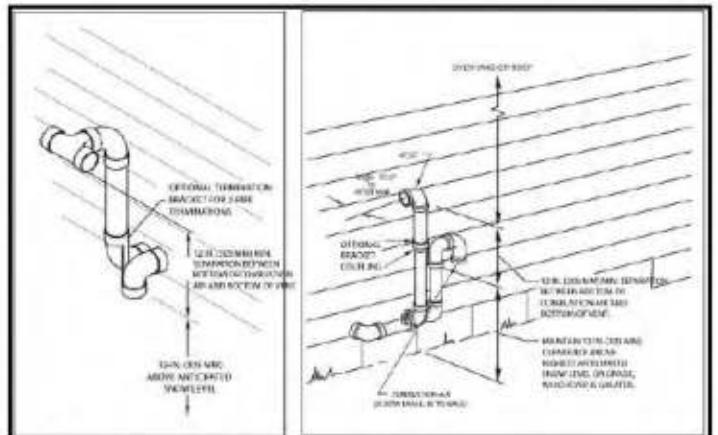
15. Poor vent location, arrangement

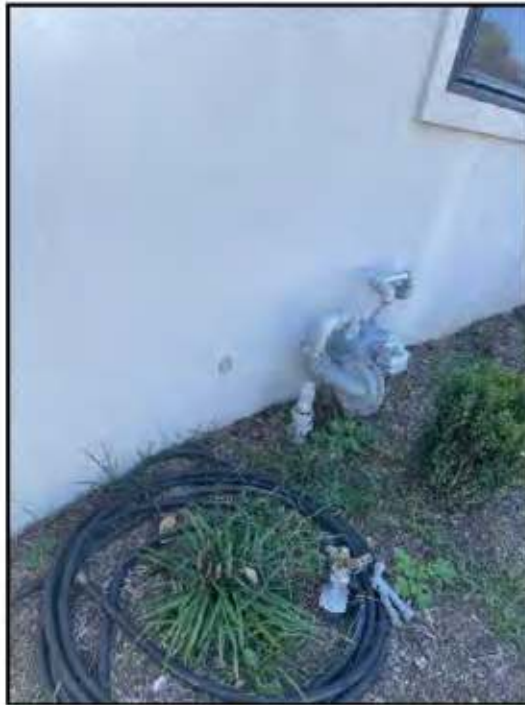
Condition: • [Poor vent location, arrangement](#)

Missing vent piping

Implication(s): Equipment not operating properly | Equipment inoperative | Hazardous combustion products

16. Poor vent location, arrangement

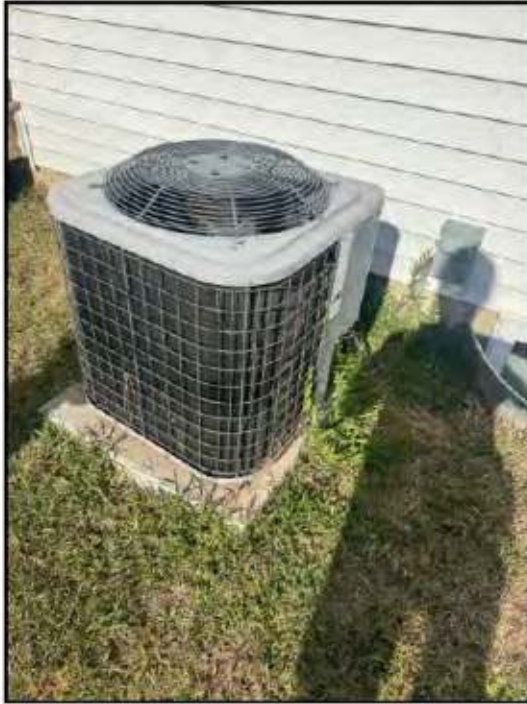
**Condition:** • Vegetation around compressor

**Implication(s):** Decreased efficiency

17. Vegetation around compressor

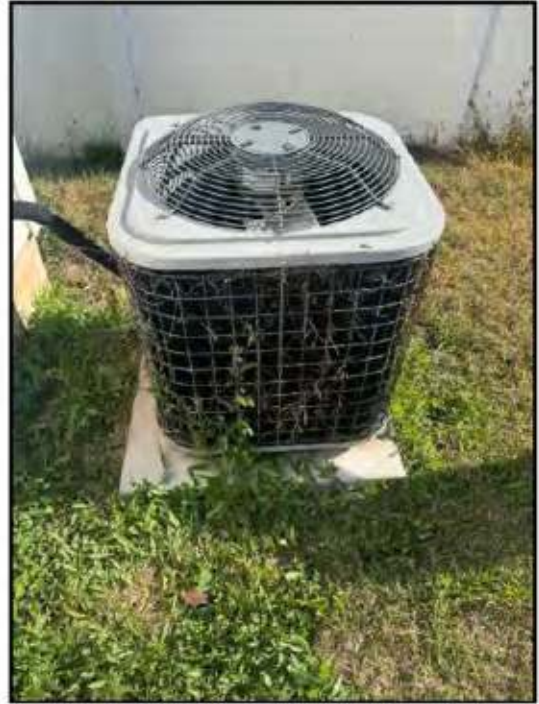
18. Vegetation around compressor

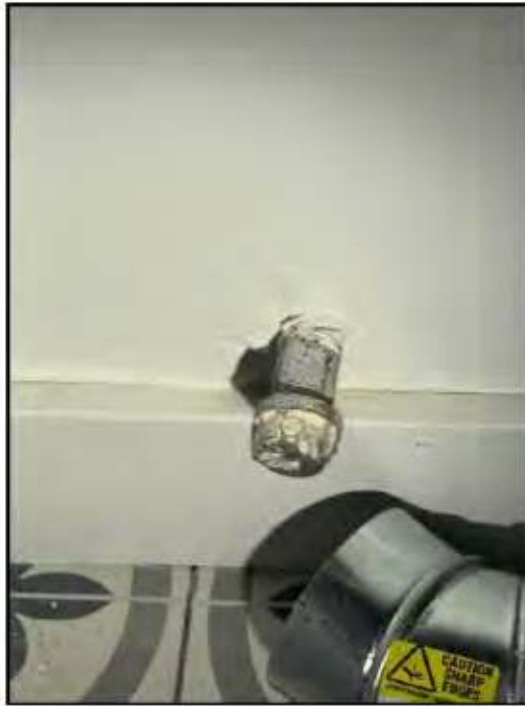
Condition: • [Missing shut off valve](#)

Implication(s): Difficult to service

Location: Laundry Area

19. Missing shut off valve

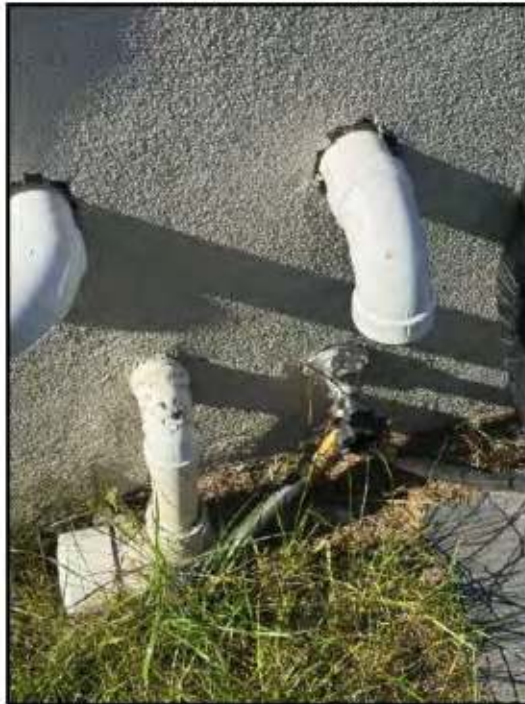
**Condition:** • Sump pump discharge point was not found at time of the inspection

20. Sump pump discharge point was not found at...

**Task:** Further evaluation

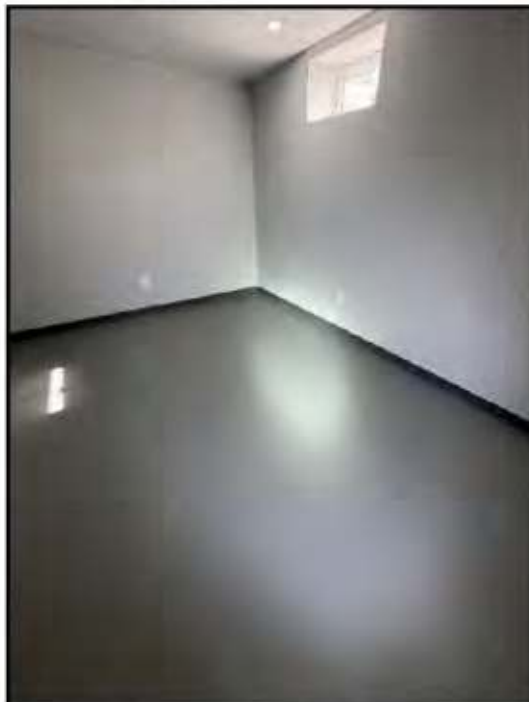
**Condition:** • Questionable installation

A lower section of the basement appears to be missing a French drain and sump pump system. Water marks can be seen on the door, approximately 8-10 inches high.

21. Questionable installation

**Task:** Further evaluation

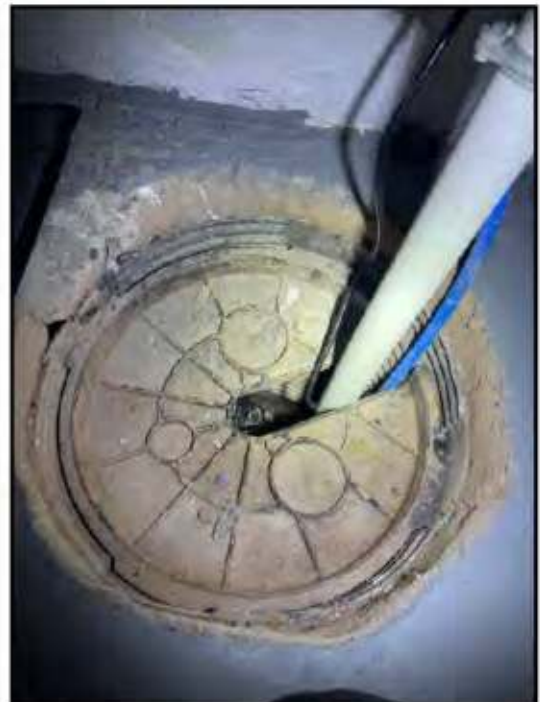
22. Questionable installation

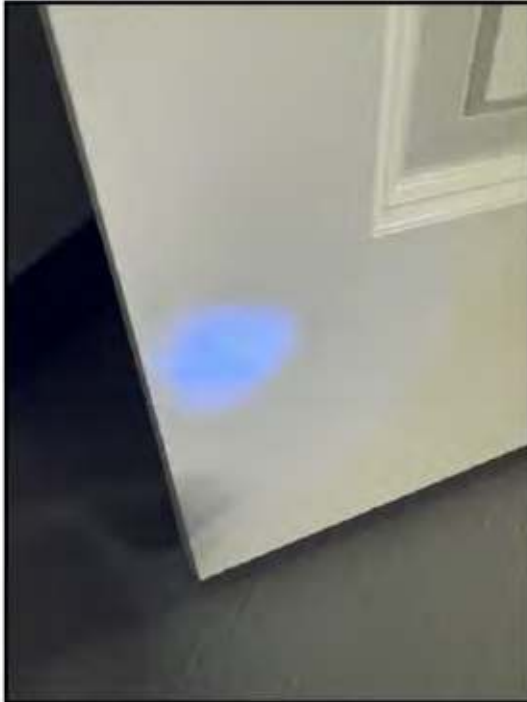
23. Questionable installation

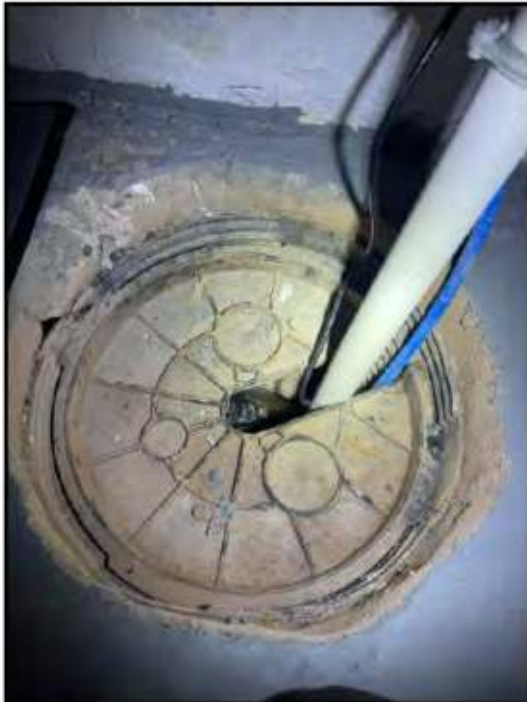
Condition: • Sump pump emergency backup system is highly recommended

25. Sump pump emergency backup system is highly...

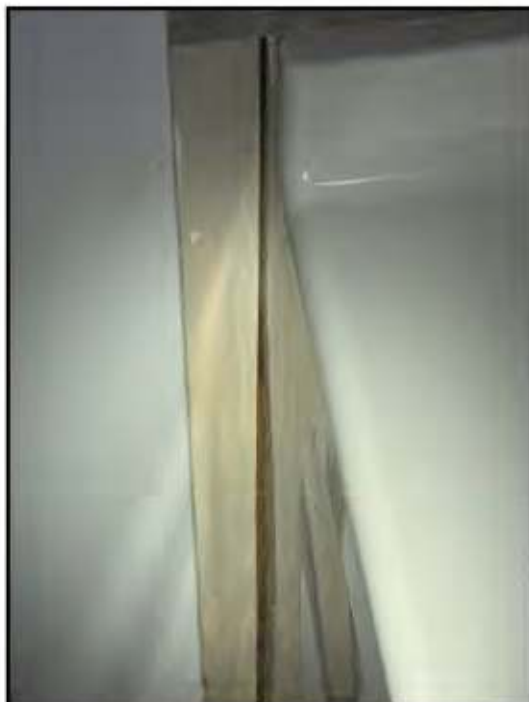
**FIXTURES AND FAUCETS \ Bathtub enclosure****Condition:** • [Tile loose, broken or missing](#)**Implication(s):** Chance of water damage to structure, finishes and contents**Location:** Basement Bathroom

**27.** Tile loose, broken or missing

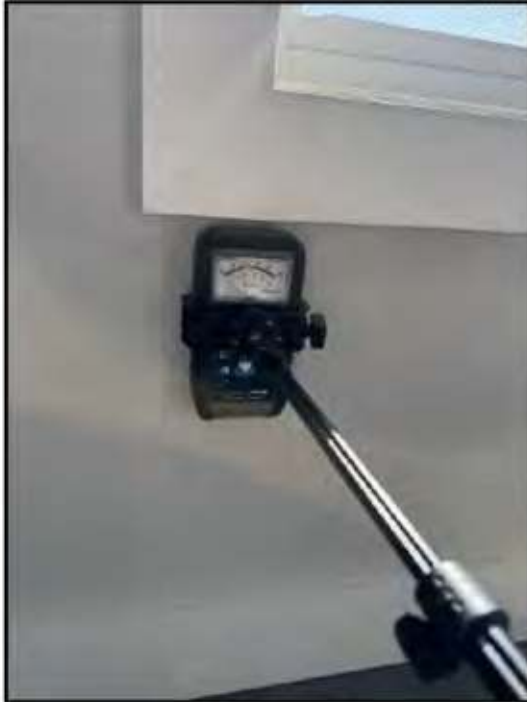
**Condition:** • Active water leak detected

**Implication(s):** Chance of movement, Rot, Leakage

**Location:** Rear Second Floor Bedroom

29. Active water leak detected

**Task:** Further evaluation

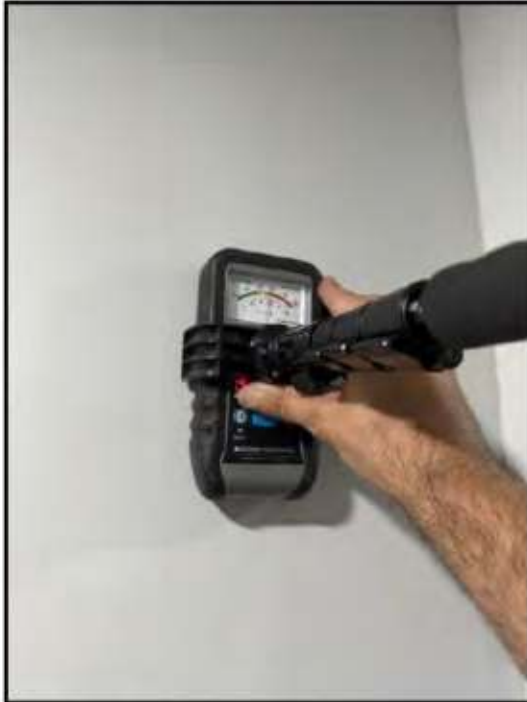
**Condition:** • Active water leak detected

The area appears to be located below the EIFS water infiltration point.

**Implication(s):** Chance of movement, Rot, Leakage

31. Active water leak detected

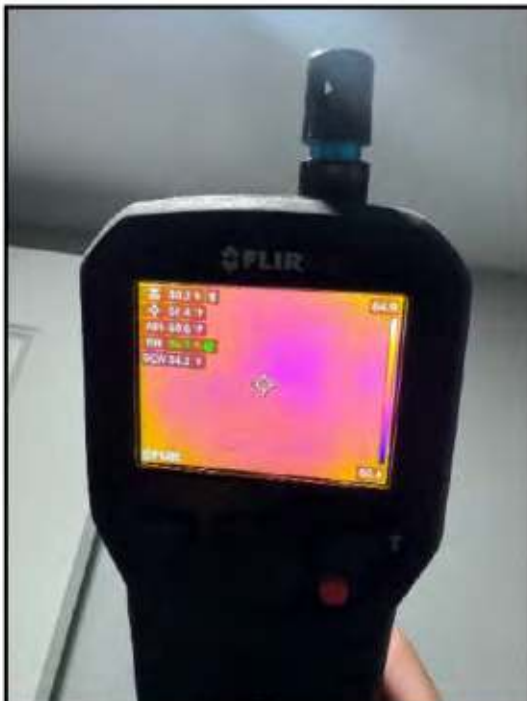
33. Active water leak detected

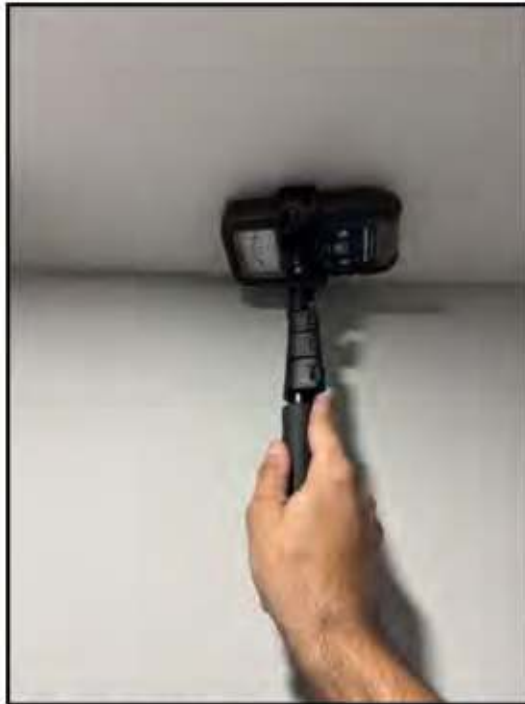
35. Active water leak detected

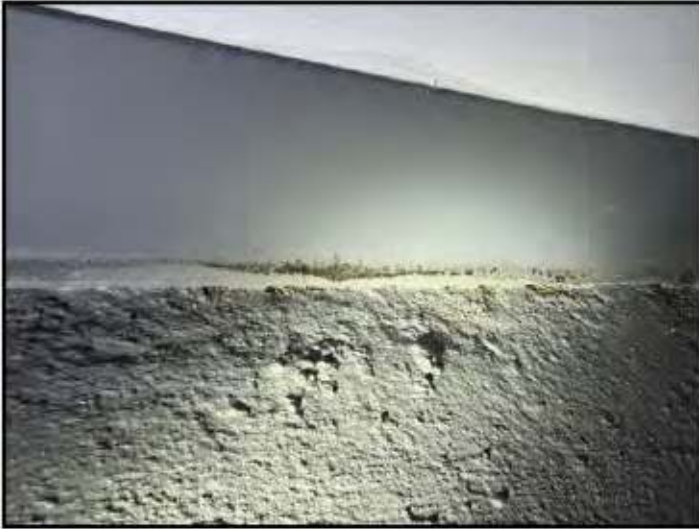
**BASEMENT \ Wet basement - evidence**Condition: • [Mold](#)

Implication(s): Chance of water damage to structure, finishes and contents | Contaminants may enter building air

37. Mold

**Task:** It is recommended to have a mold remediation company properly clean the mold seen throughout the basement. Given the extent of the issue, some drywall may need to be removed during this process.

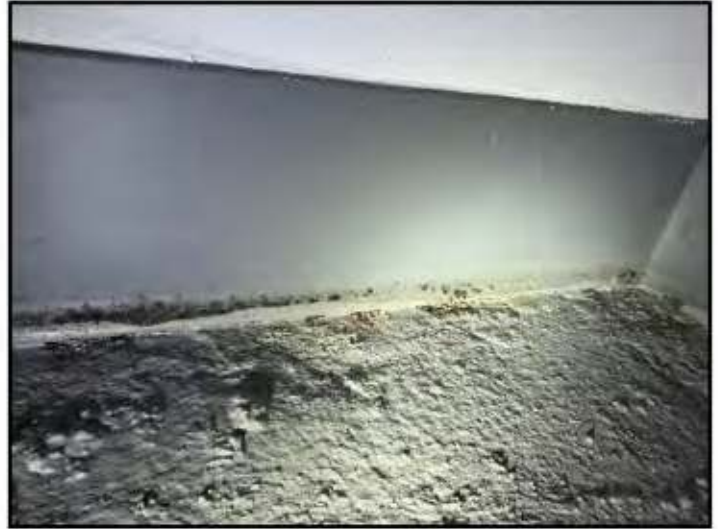
38. Mold

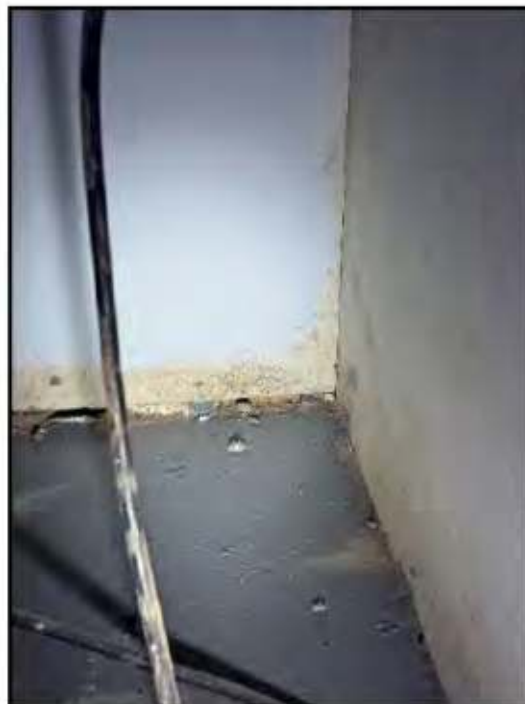
39. Mold

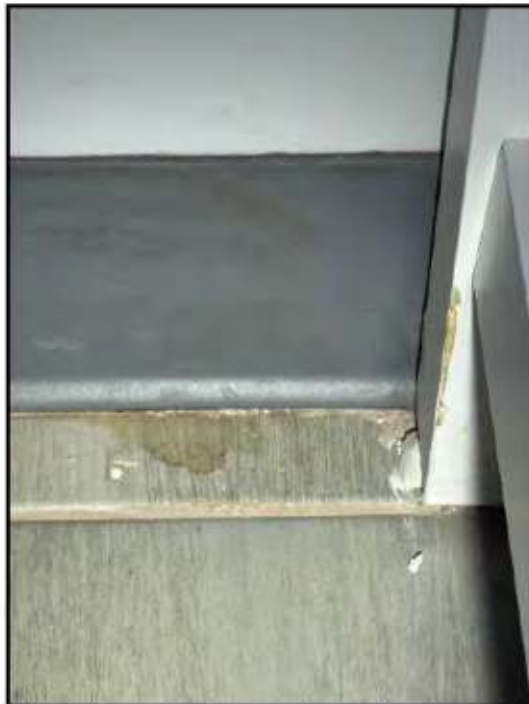
Condition: • [Water marks](#)

Implication(s): Chance of water damage to structure, finishes and contents

40. Water marks

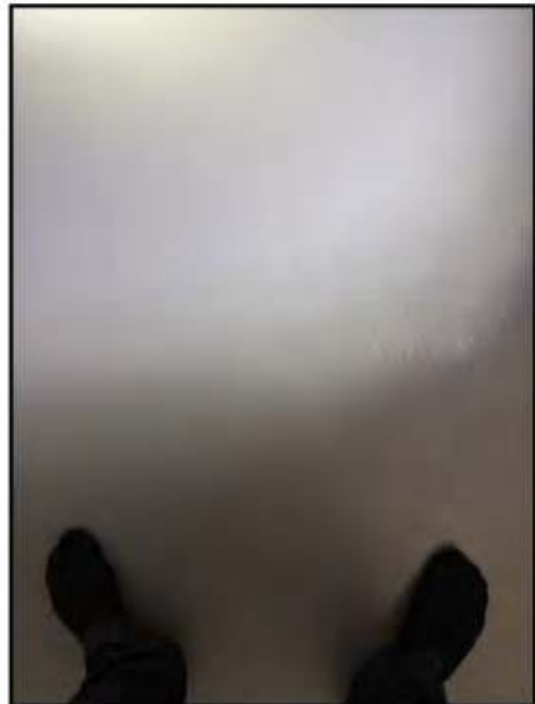
41. Water marks

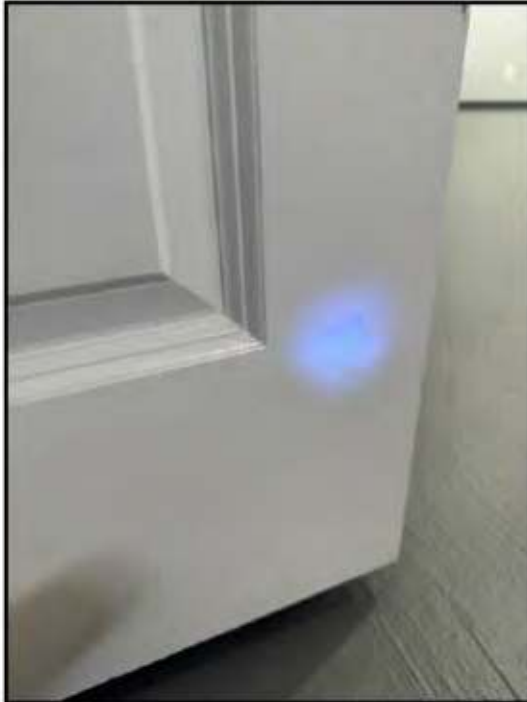
42. Water marks

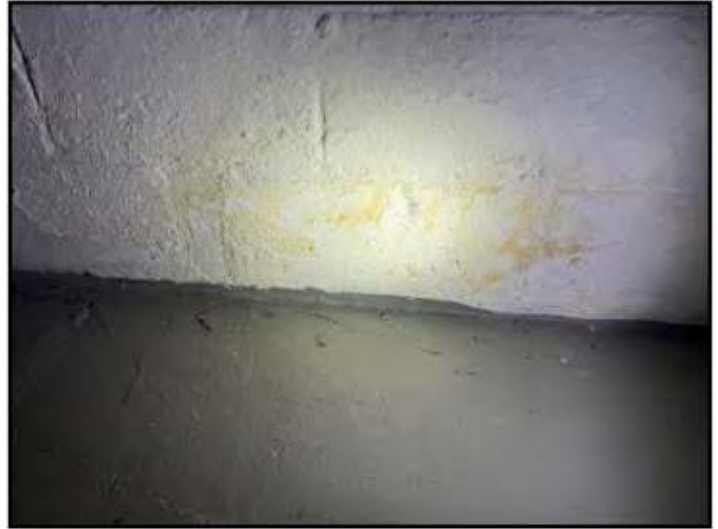
43. Water marks

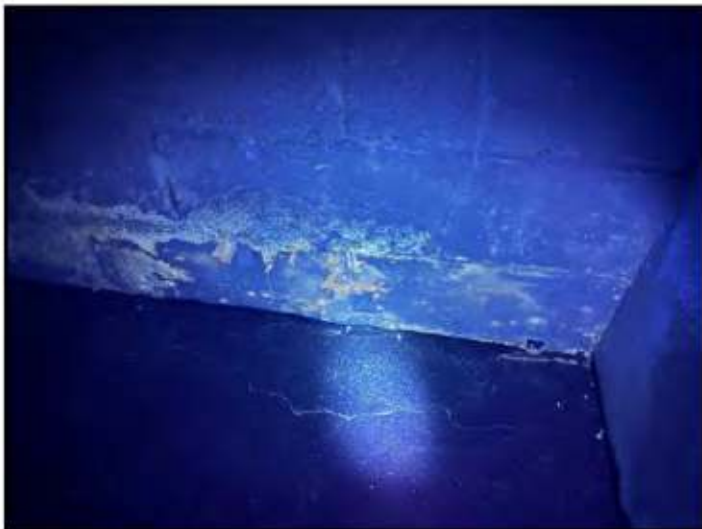
44. Water marks

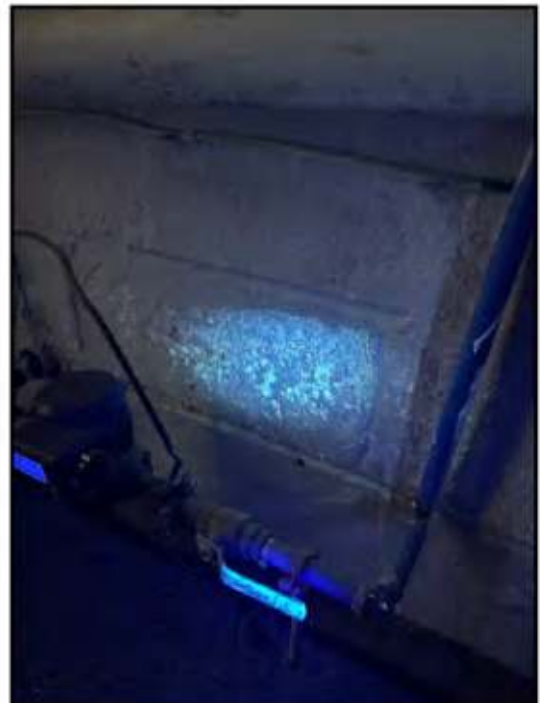
45. Water marks

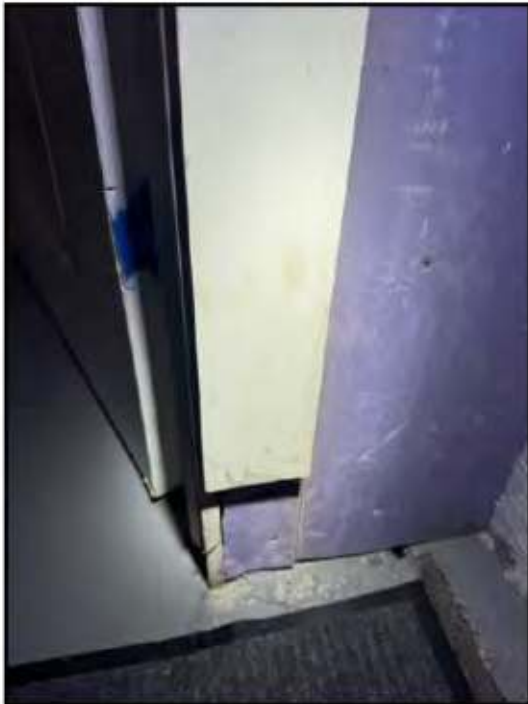
46. Water marks

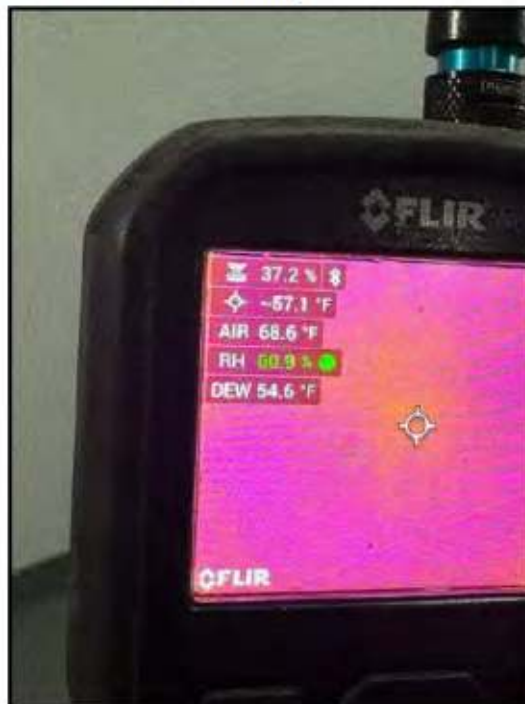
**Condition:** • Humidity levels over 60%

60.9% of relative humidity was detected in basement. Humidity levels over 60% inhibit mold growth.

48. Humidity levels over 60%

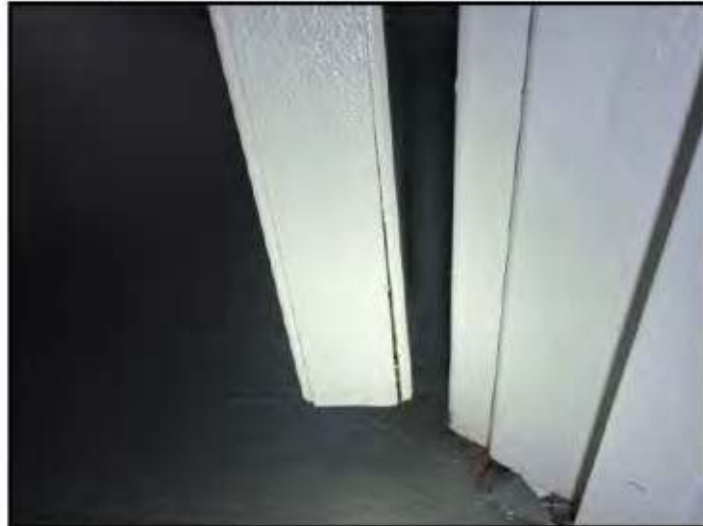
**Condition:** • Water damage

**Implication(s):** Chance of water damage to structure, finishes and contents, Material deterioration

49. Water damage

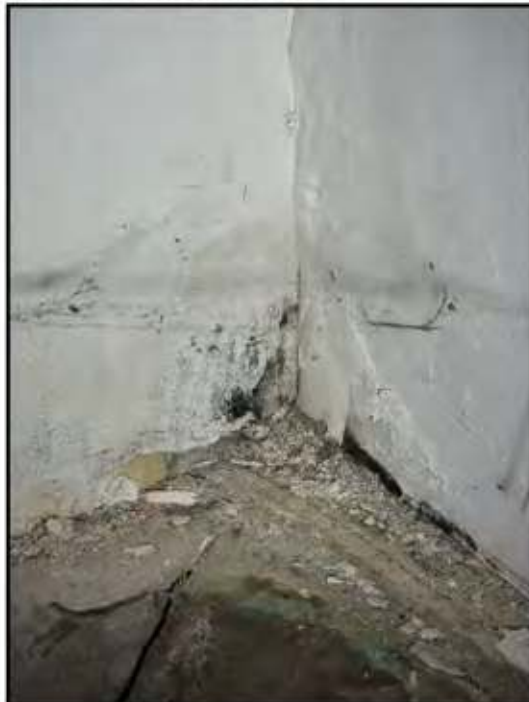
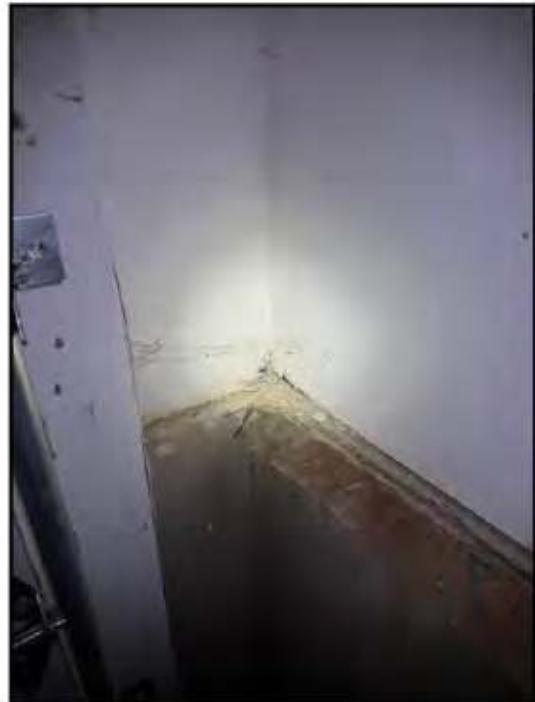
**Condition:** • Mold

**Implication(s):** Health hazard

**Location:** Garage

50. Mold

51. Mold

**Task:** Further evaluation and repair

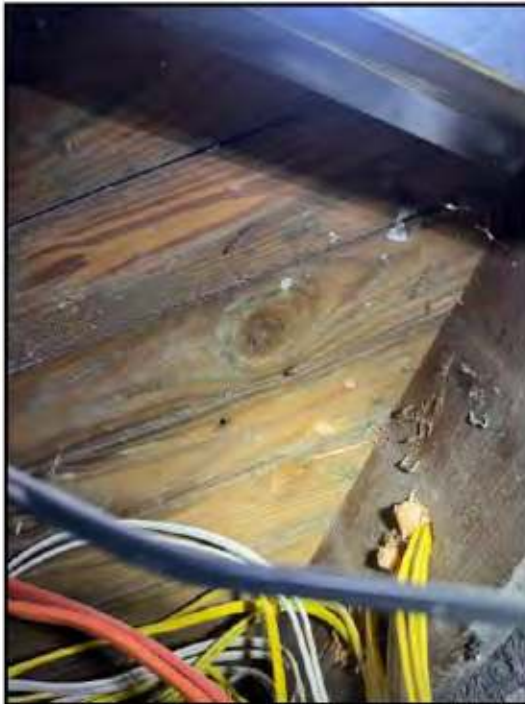
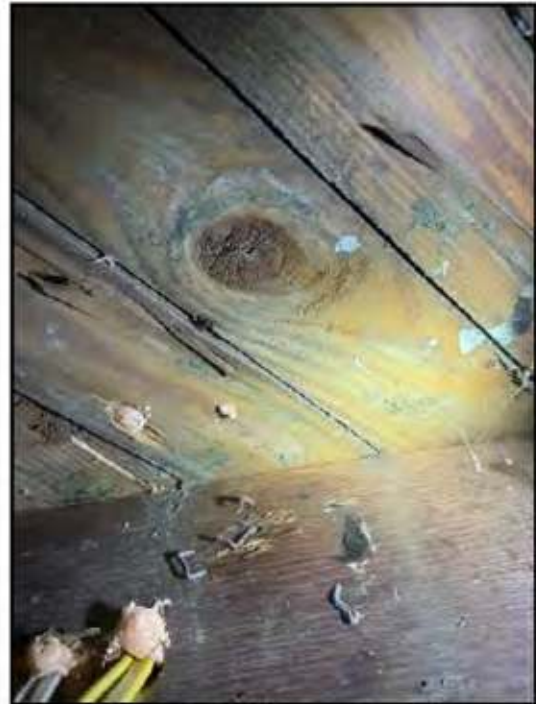
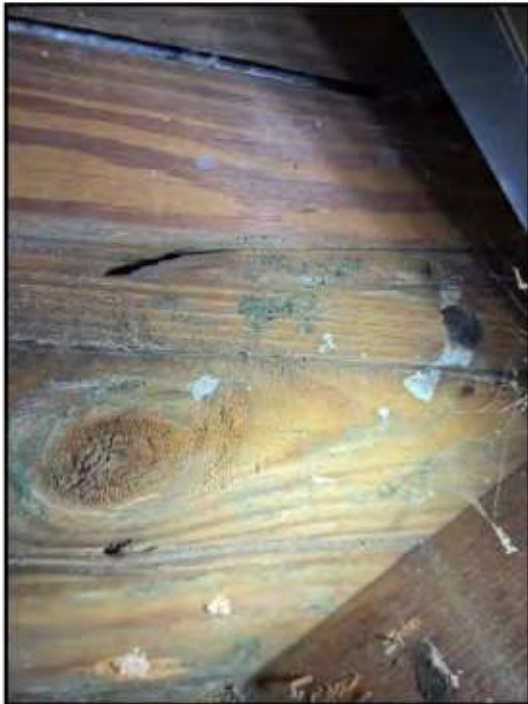
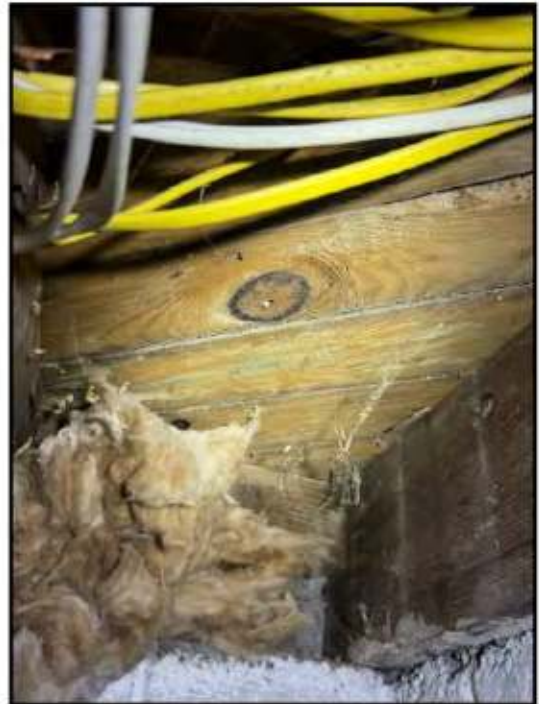
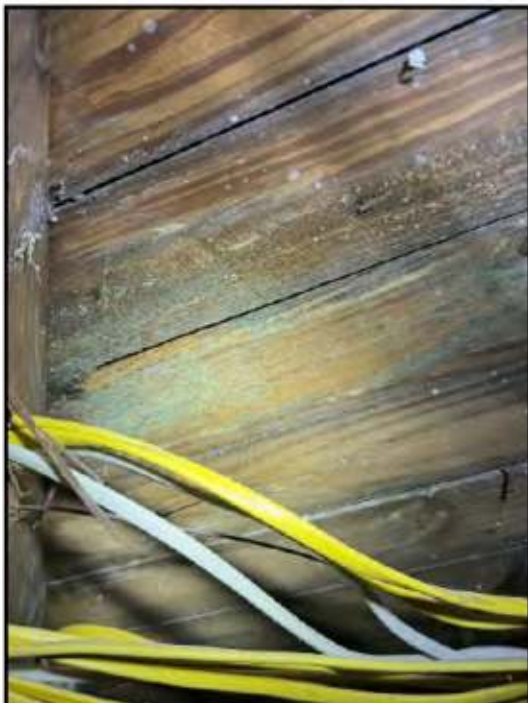
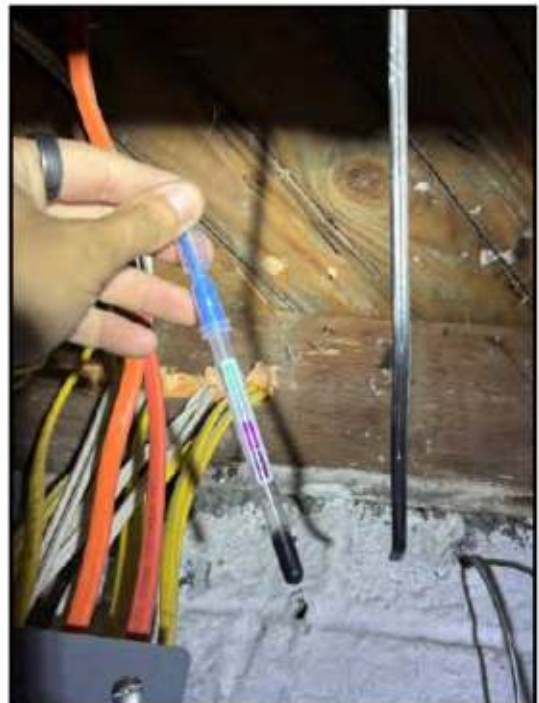
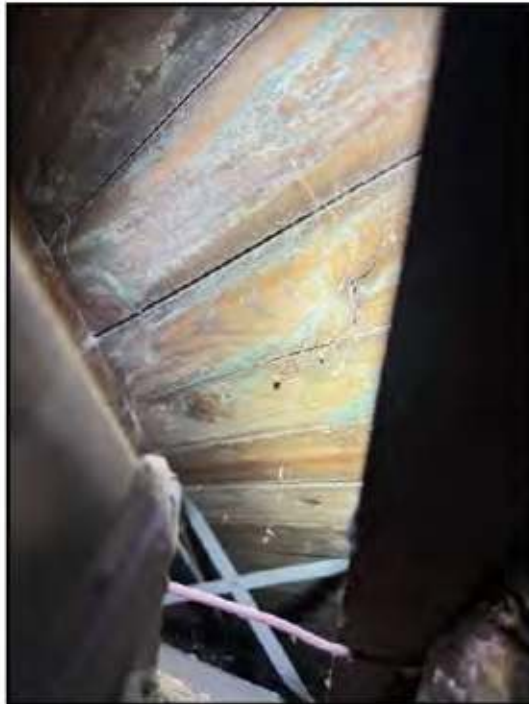
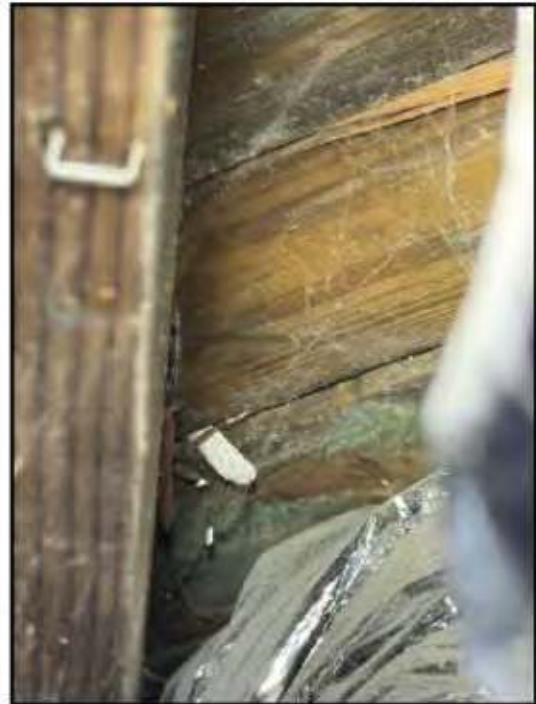
**Condition:** • Positive mold test swab

**Location:** Throughout basement

52. Positive mold test swab

53. Positive mold test swab

54. Positive mold test swab

55. Positive mold test swab

56. Positive mold test swab

57. Positive mold test swab

58. Positive mold test swab

59. Positive mold test swab

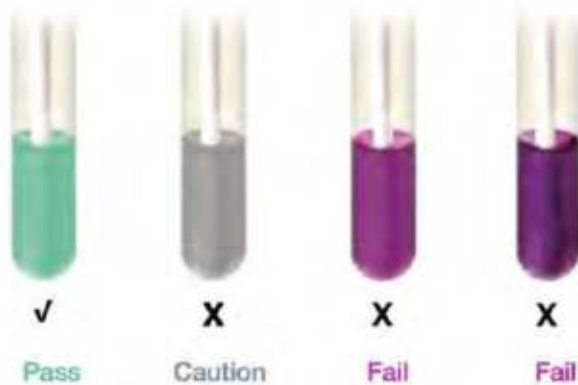
60. Positive mold test swab

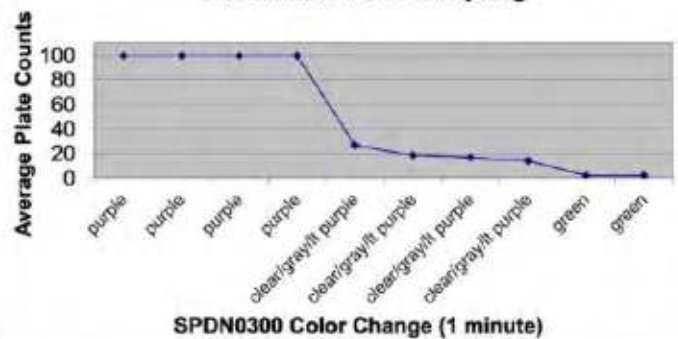
61. Positive mold test swab

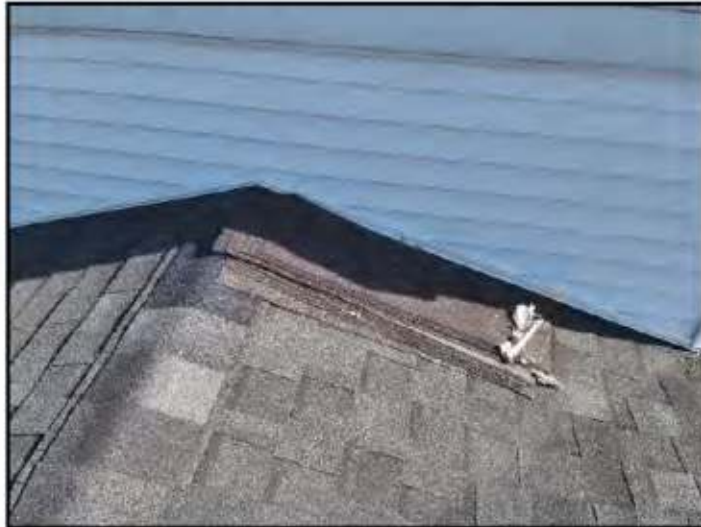
1. Condition: • Debris/moss

Debris left on roof

Implication(s): Shortened life expectancy of material

62. Debris/moss

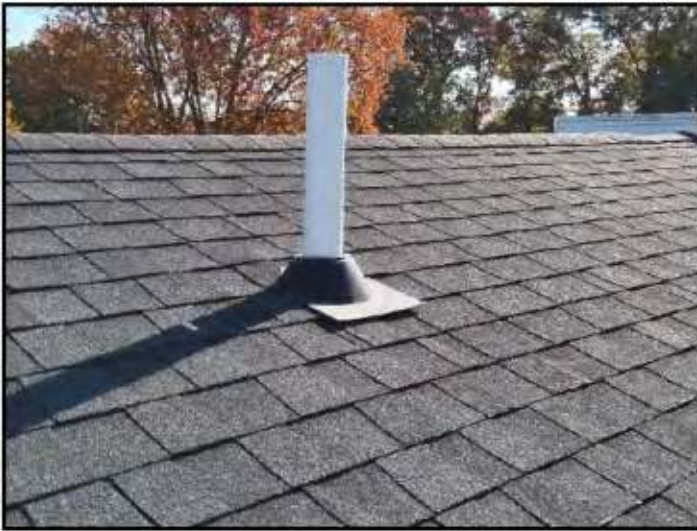
2. Condition: • Loose

63. Loose

Recommend nailing flashing down and sealing over nails

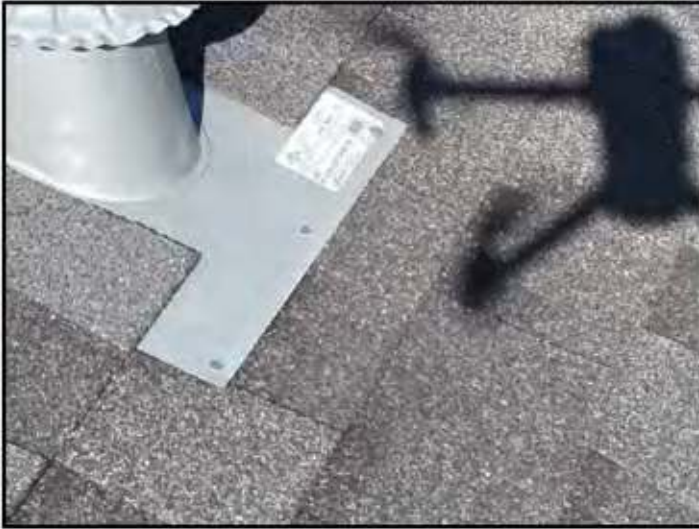
3. Condition: • [Fasteners - exposed / missing](#)

Implication(s): Chance of water damage to structure, finishes and contents

65. Fasteners - exposed / missing

Recommend sealing over fasteners

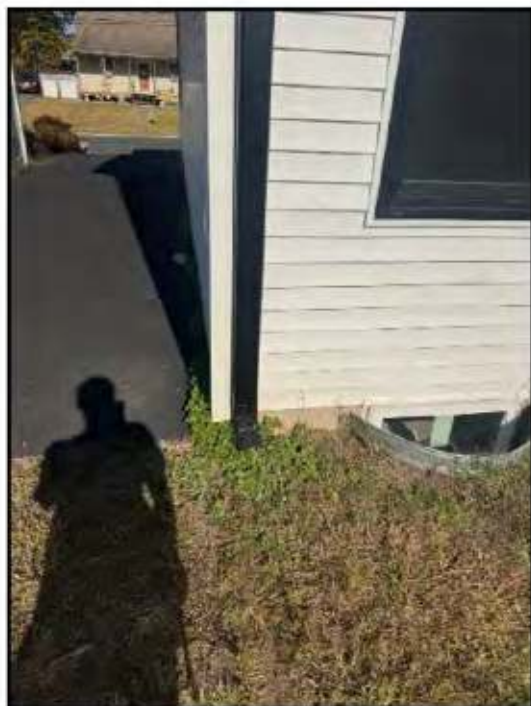
4. Condition: • [Discharge too close to building](#)

Implication(s): Chance of water damage to structure, finishes and contents

67. Discharge too close to building

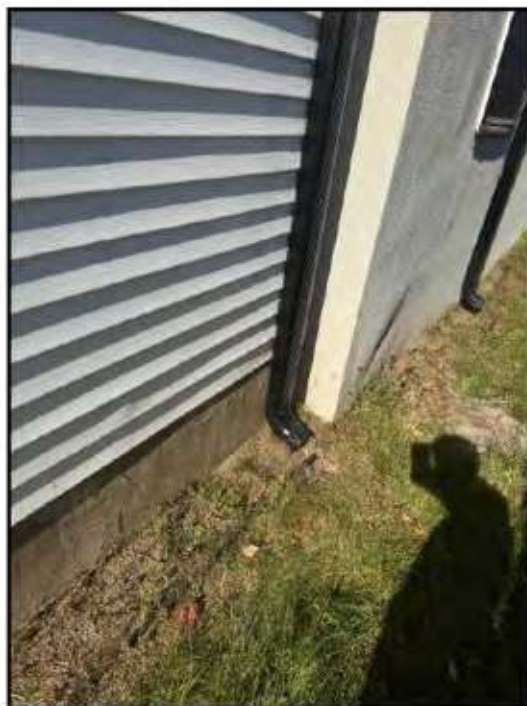
68. Discharge too close to building

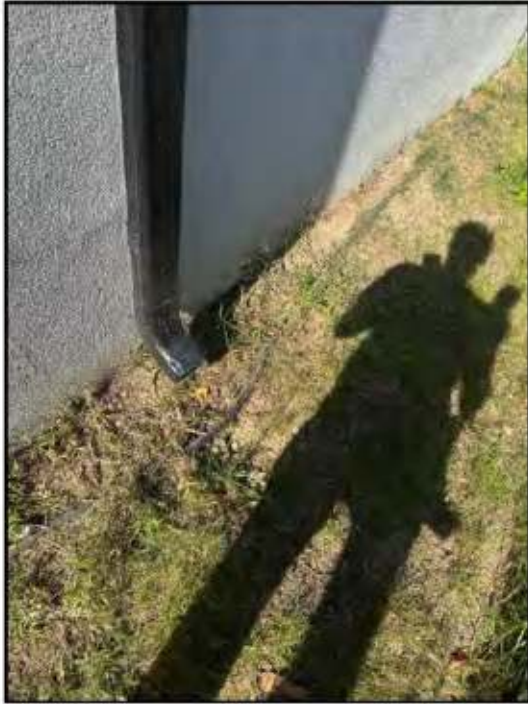
69. Discharge too close to building

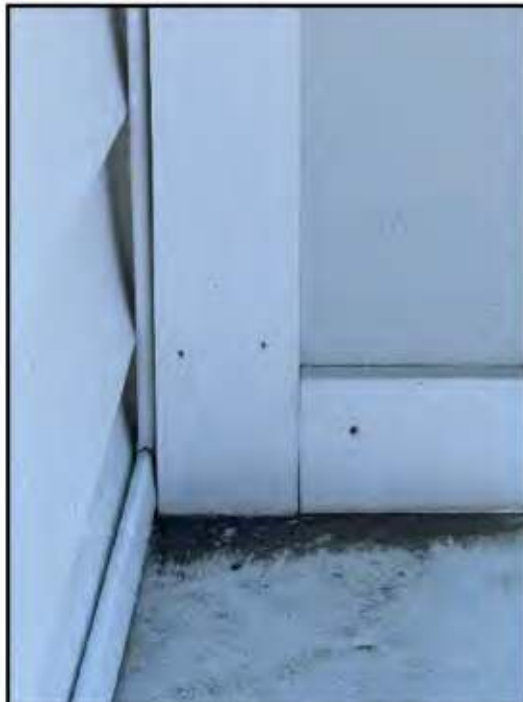
**WALLS \ Trim****5. Condition:** • Exposed fasteners

71. Exposed fasteners

Recommend sealing nails holes to prevent them from rusting.

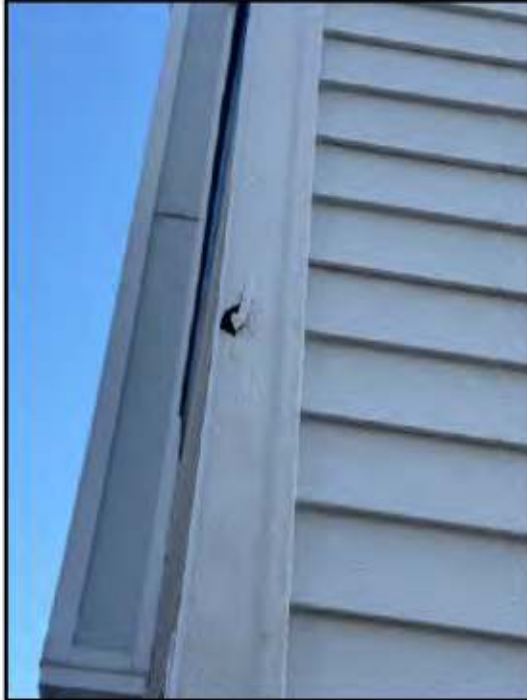
**WALLS \ Vinyl siding****6. Condition:** • [Mechanical damage](#)**Implication(s):** Chance of water damage to structure, finishes and contents

**72. Mechanical damage**

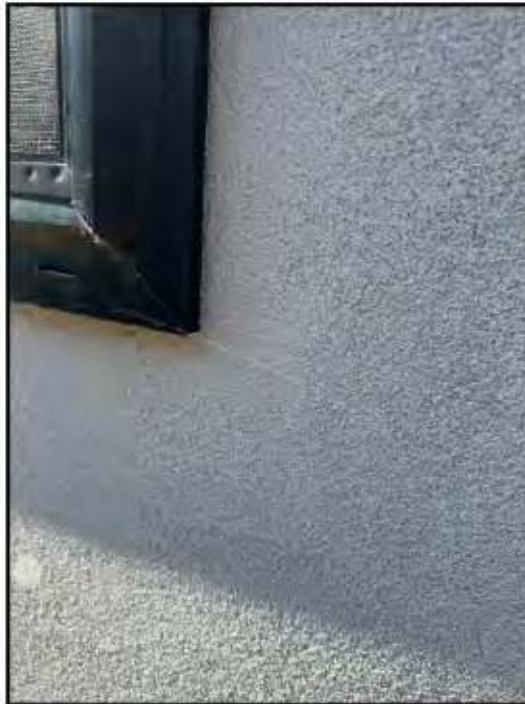
**73. Mechanical damage****WALLS \ EIFS (Exterior Insulation and Finishing System)****7. Condition:** • [Cracked](#)**Implication(s):** Chance of water damage to structure, finishes and contents | Material deterioration**Location:** Left Side

74. Cracked

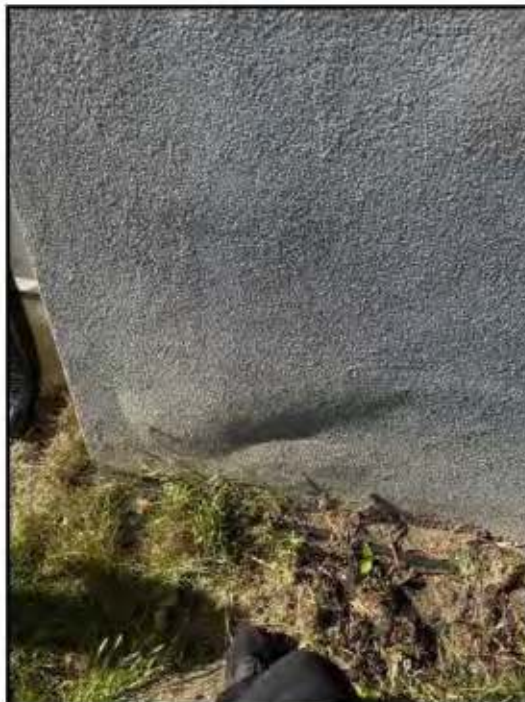
**8. Condition:** • [Bulging](#)

**Implication(s):** Chance of water damage to structure, finishes and contents | Material deterioration

**Location:** Left Side

75. Bulging

**Task:** Further evaluation

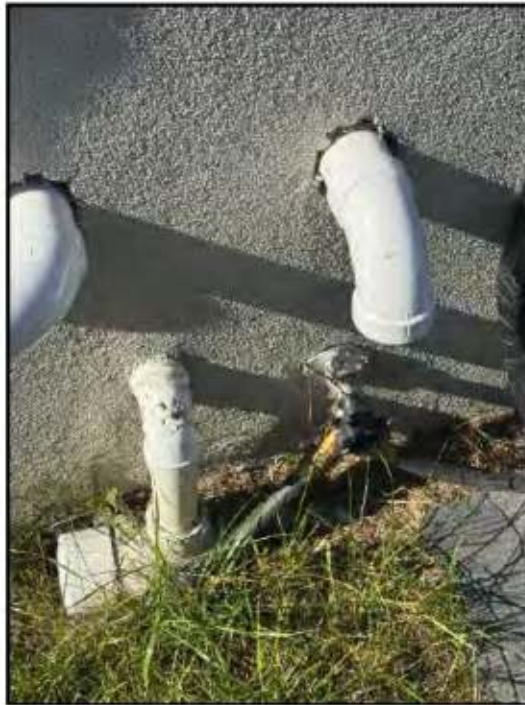
**9. Condition:** • Unsealed openings

**76. Unsealed openings****10. Condition:** • Possible water infiltration behind EIFS
