# Your Inspection Report

Tuesday, October 22, 2024

Leonardo Betancor, CMI, 24GI00182600, HOI.0001093

Smart Choice Inspections LLC  
173 Ridge Road, Suite H1  
Cedar Grove, NJ 07009

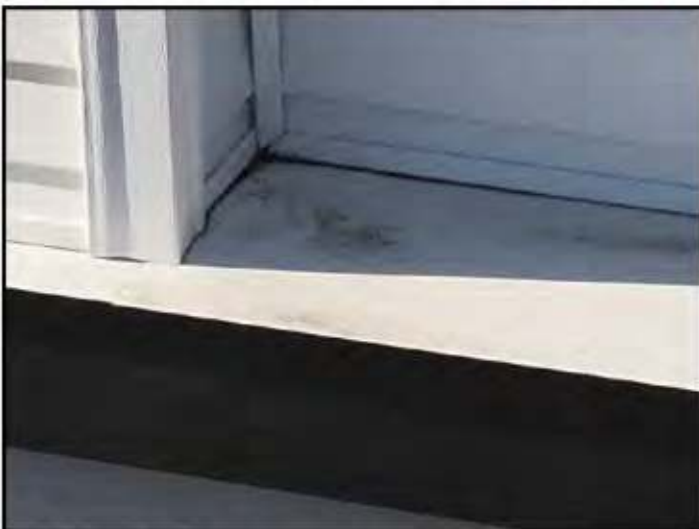
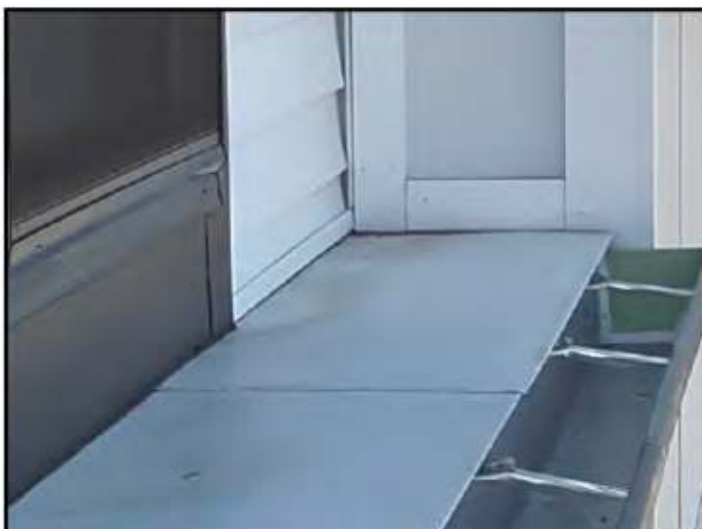
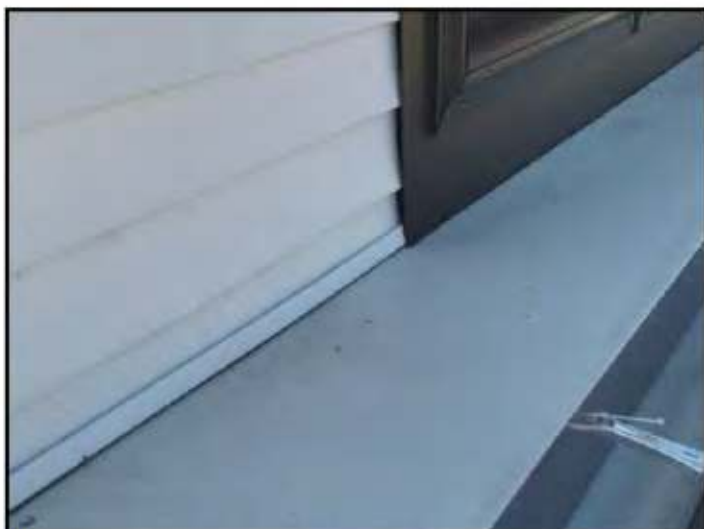
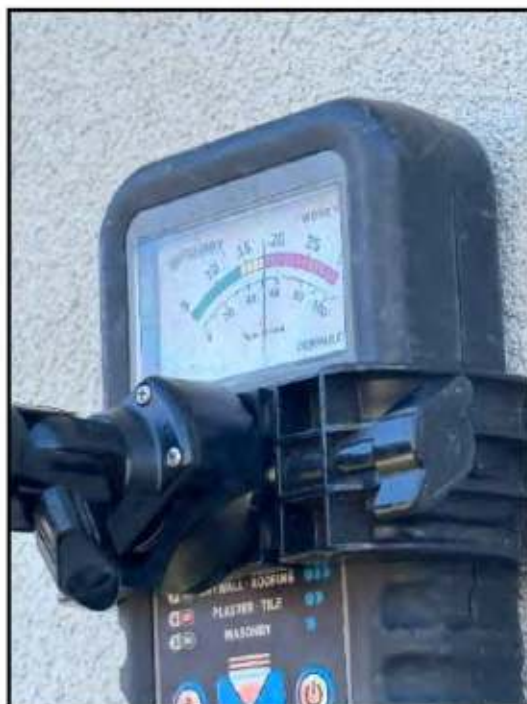
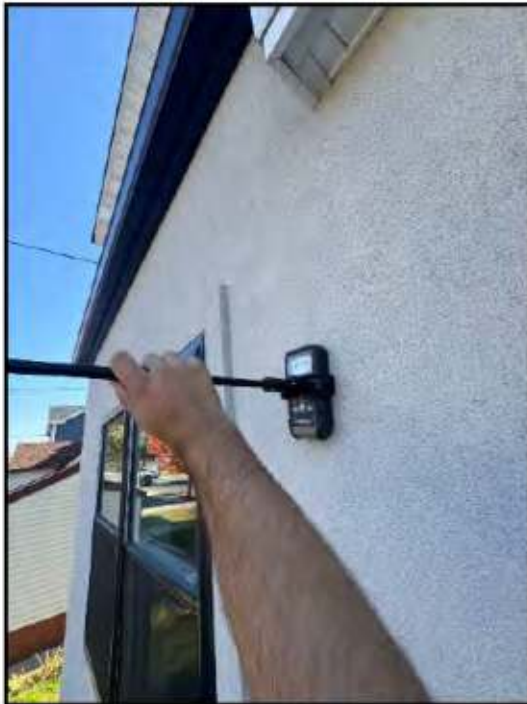
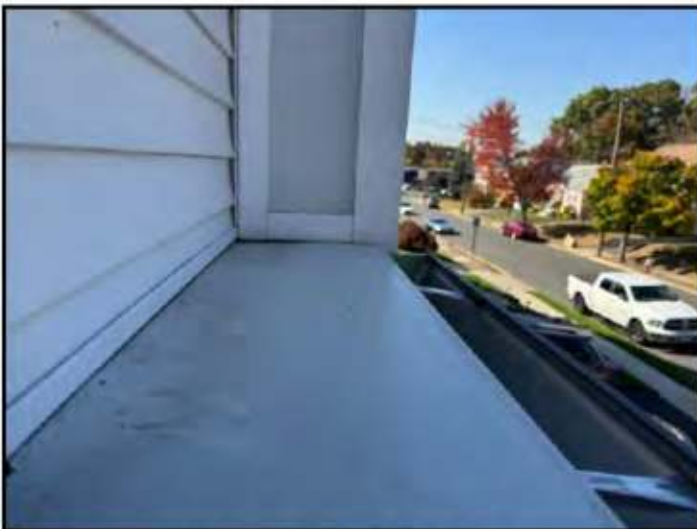
It appears that the small roof section above the front EIFS facade has an improper slope, pitched downward towards the building instead of away from it. This is causing water to seep into the wall cavity, as confirmed by thermal imaging and moisture readings. The first step in correcting this issue will be to rebuild the small roof sections with the correct pitch and open the wall cavity to inspect for water damage and mold.

**77. Possible water infiltration behind EIFS**

79. Possible water infiltration behind EIFS

80. Possible water infiltration behind EIFS

82. Possible water infiltration behind EIFS

83. Possible water infiltration behind EIFS

85. Possible water infiltration behind EIFS

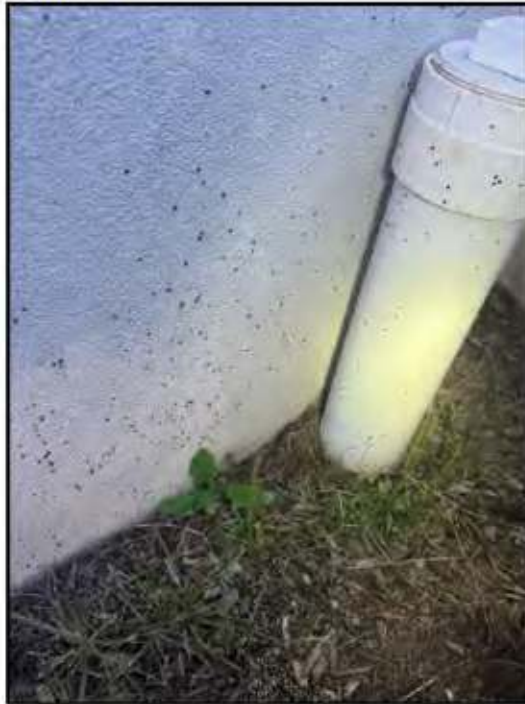
It appears that artillery fungus is growing in the mulch near the EIFS siding, possibly due to a moisture issue behind the siding. This type of fungus thrives in moist, decaying organic matter and shoots tiny black spores onto nearby surfaces,

creating small, tar-like specks that stick to walls and siding. The suspected water issue behind the EIFS could be contributing to the favorable conditions for this fungus. To address this, it's essential to investigate and resolve any water intrusion issues behind the siding, and consider replacing the mulch with non-organic alternatives, such as stones, or refreshing it regularly to discourage fungal growth.

87. Possible water infiltration behind EIFS

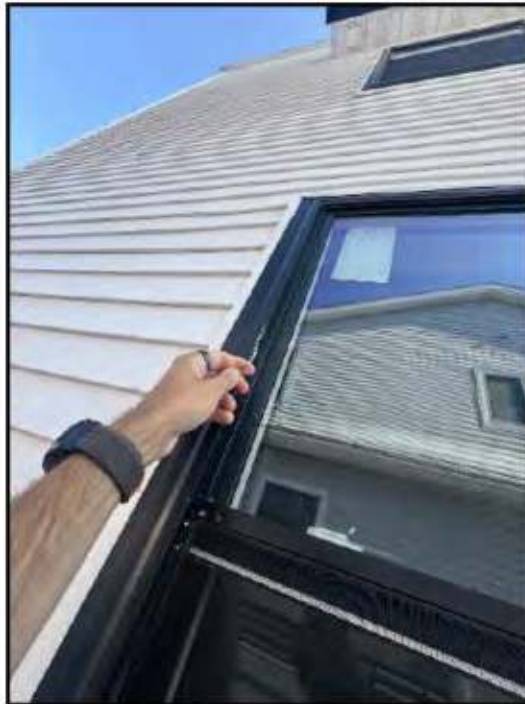
12. Condition: • Damage

Location: Various

88. *Damage*

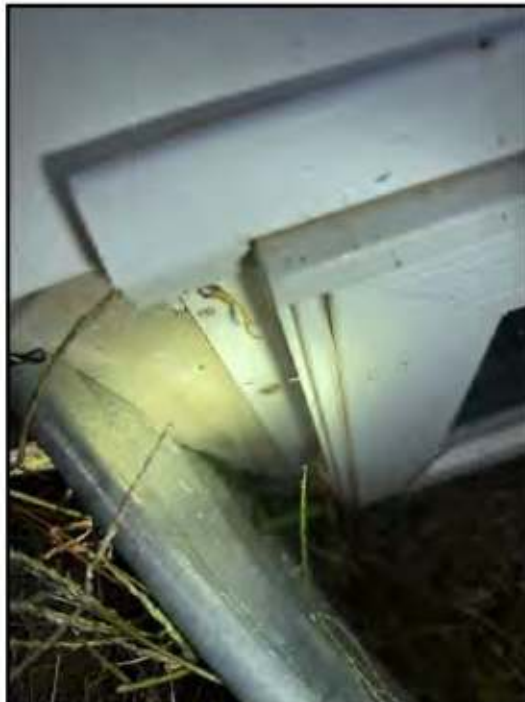
13. Condition: • [Missing or loose pieces](#)

Implication(s): Chance of water damage to structure, finishes and contents

89. *Missing or loose pieces*

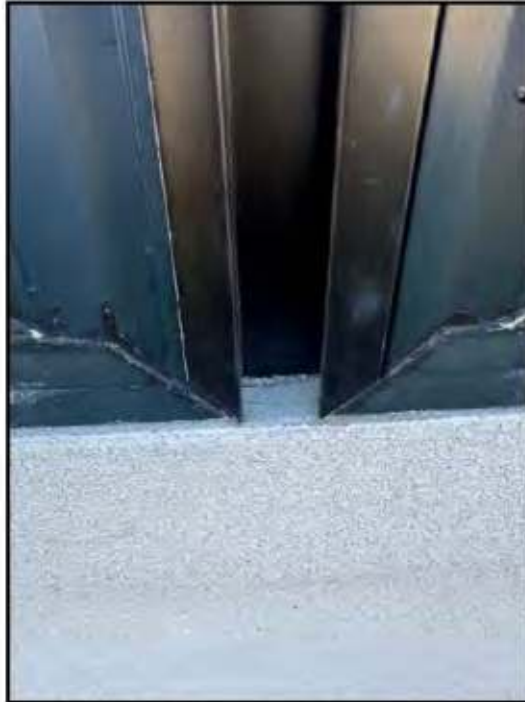
14. Condition: • [Missing or loose pieces](#)

Implication(s): Chance of water damage to structure, finishes and contents

Location: Front

90. Missing or loose pieces

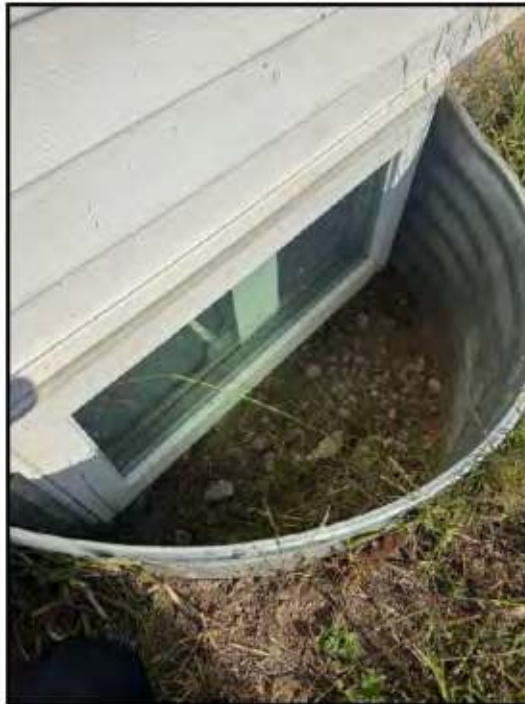
15. Condition: • Window well cover missing

91. Window well cover missing

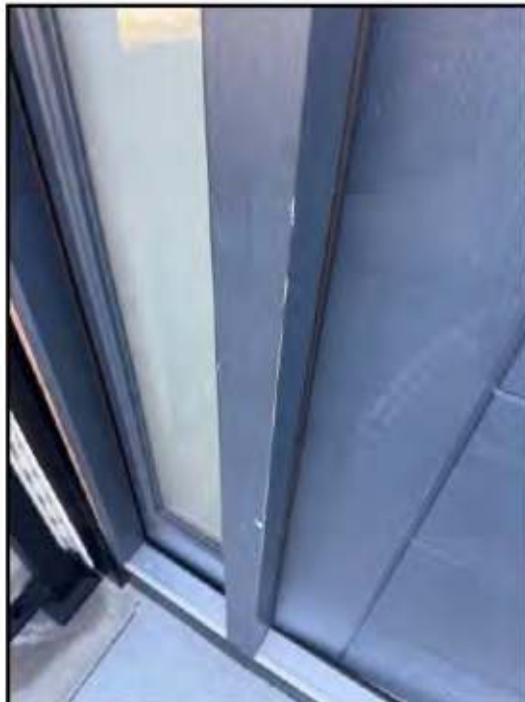
16. Condition: • Paint or stain needed

Location: Front

92. Paint or stain needed

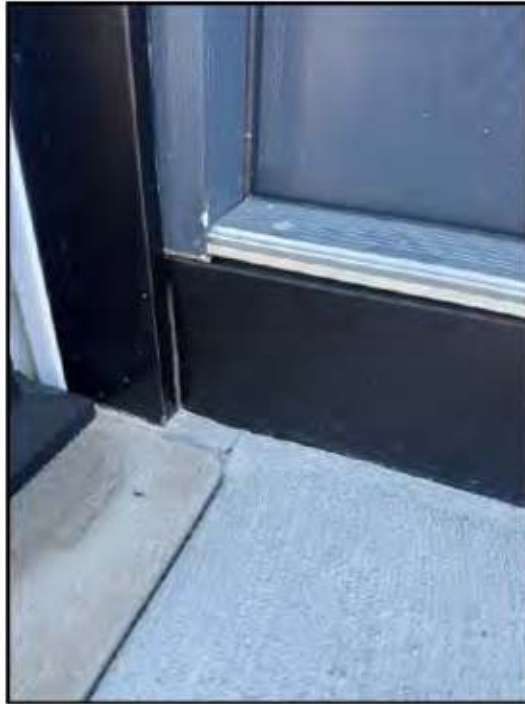
17. Condition: • Poor support under threshold

Location: Front

93. Poor support under threshold

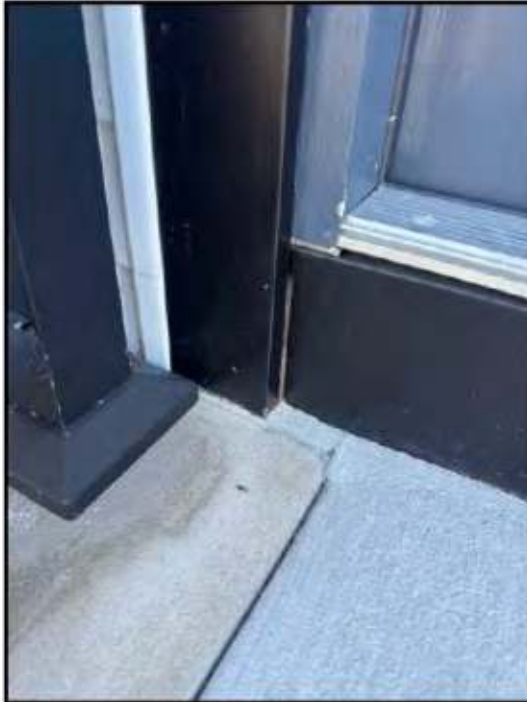
18. Condition: • [Damaged, cracked or loose](#)

Implication(s): Chance of damage to finishes and structure

94. Damaged, cracked or loose

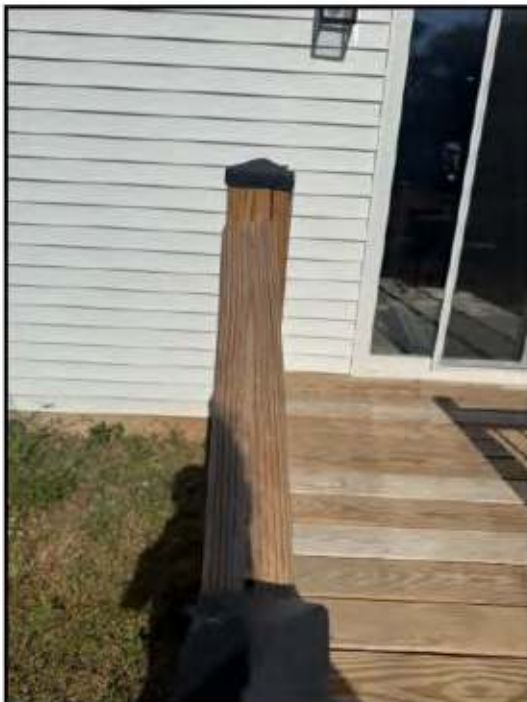
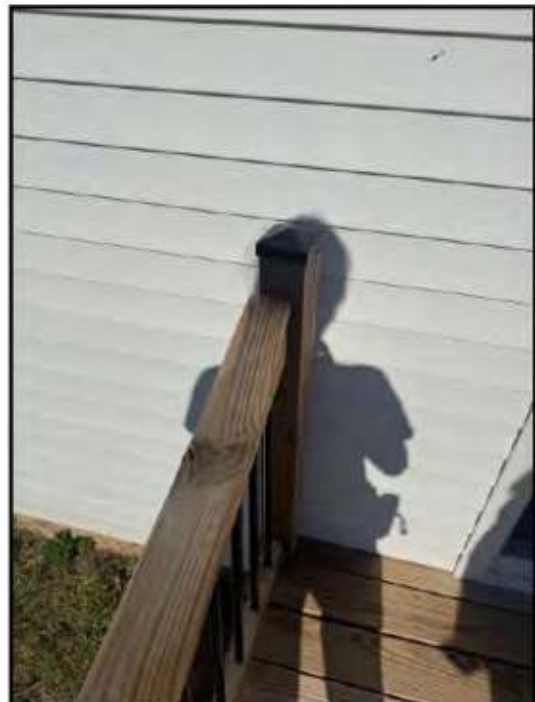
**PORCHES, DECKS, STAIRS, PATIOS AND BALCONIES \ General notes****19. Condition:** • Poorly built**Implication(s):** Weakened structure**Location:** Rear 211

96. Poorly built

97. Poorly built

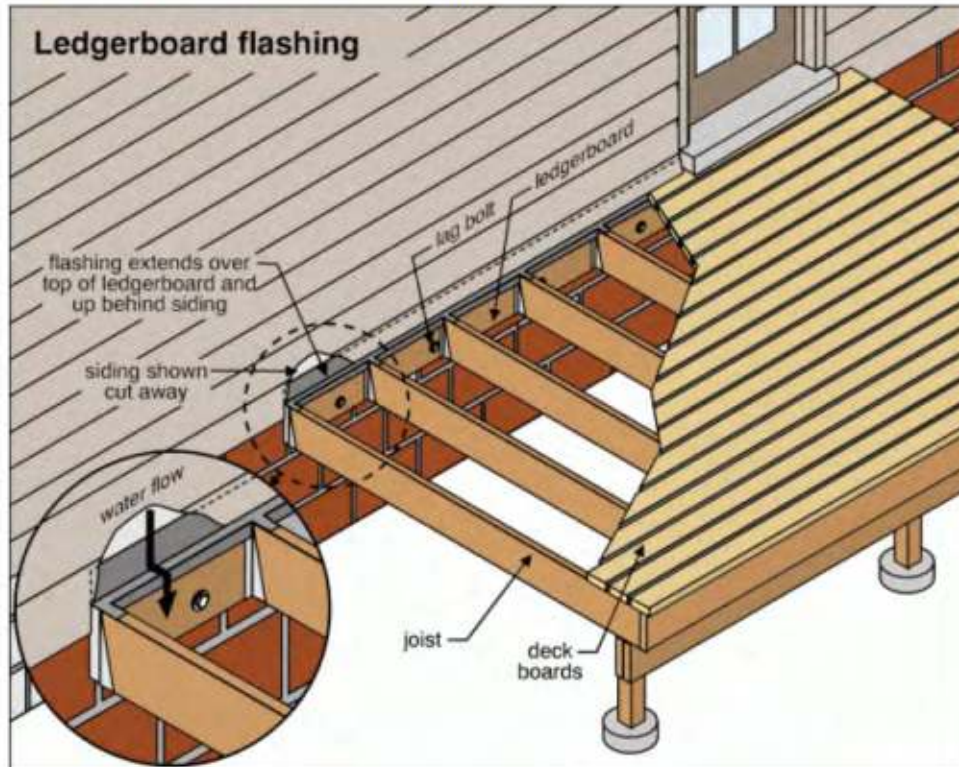
20. Condition: • [Missing flashing at deck connection](#)

Flashing should be continuous

Implication(s): Weakened structure | Chance of movement

98. Missing flashing at deck connection

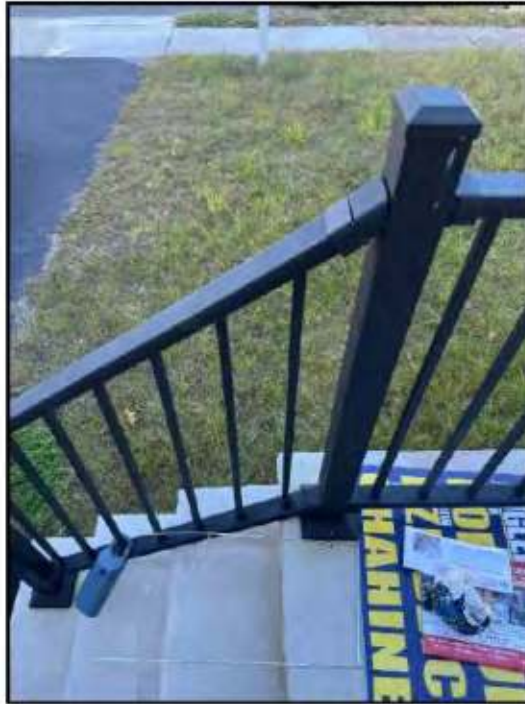
21. Condition: • [Loose](#)

Implication(s): Fall hazard

Location: Front

99. Loose

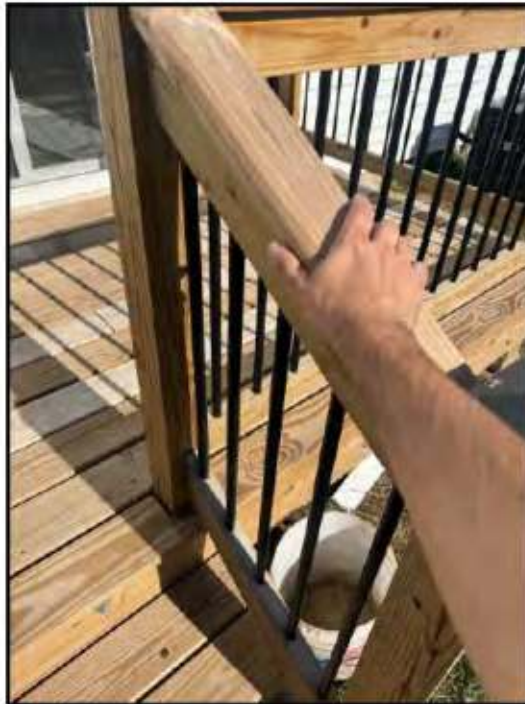
22. Condition: • [Ineffective](#)

Implication(s): Fall hazard

Location: Rear

100. Ineffective

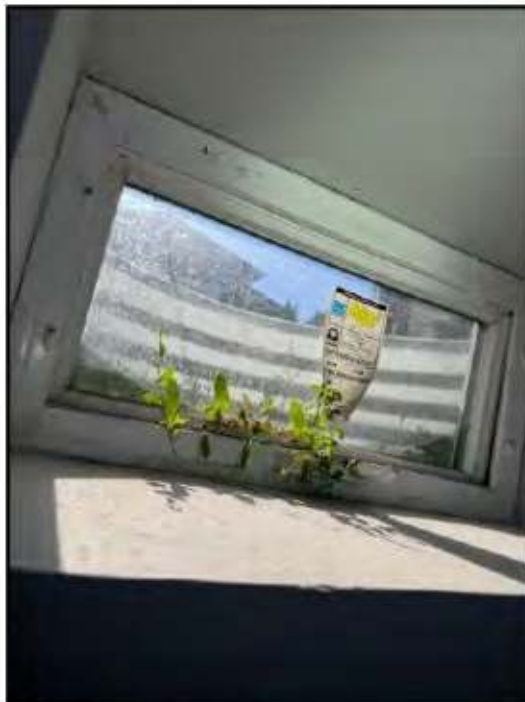
23. Condition: • Vines on building

Implication(s): Chance of damage to finishes | Chance of pests entering building

Location: Basement

101. Vines on building

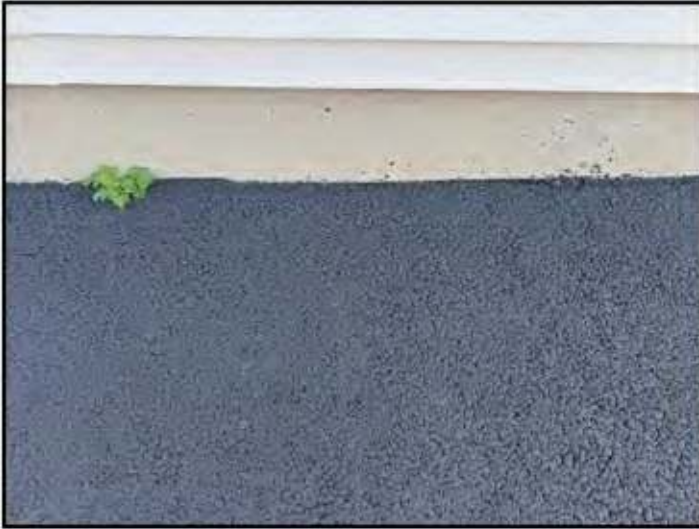
24. Condition: • [Improper slope or drainage](#)

Implication(s): Chance of water damage to structure, finishes and contents

102. Improper slope or drainage

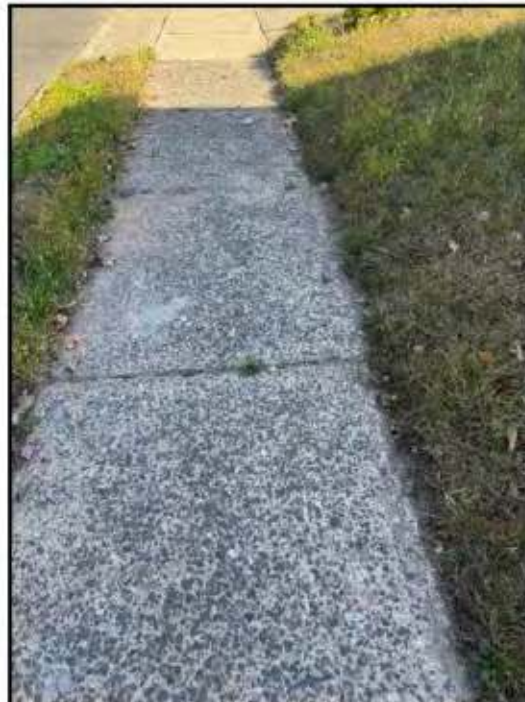
25. Condition: • [Uneven \(trip hazard\)](#)

Implication(s): Physical injury

104. Uneven (trip hazard)

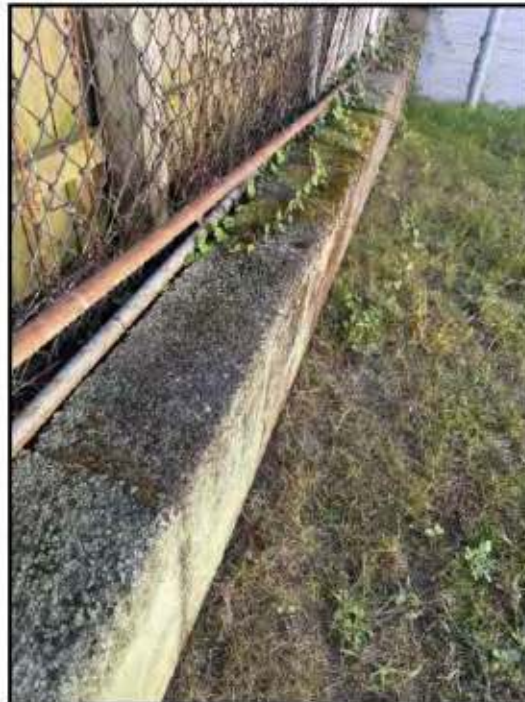
**LANDSCAPING \ Retaining wall**26. Condition: • [Leaning](#)

Implication(s): Weakened structure | Chance of movement

105. Leaning

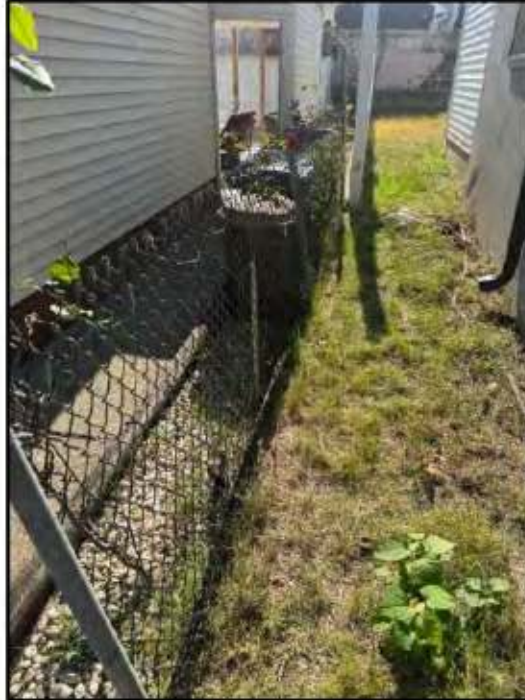
27. Condition: • Leaning

Implication(s): Chance of movement | Damage or physical injury due to falling materials

106. Leaning

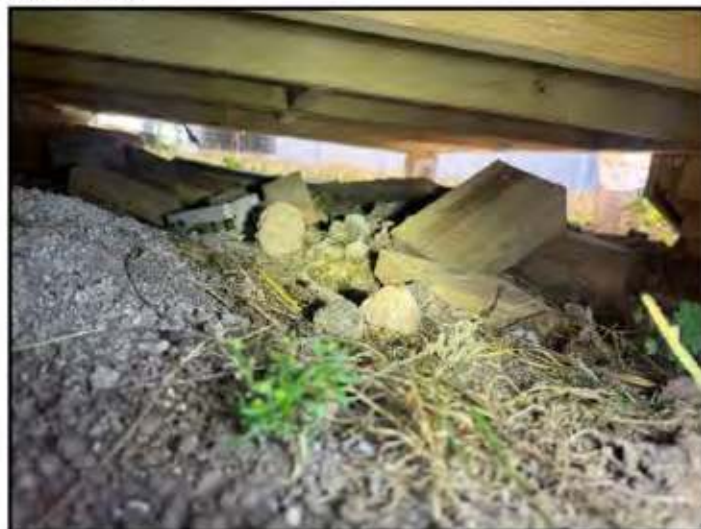
28. Condition: • Debris seen under deck

107. Construction debris seen under deck

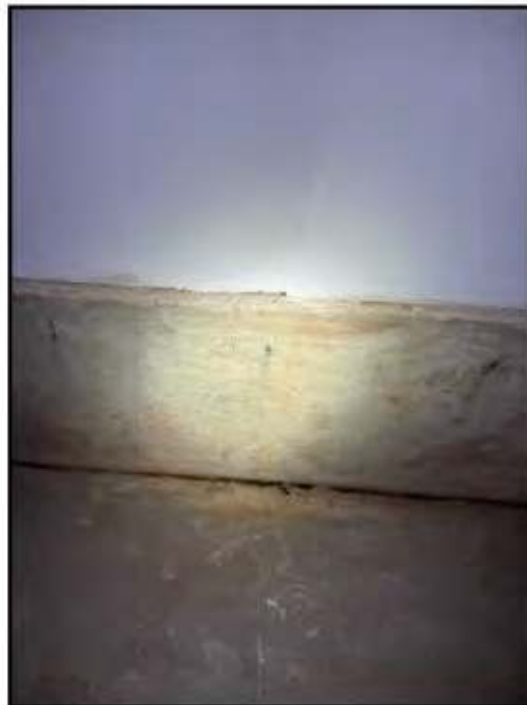
29. Condition: • [Cracked](#)

Implication(s): Chance of water damage to structure, finishes and contents | Weakened structure

110. Cracked

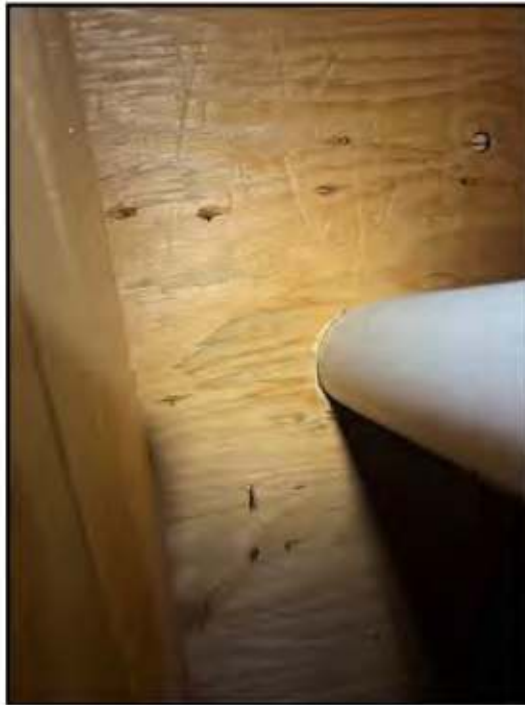
**ROOF FRAMING \ Sheathing (roof/attic)****30. Condition:** • [Water stains](#)**Implication(s):** Material deterioration

**Location:** Attic

**111.** *Water stains*

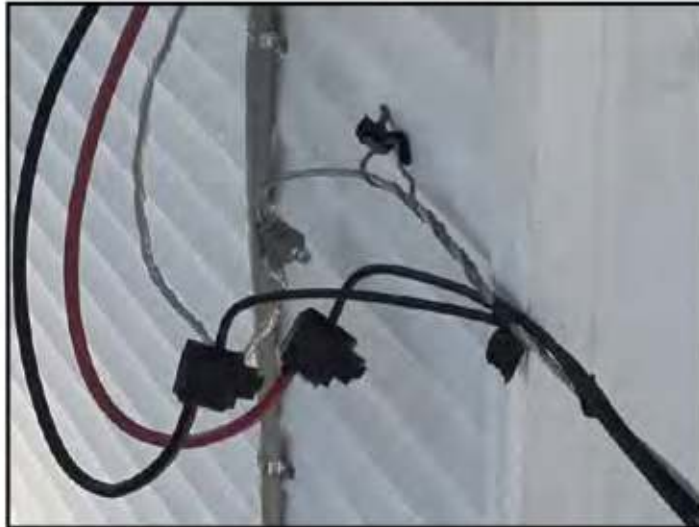
**31. Condition:** • Uninsulated Service Entrance wire holder

- **Electrical Safety:** An uninsulated holder could present a higher risk of electrical shock or short-circuits, especially if improperly handled or if adjacent materials are conductive.
- **Weather Vulnerability:** Lack of insulation could make the wire holder more susceptible to environmental factors like rain, which may increase the risk of corrosion or electrical issues.
- **Local Code Violations:** Depending on local building codes or utility regulations, an uninsulated wire holder may not be up to standard, potentially resulting in fines or required modifications.

- Durability: Uninsulated holders may wear out more quickly, requiring more frequent replacements or adjustments over time.
- Potential for Arcing: There's a higher risk of electrical arcing between the wire and the holder if they are both uninsulated, which could lead to fires or other electrical hazards.
- Reduced Energy Efficiency: While not a direct impact of the holder itself, an uninsulated system can indicate other areas where electrical infrastructure may not be optimized, leading to energy loss.

113. Uninsulated Service Entrance wire holder

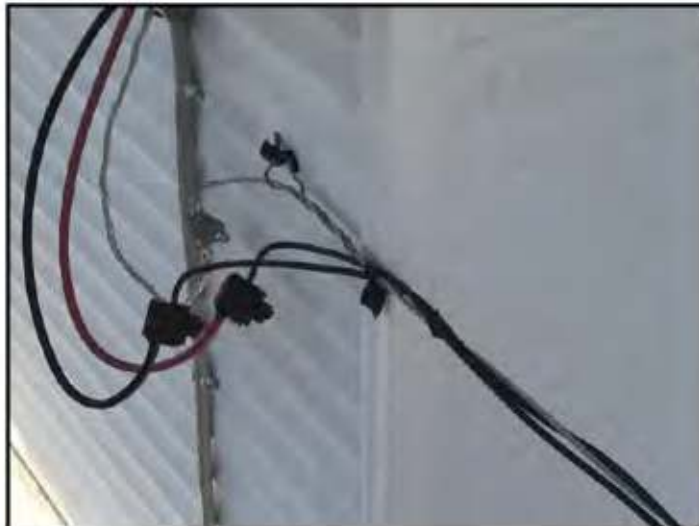
114.

32. Condition: • Wires too close to siding

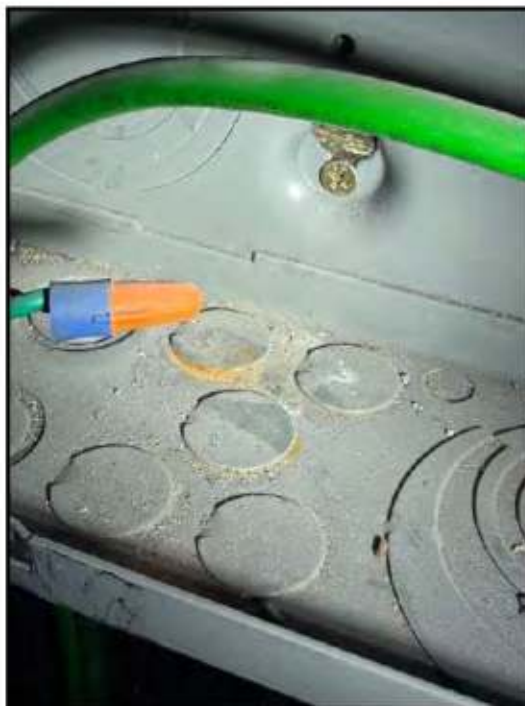
33. Condition: • [Rust or water in panel](#)

Implication(s): Electric shock | Fire hazard

115. Rust or water in panel

## Task: Monitor

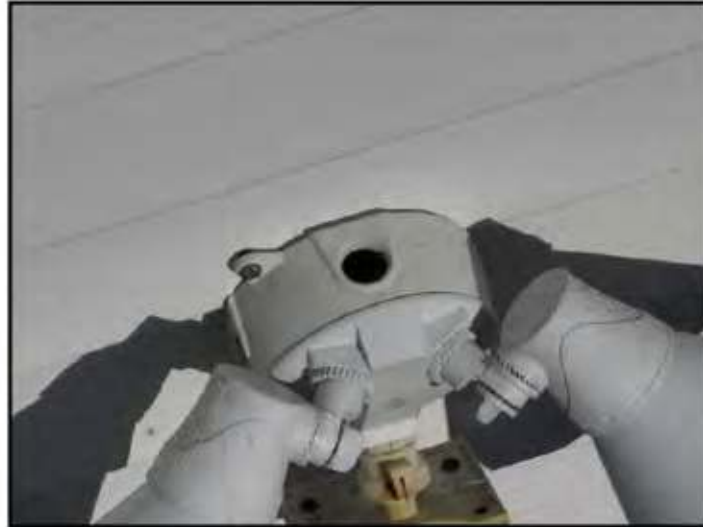
**116.** *Open knockout***DISTRIBUTION SYSTEM \ Outlets (receptacles)****35. Condition:** • [Loose](#)**Implication(s):** Electric shock | Fire hazard**Location:** Basement

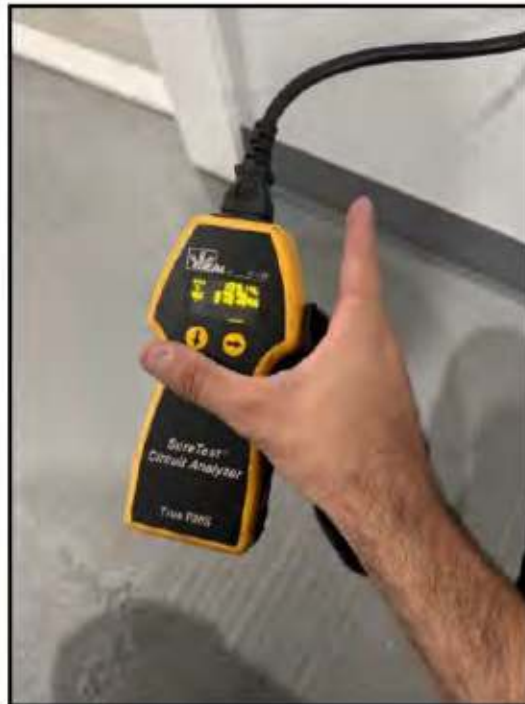
**117.** *Loose*

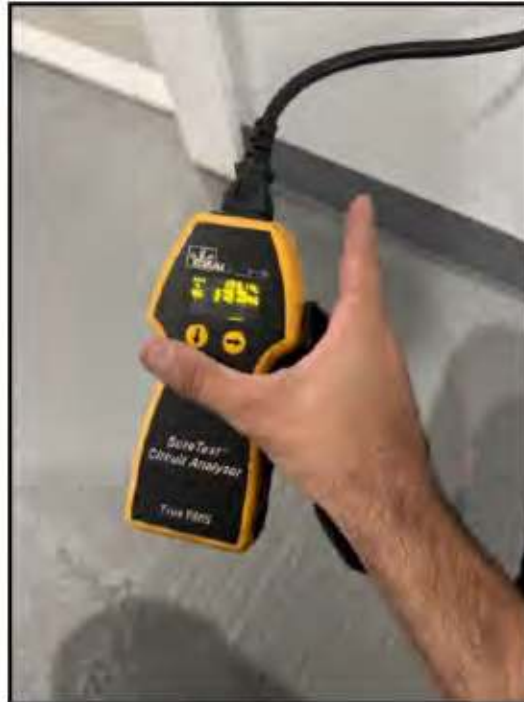
**36. Condition:** • Wiring problems

National electrical code recommends voltage drop levels to be under 5%. The high voltage drop can be attributed to an undersize wire, wrong size of wire for the length of the run, or loose/bad connections. Some sensitive equipment can be damaged and stop working when voltage is not higher than 108V.

**Implication(s):** Shock and fire hazard.

**Location:** Basement

**118.** Wiring problems

**Task:** Further evaluation

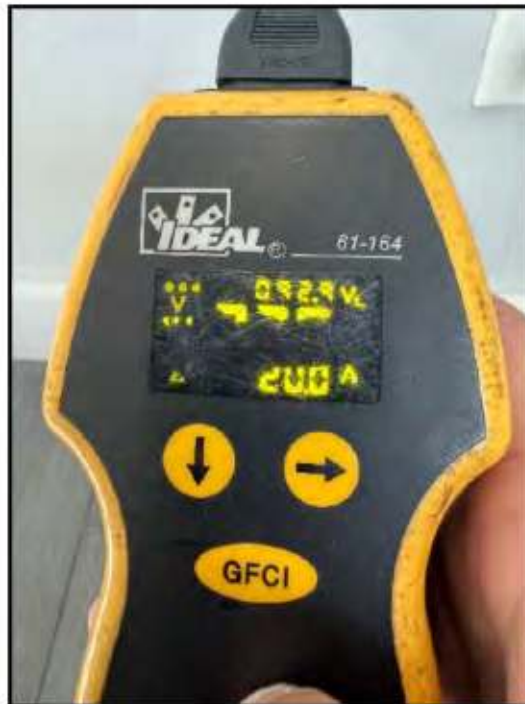
**37. Condition:** • Wiring problems

National electrical code recommends voltage drop levels to be under 5%. The high voltage drop can be attributed to an undersize wire, wrong size of wire for the length of the run, or loose/bad connections. Some sensitive equipment can be damaged and stop working when voltage is not higher than 108V.

**Implication(s):** Shock and fire hazard.

**Location:** Second Floor Bedroom

119. Wiring problems

**Task:** Further evaluation

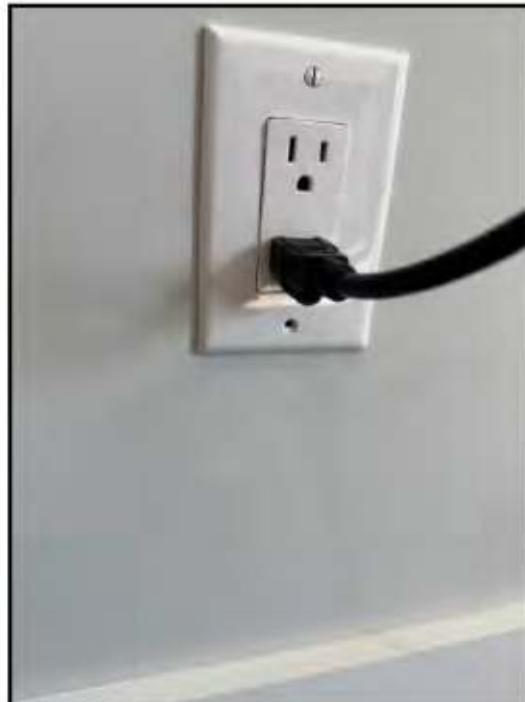
38. Condition: • Missing screws

Location: First Floor

120. Missing screws

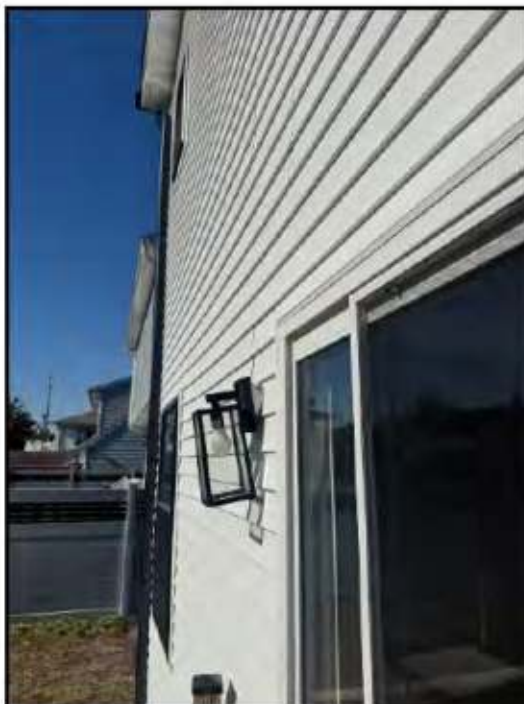
39. Condition: • [Loose](#)

Implication(s): Electric shock | Fire hazard

Location: Various

121. *Loose*

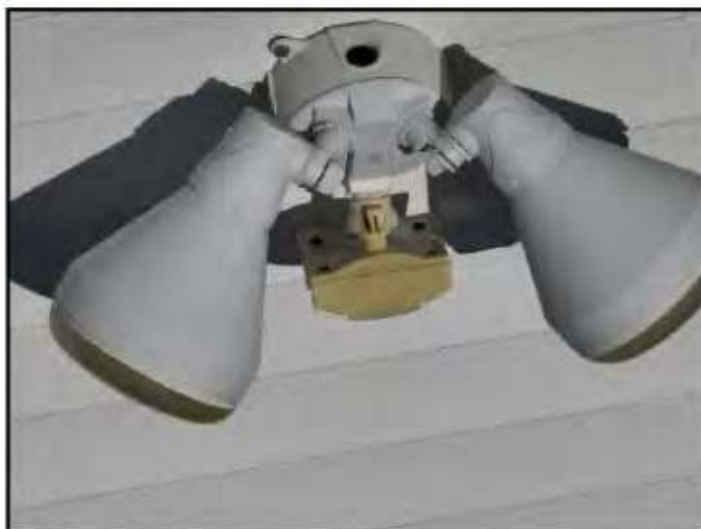
40. Condition: • Rust

Flood light appears to be using old rusted parts

122. *Rust*

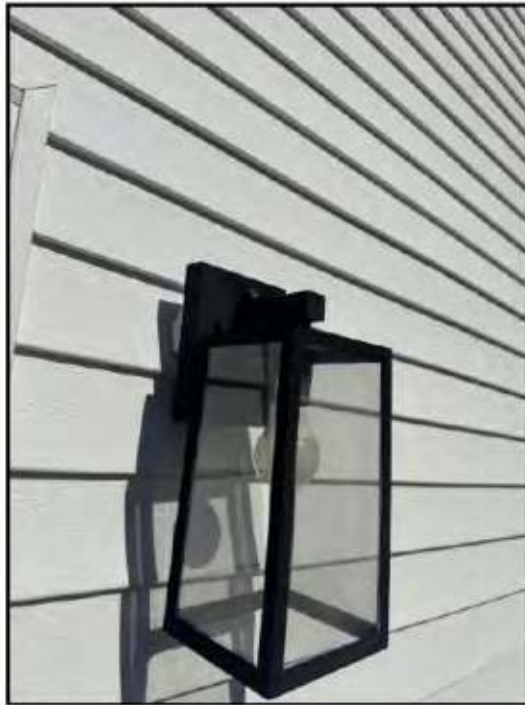
41. Condition: • Fixtures are missing the matching siding's mounting block

123. Fixtures are missing the matching siding's...

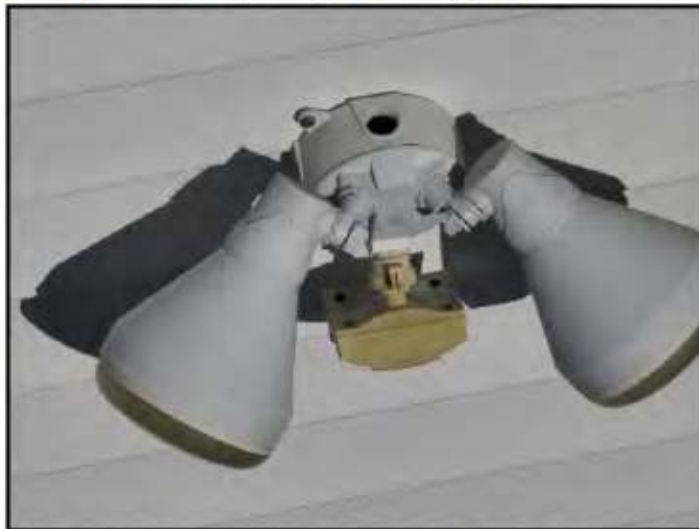
42. Condition: • Fixtures are missing the matching siding's mounting block

124. Fixtures are missing the matching siding's...

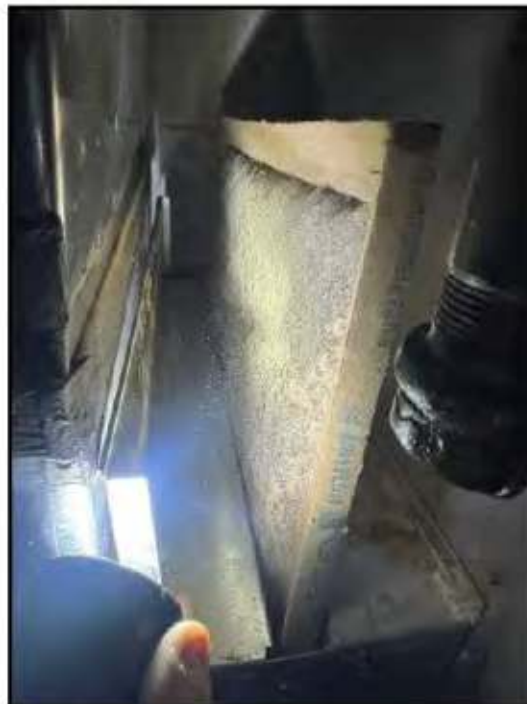
43. Condition: • Dirty

Implication(s): Increased heating costs | Reduced comfort

127. Dirty

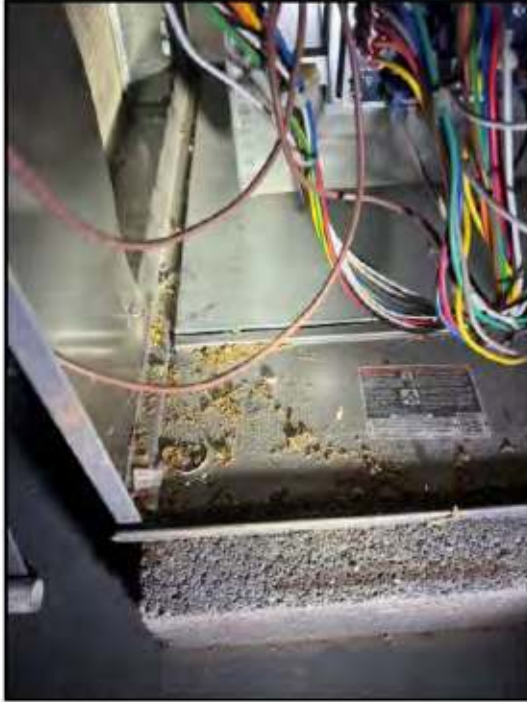
**FURNACE \ Ducts, registers and grilles****44. Condition:** • [Dirty](#)**Implication(s):** Increased heating and cooling costs | Reduced comfort

128. Dirty

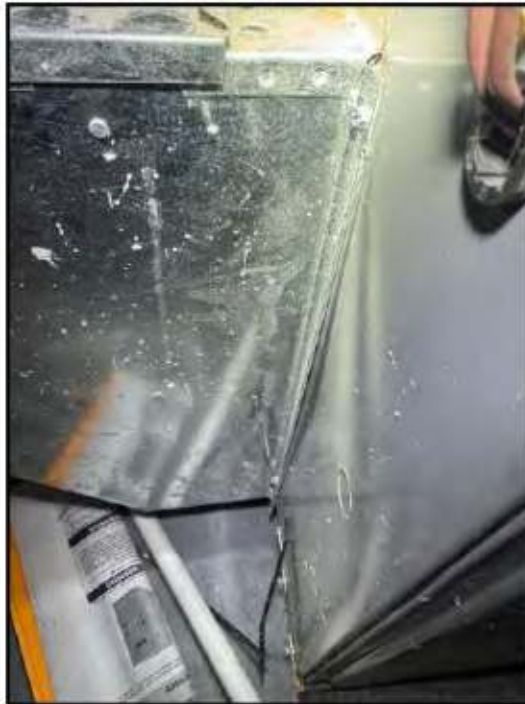
**45. Condition:** • [Leaky joints](#)**Implication(s):** Increased heating costs | Reduced comfort**Location:** Basement**Task:** Recommend sealing the ductwork with mastic or UL 181 foil tape in order to promote better airflow and stop potential or current leakage.

130. Leaky joints

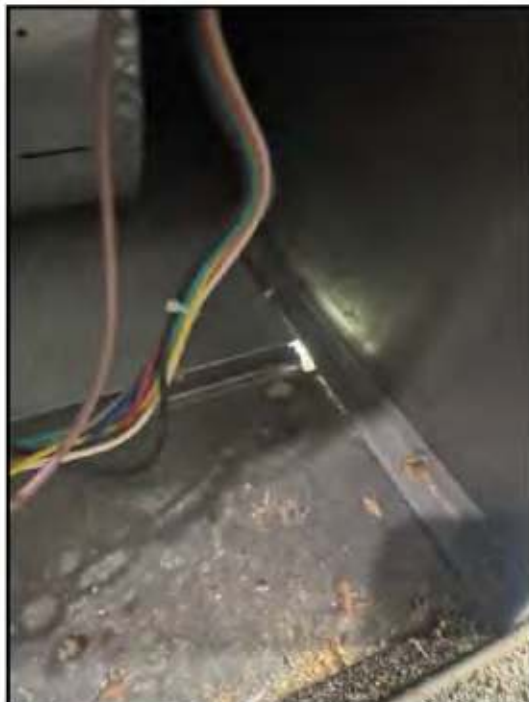
**46. Condition:** • Air leakage entering from return side

**Implication(s):** Openings found on the return side (before the blower) can pull back gases and pollutants from the utility area, INTO the supply side. These pollutants can include carbon monoxide.

131. Air leakage entering from return side

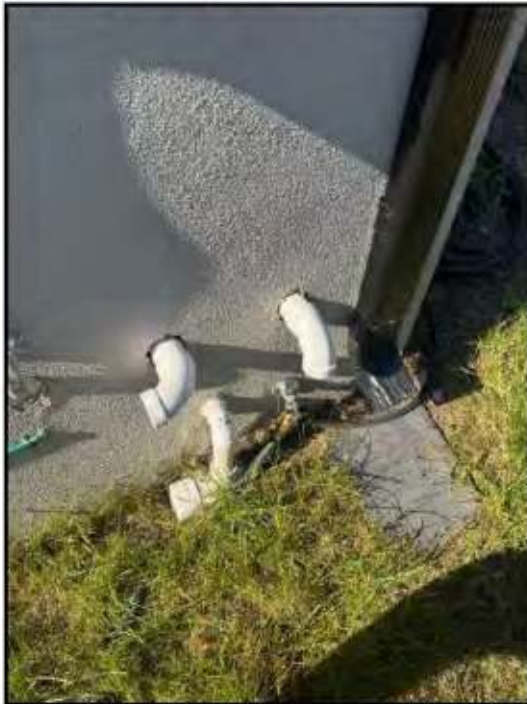
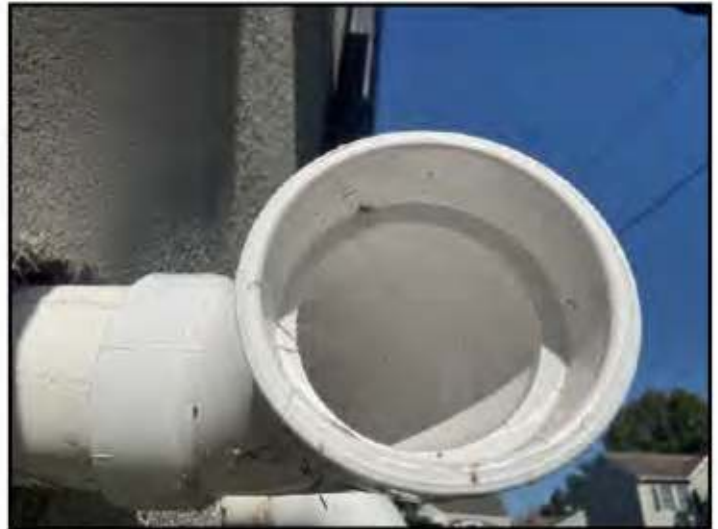
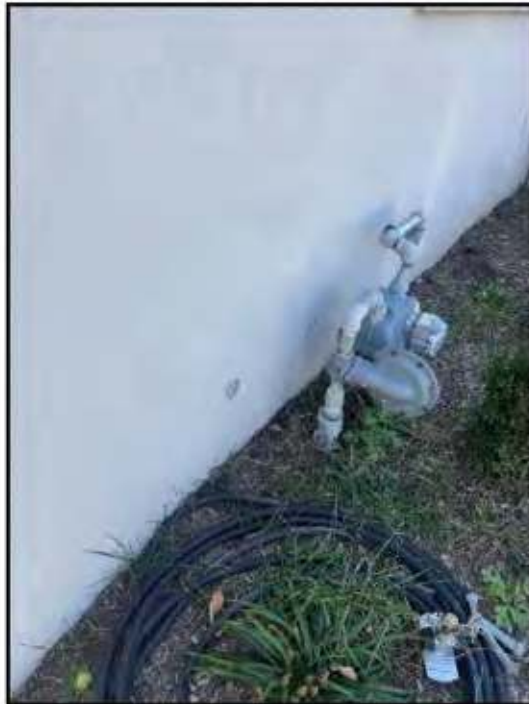
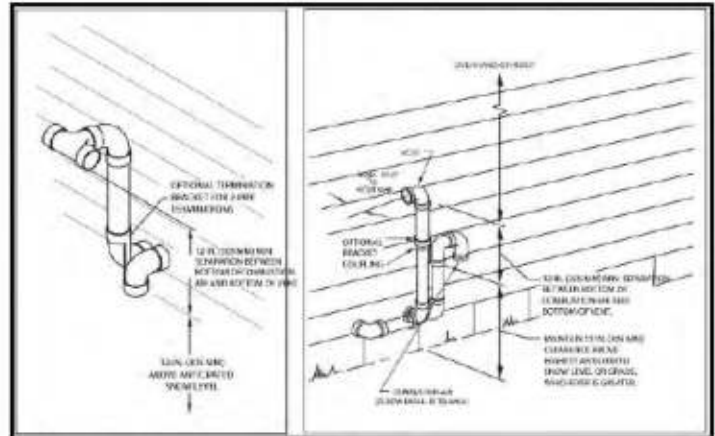
**GAS FURNACE \ Mid- and high-efficiency gas furnace****47. Condition:** • [Poor vent location, arrangement](#)

**Implication(s):** Equipment not operating properly | Equipment inoperative | Hazardous combustion products entering home

**133.** *Poor vent location, arrangement*

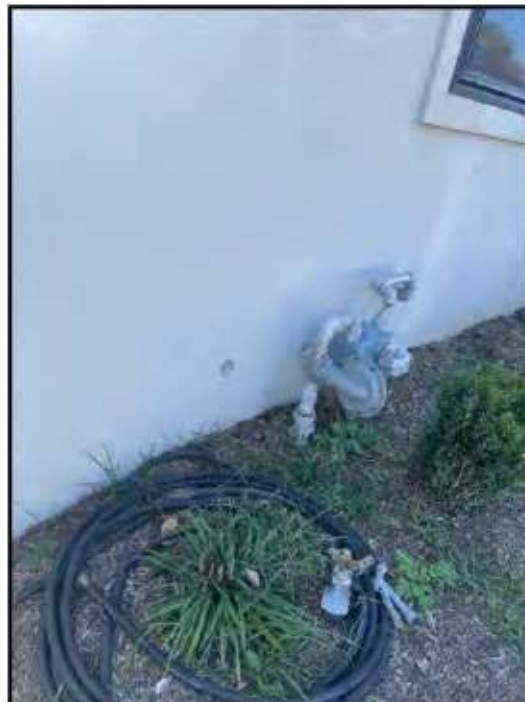
48. Condition: • [Poor vent location, arrangement](#)

Missing vent piping

**Implication(s):** Equipment not operating properly | Equipment inoperative | Hazardous combustion products entering home

137. Poor vent location, arrangement

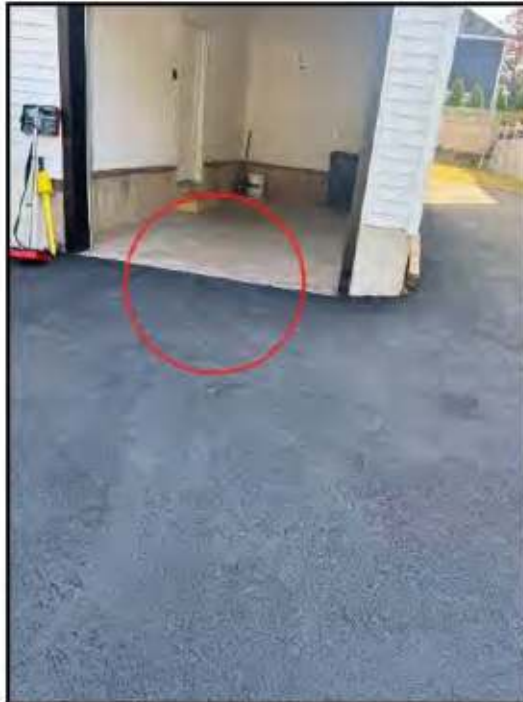
**COMMENTS \ Additional****49. Condition:** • Oil tank sweep notes

While conducting a sweep of the grounds for underground oil tanks, we detected a metallic anomaly in front of the garage. This may be rebar, possibly part of the foundation footing, but we cannot confirm this. To gather more information on potential decommissioned oil tanks, we recommend submitting an OPRA request. Additionally, consulting the builder could help clarify whether the anomaly is indeed rebar associated with the foundation.

**138.** Oil tank sweep notes

**Task:** Further evaluation

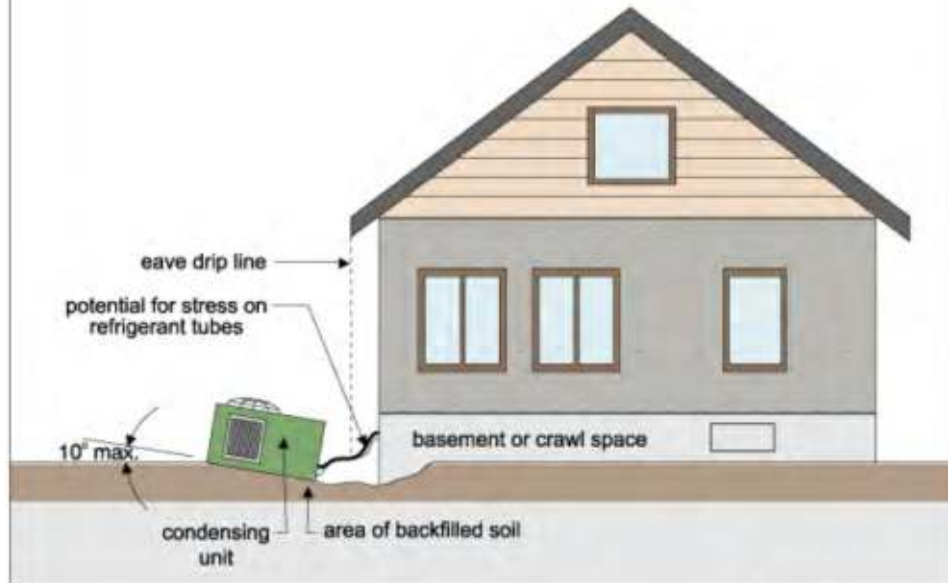
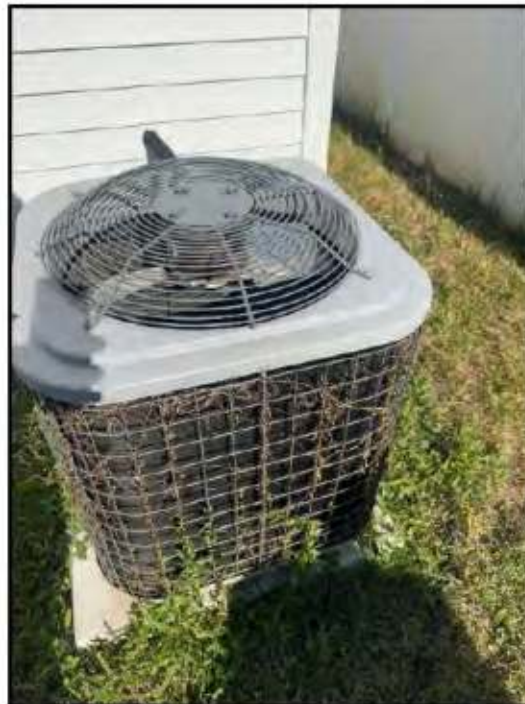
50. Condition: • [Out of level](#)

Implication(s): Reduced system life expectancy | Damage to equipment

141. Out of level

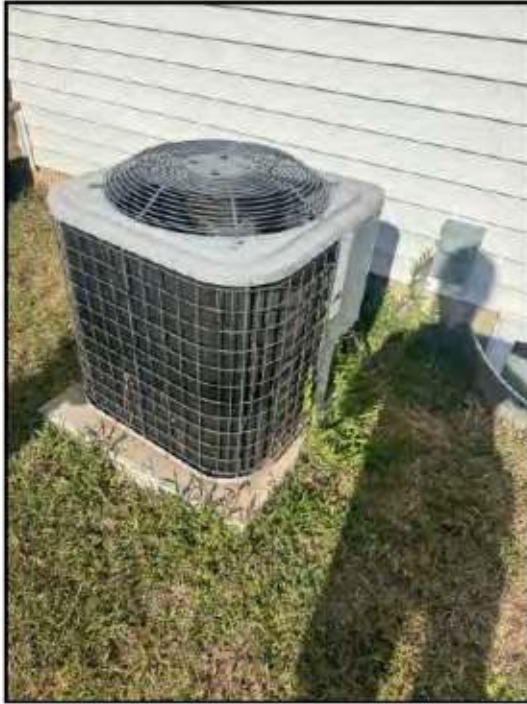
**51. Condition:** • Vegetation around compressor

**Implication(s):** Decreased efficiency

142. Vegetation around compressor

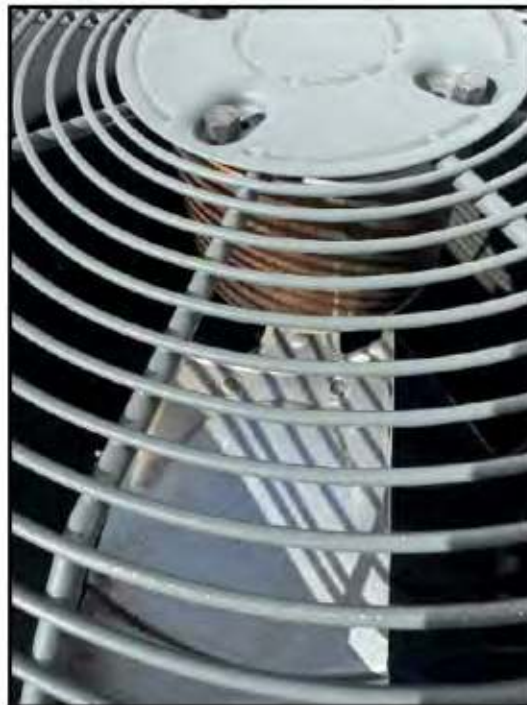
52. Condition: • Rust

144. Rust

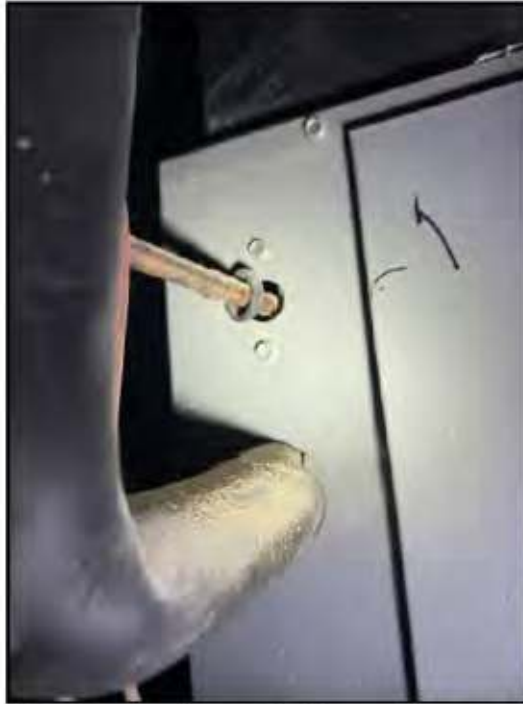
**53. Condition:** • Poor seal around refrigerant lines entering evaporator coil cabinet

**Implication(s):** Air leakage and possible condensation build up

145. Poor seal around refrigerant lines entering...
