# Your Inspection Report

Tuesday, October 22, 2024

Leonardo Betancor, CMI, 24GI00182600, HOI.0001093

Smart Choice Inspections LLC  
173 Ridge Road, Suite H1  
Cedar Grove, NJ 07009

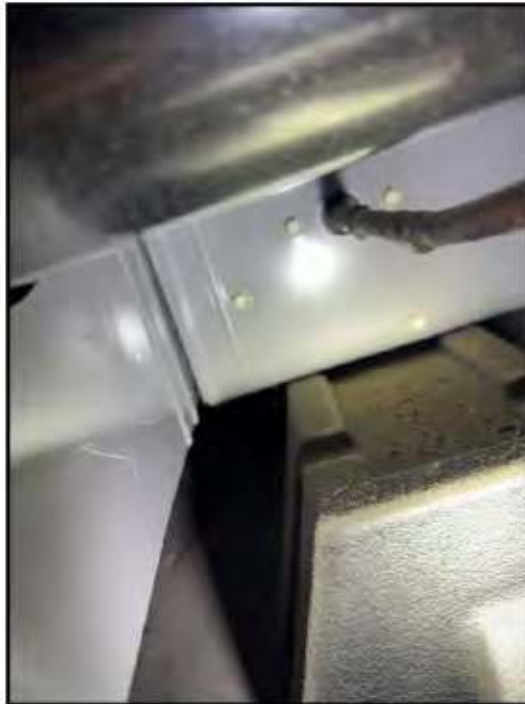
**54. Condition:** • Leaky joints

146. Leaky joints

**Task:** Recommend sealing the ductwork with mastic or UL 181 foil tape in order to promote better airflow and stop potential or current leakage.

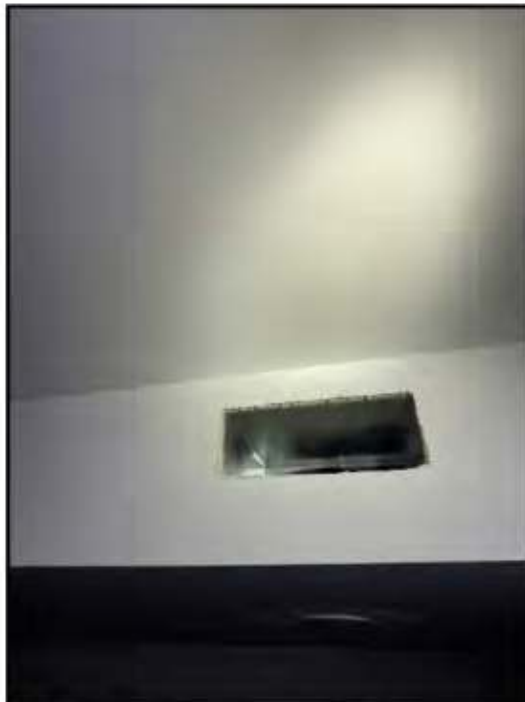
55. Condition: • Supply register/diffuser is missing

147. Supply register/diffuser is missing

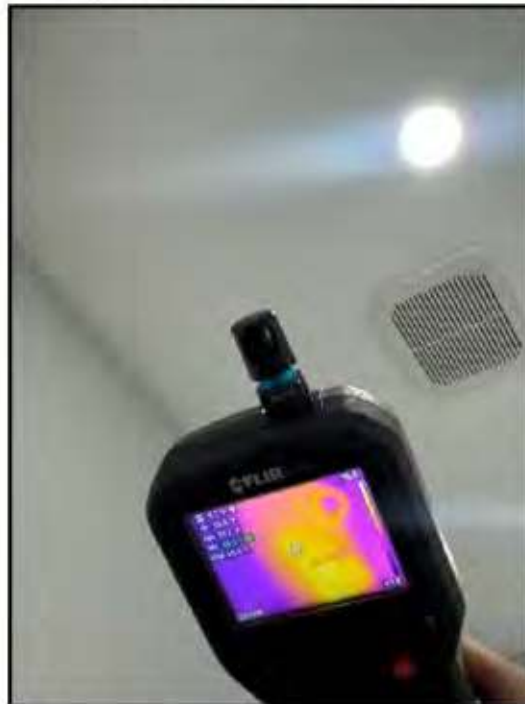
56. Condition: • [Gaps or voids](#)

Implication(s): Increased heating and cooling costs | Reduced comfort

148. Gaps or voids

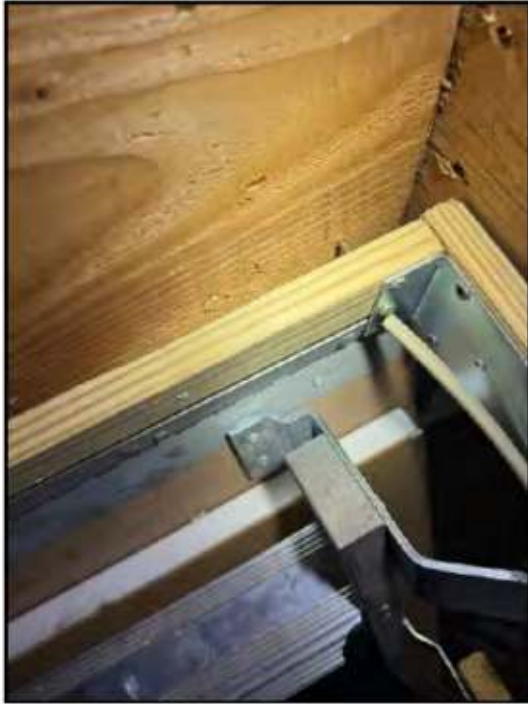
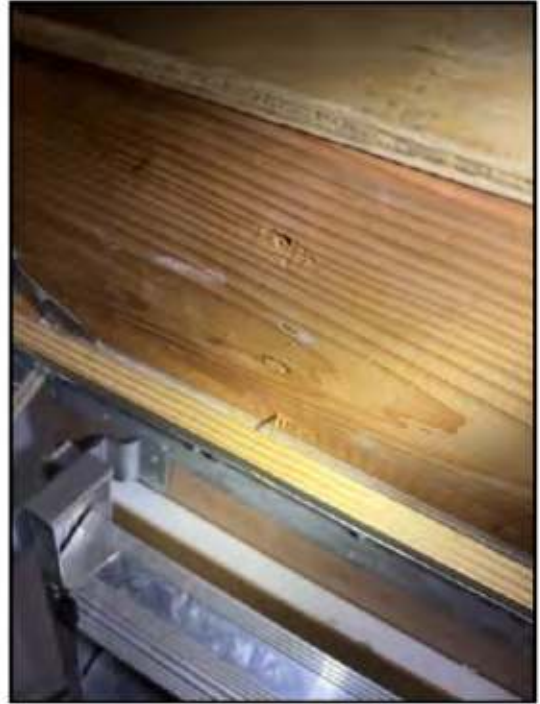
57. Condition: • Not well secured

Screws were used to secure attic pull-down stairs frame in place. Recommend using 16d nails in when securing stairs to ceiling framing as per manufacturer instructions. Screws do not offer the shear value 16d nails have.

149. Not well secured

The gap between the joist and the stair frame should also be filled in. Fasteners must tighten the frame tightly against the joists to provide proper support.

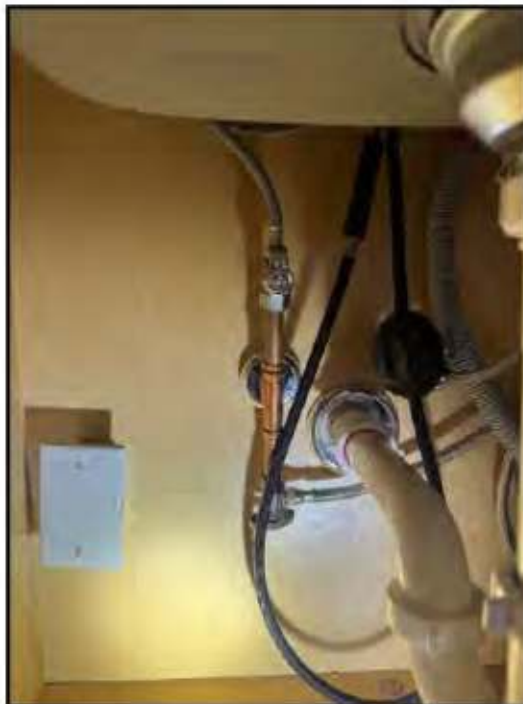
58. Condition: • [Poor support](#)

Implication(s): Chance of water damage to structure, finishes and contents | Leakage

151. Poor support

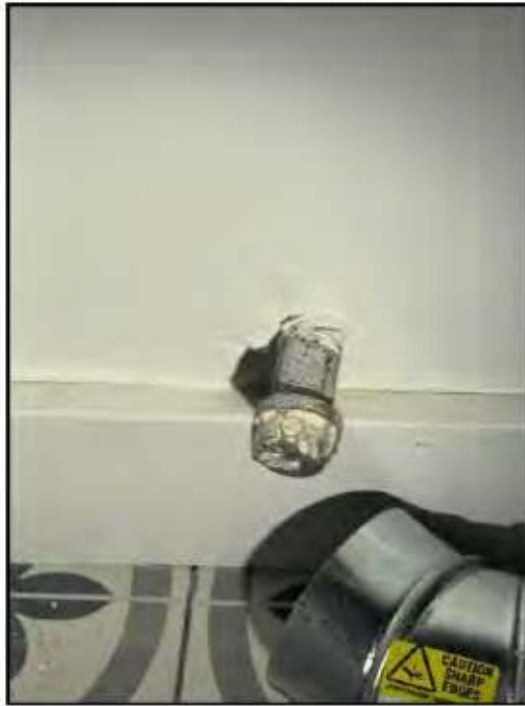
59. Condition: • [Missing shut off valve](#)

Implication(s): Difficult to service

152. Missing shut off valve

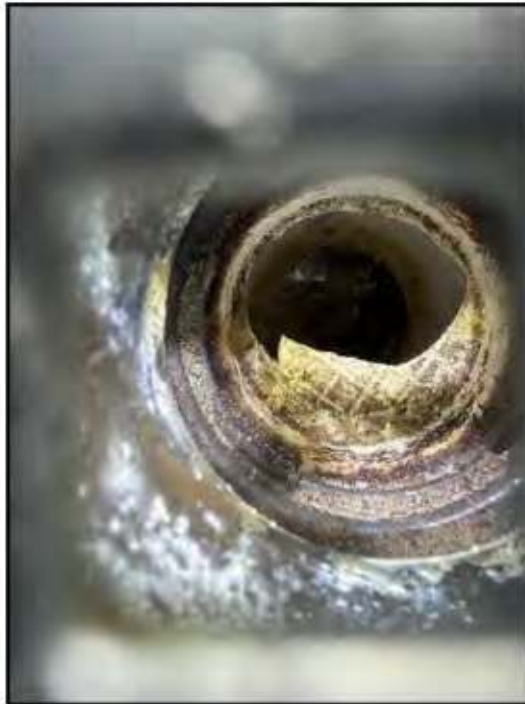
153.

**61. Condition:** • Debris appears to be stuck inside master bathroom shower drain

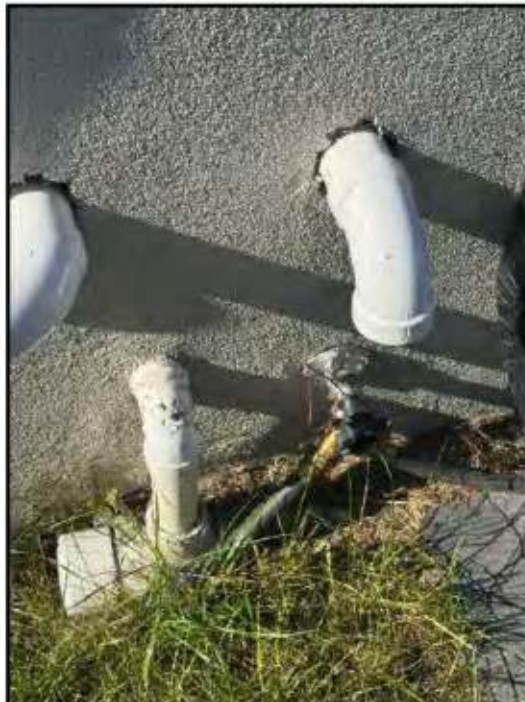
62. Condition: • Sump pump discharge point was not found at time of the inspection

154. Sump pump discharge point was not found at...

Task: Further evaluation

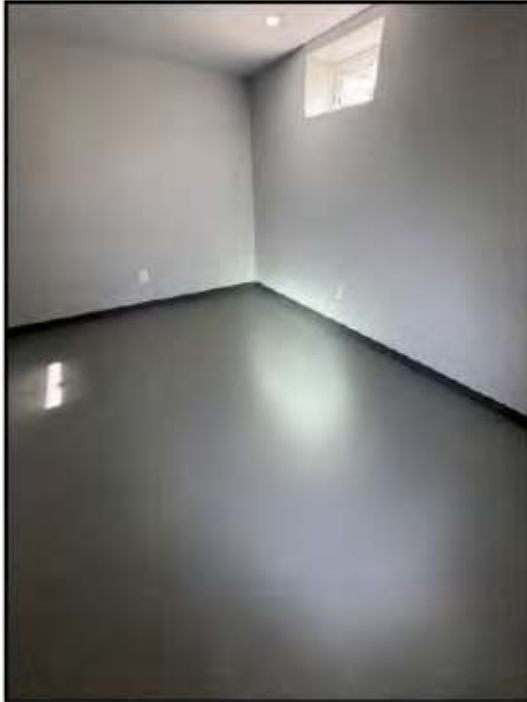
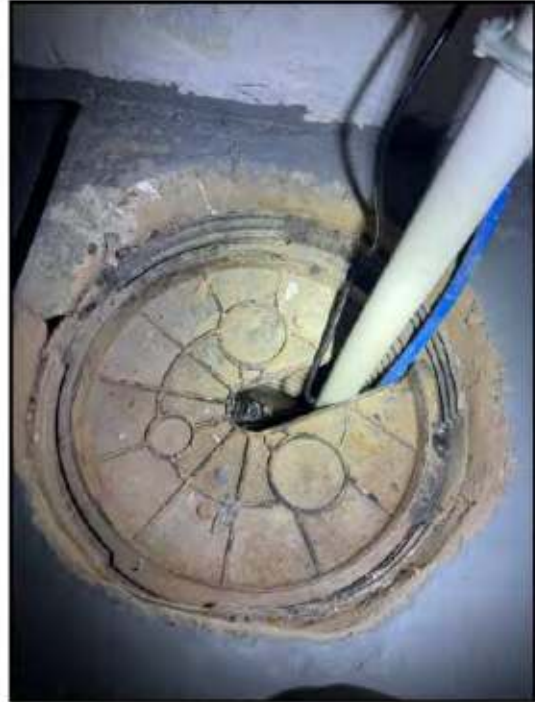
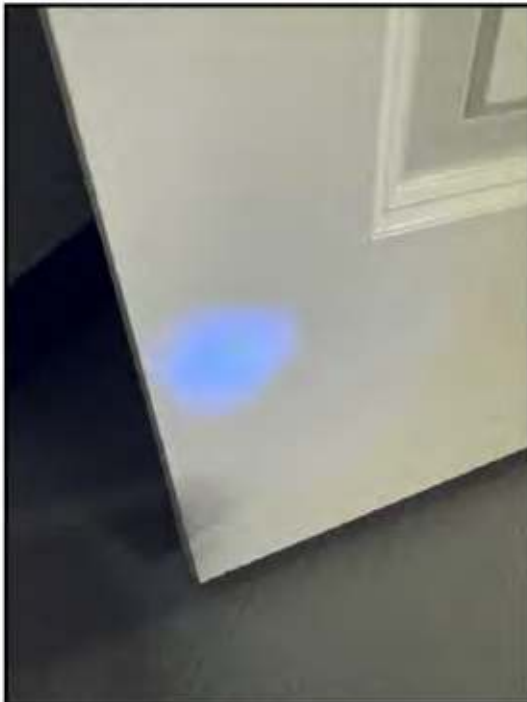
## 63. Condition: • Questionable installation

A lower section of the basement appears to be missing a French drain and sump pump system. Water marks can be seen on the door, approximately 8-10 inches high.

155. Questionable installation

Task: Further evaluation

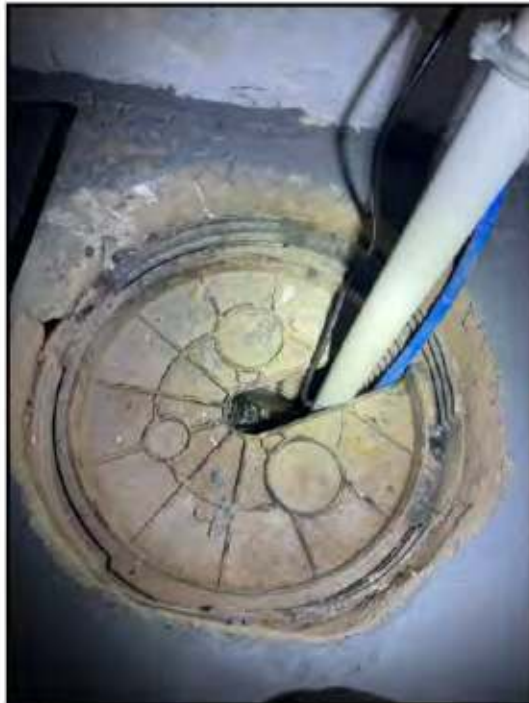
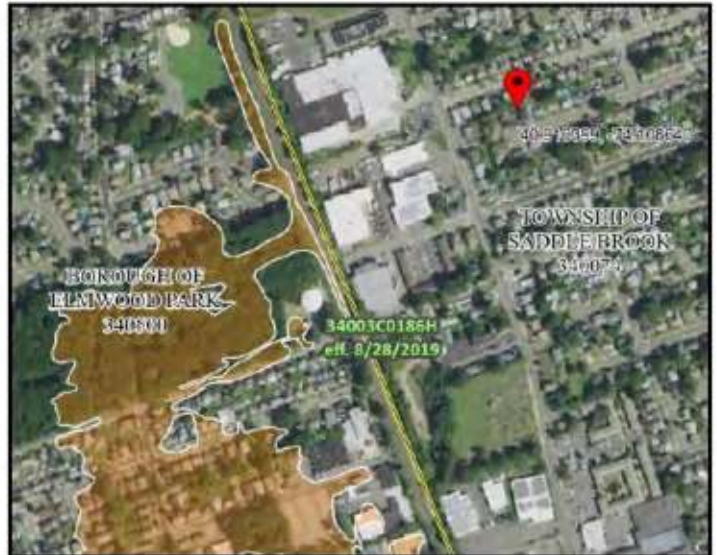
64. Condition: • Sump pump emergency backup system is highly recommended

159. Sump pump emergency backup system is highly...

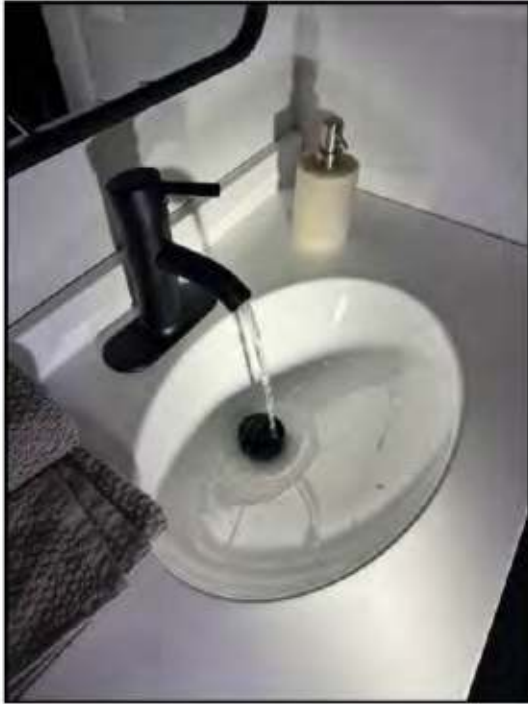
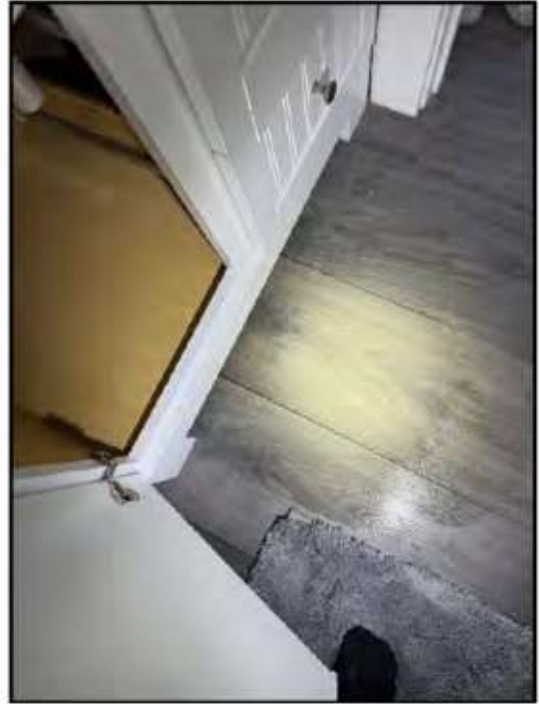
65. Condition: • It seems that an inappropriate type of faucet has been installed for this small sink, causing water to splash out whenever the faucet is turned on.

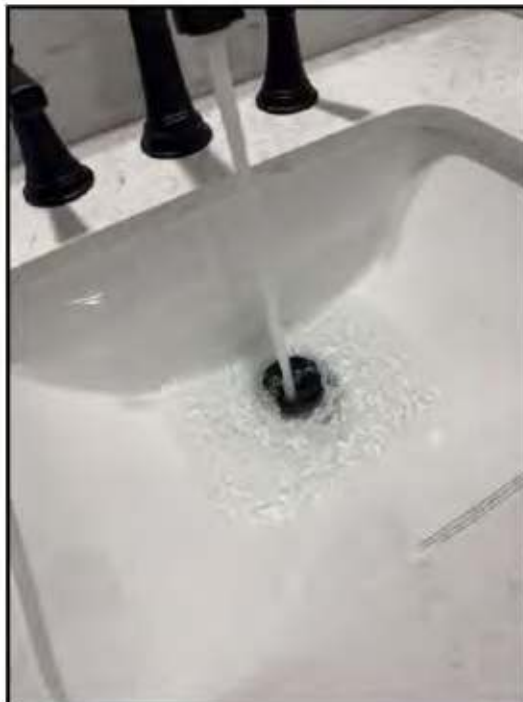
66. Condition: • [Slow drains](#)

Implication(s): Chance of water damage to structure, finishes and contents

163. *Slow drains*

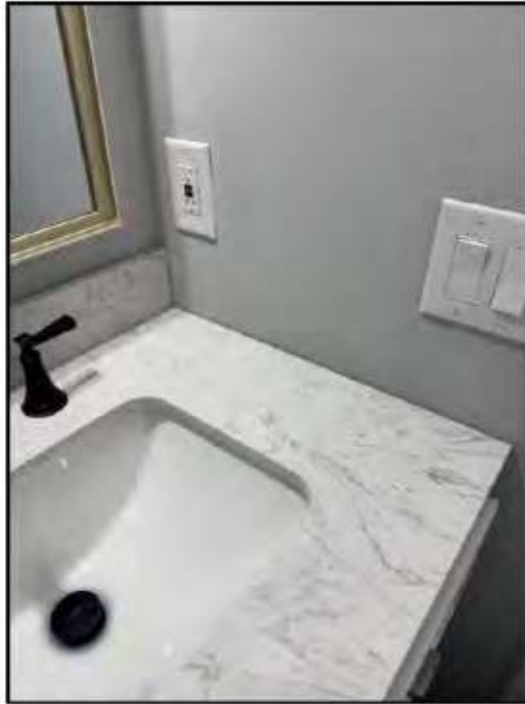
**67. Condition:** • Caulking loose, missing or deteriorating

**164.** Caulking loose, missing or deteriorating

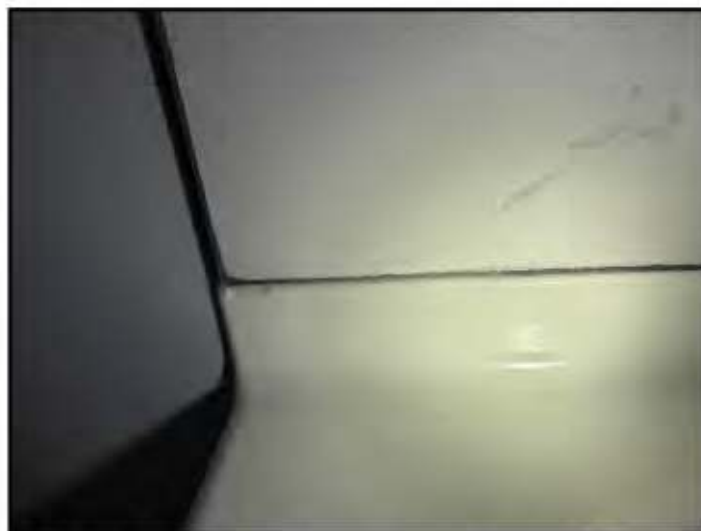
**68. Condition:** • Bathtub weep holes were covered/clogged with grout

Weep holes on bathtub and shower pans are made so that they help drain any water trapped behind shower walls

**165.** Bathtub weep holes were covered/clogged wit...

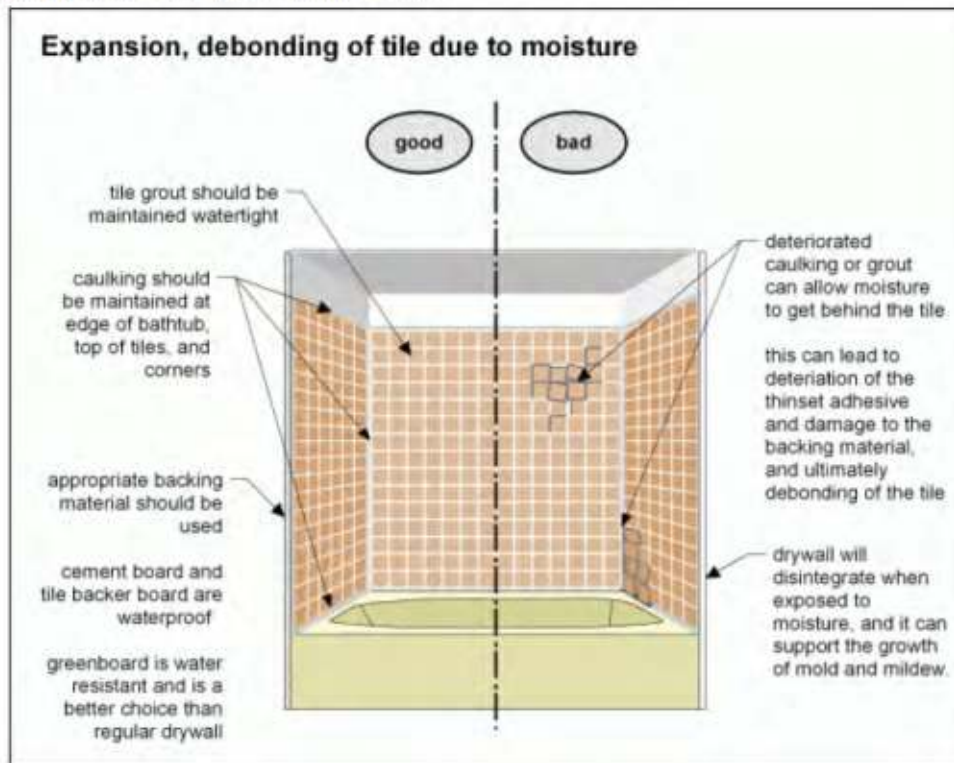
69. Condition: • [Caulking loose, missing or deteriorated](#)

Implication(s): Chance of water damage to structure, finishes and contents

166. Caulking loose, missing or deteriorated

Task: Recommend using SILICONE grout on all seams

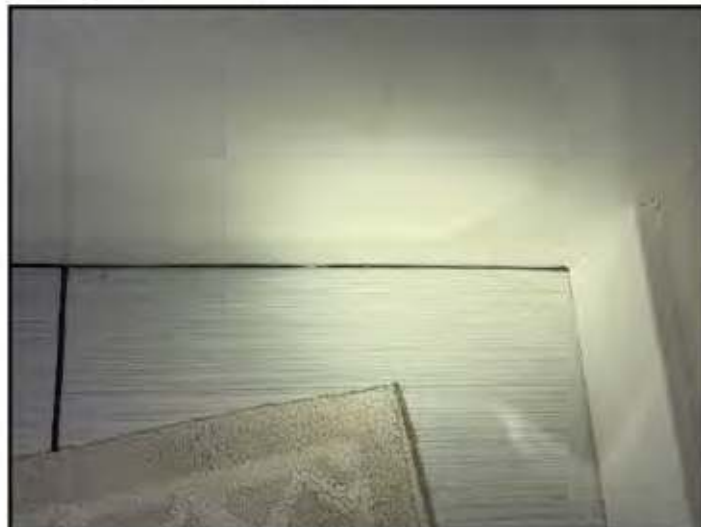
70. Condition: • [Caulking loose, missing or deteriorated](#)

Implication(s): Chance of water damage to structure, finishes and contents

Location: First Floor Bathroom

167. Caulking loose, missing or deteriorated

Task: Recommend using SILICONE grout on all seams

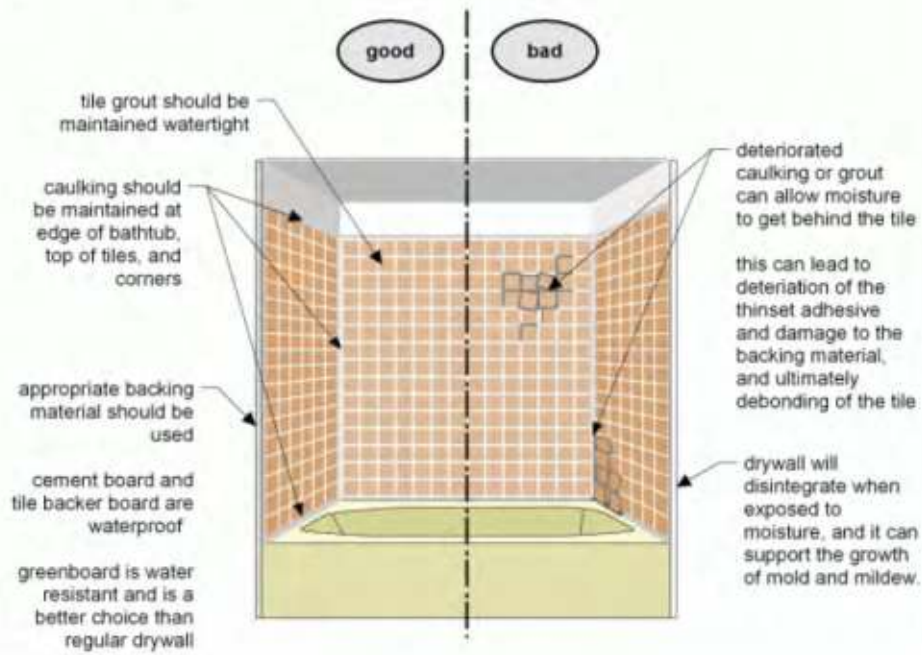
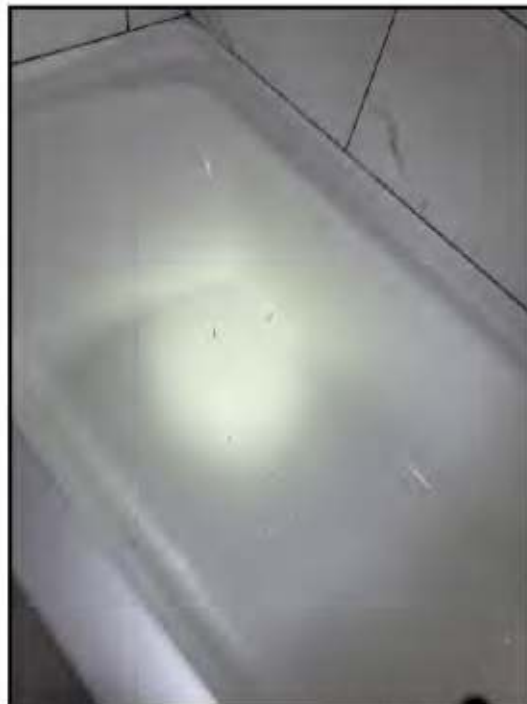
71. Condition: • [Grout loose, missing or deteriorated](#)

Implication(s): Chance of water damage to structure, finishes and contents

Location: Second Floor Bathroom

168. Grout loose, missing or deteriorated

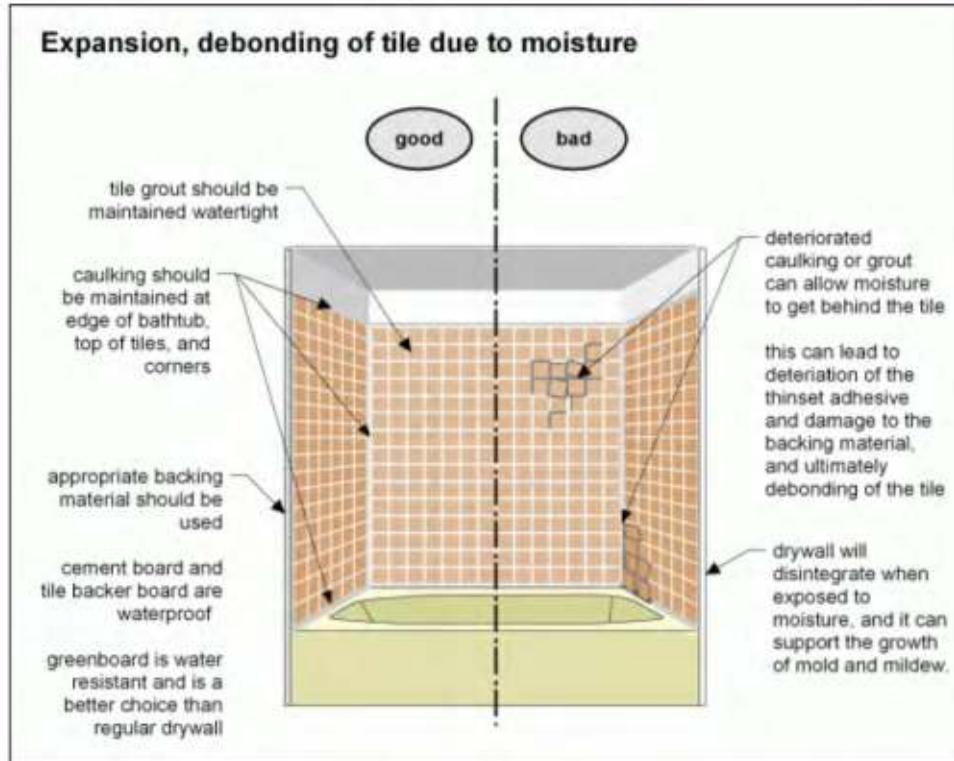
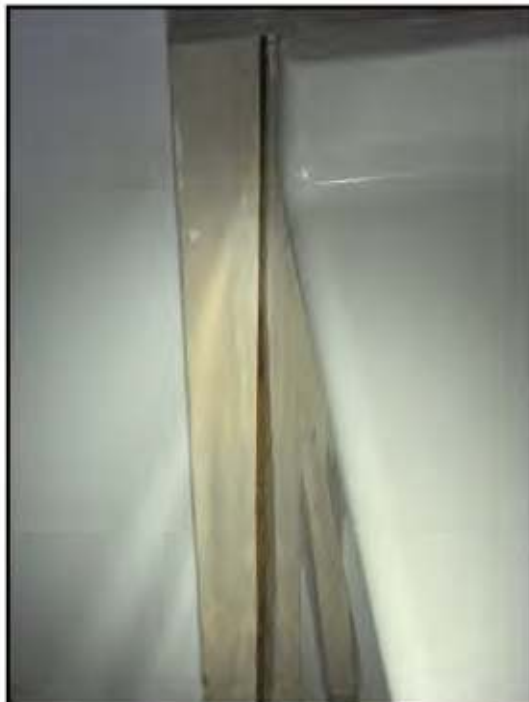
## 72. Condition: • [Tile loose, broken or missing](#)

Implication(s): Chance of water damage to structure, finishes and contents

Location: Basement Bathroom

169. Tile loose, broken or missing

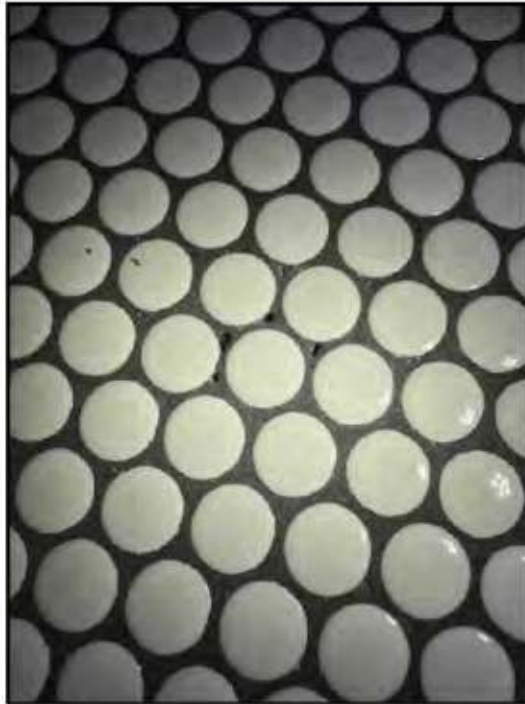
**FIXTURES AND FAUCETS \ Shower stall****73. Condition:** • [Grout loose, missing or deteriorated](#)**Implication(s):** Chance of water damage to structure, finishes and contents**Location:** Master Bathroom

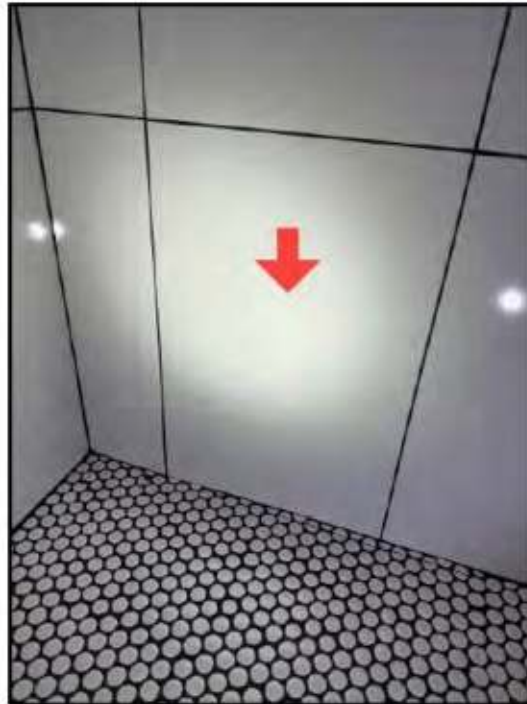
**75. Condition:** • Tiles, loose, cracked or broken

**Location:** Master Bathroom

173. Tiles, loose, cracked or broken

**Task:** Further evaluation

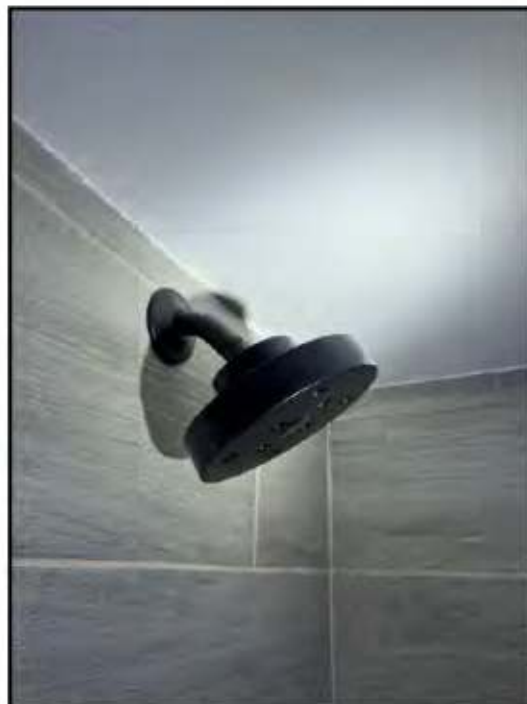
**76. Condition:** • Longer shower arms are recommended when using wide rainfall shower heads.

**Location:** Basement Bathroom

174. Longer shower arms are recommended when...

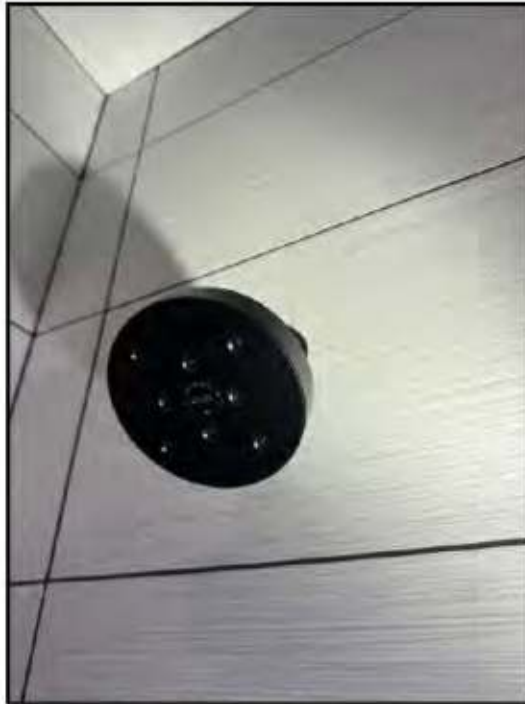
**77. Condition:** • Loose shower head

**Implication(s):** Chance of water damage to structure, finishes and contents.

**Location:** Second Floor Bathroom

**175.** Loose shower head

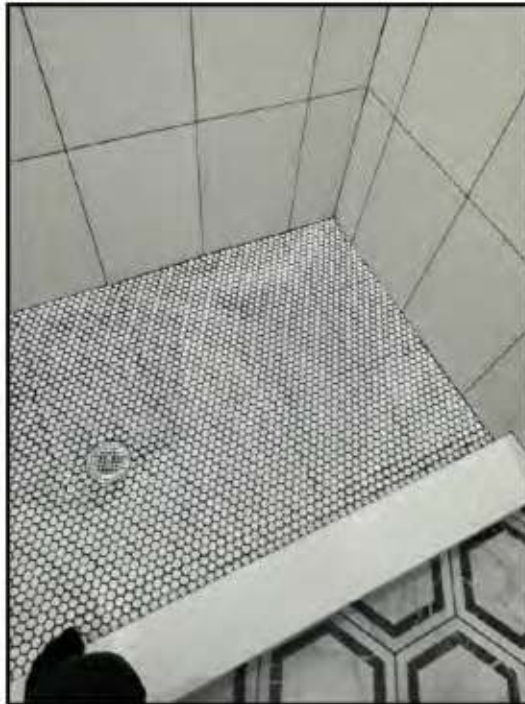
**78. Condition:** • Grout sealant recommended

**Location:** Master Bathroom

176. Grout sealant recommended

It is recommended to apply a sealant to the shower pan grout to protect it from water penetration and extend its durability. This will help prevent moisture from seeping into the grout, reducing the risk of water damage and mold growth.

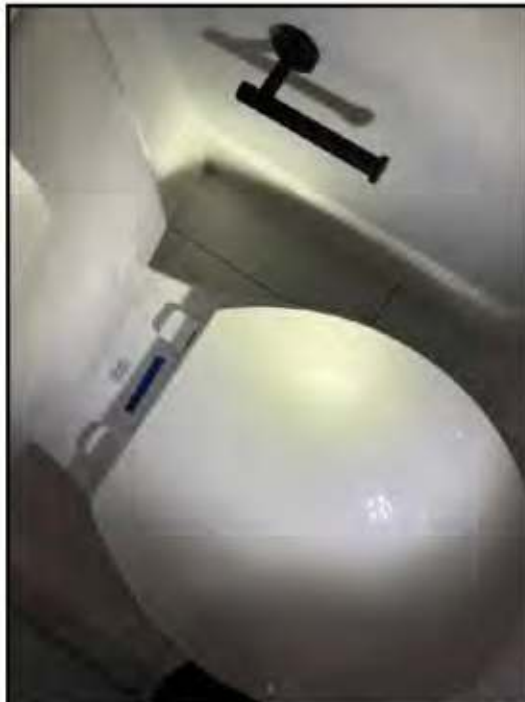
79. Condition: • Damaged toilet seat

Location: Second Floor Bathroom

177. Damaged toilet seat

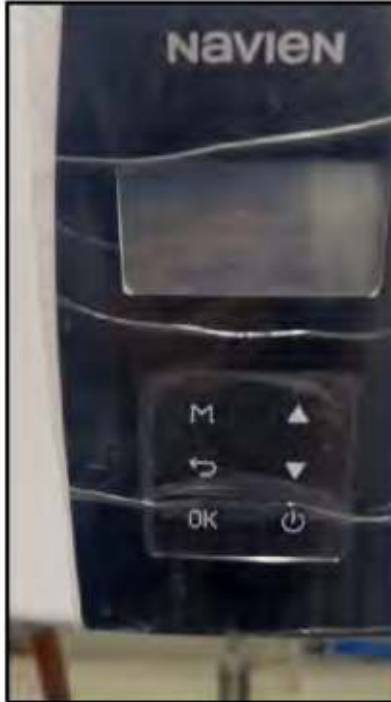
178.

80. Condition: • The tankless water heater had the gas valve shut off when the inspection began. The unit started working once the valve was opened.

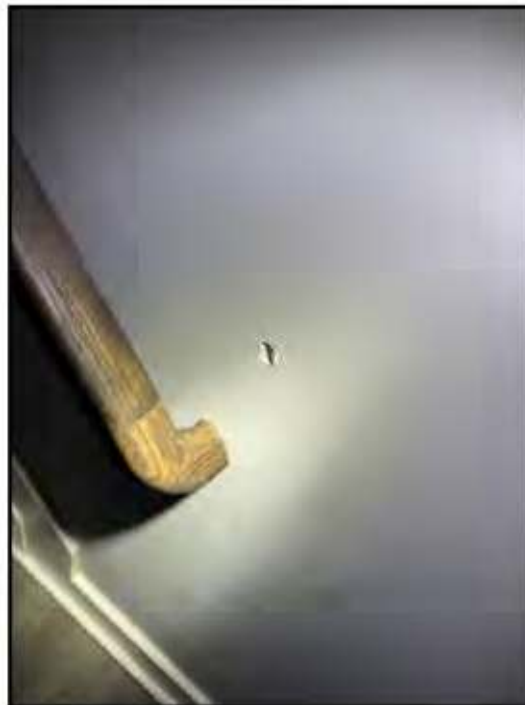
83. Condition: • Damage

Implication(s): Damage or physical injury due to falling materials

Location: Various

179. Damage

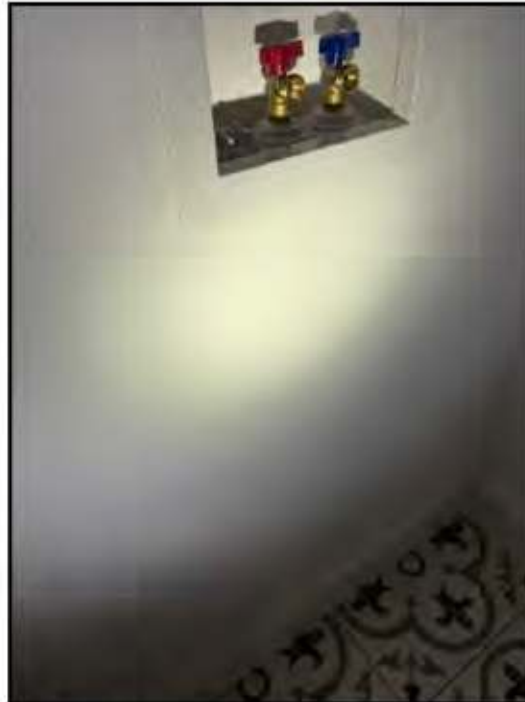
**84. Condition:** • Water stains

**Implication(s):** Chance of water damage to structure, finishes and contents

**Location:** Second Floor Laundry Area

**180.** *Water stains*

**Task:** Monitor

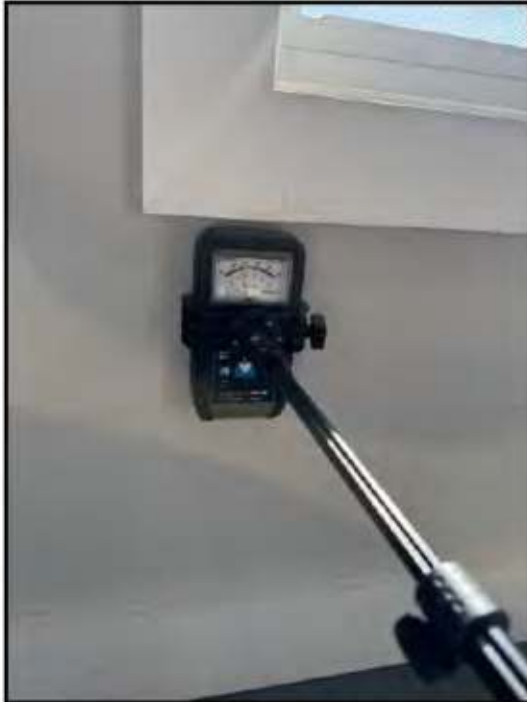
**85. Condition:** • Active water leak detected

**Implication(s):** Chance of movement, Rot, Leakage

**Location:** Rear Second Floor Bedroom

181. Active water leak detected

**Task:** Further evaluation

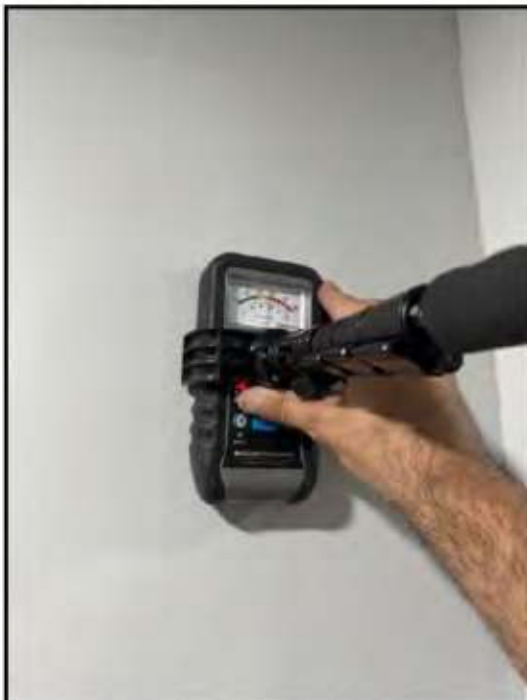
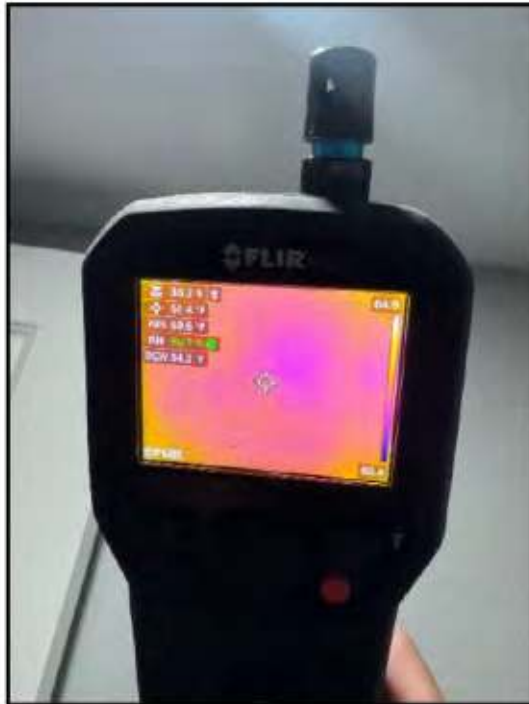
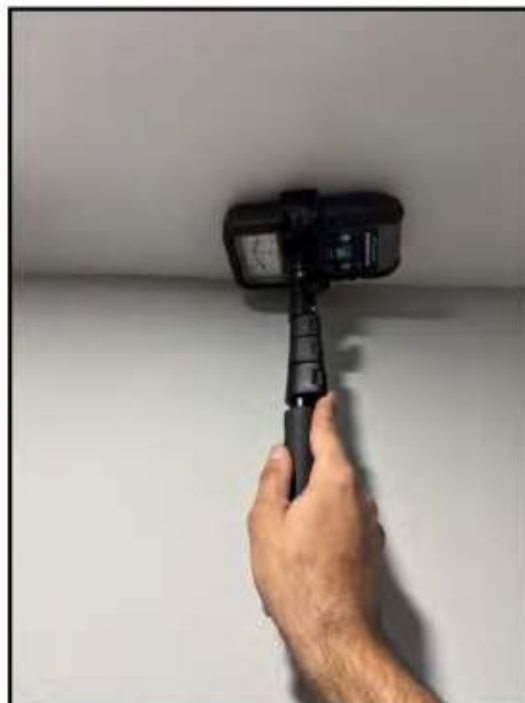
**86. Condition:** • Active water leak detected

The area appears to be located below the EIFS water infiltration point.

**Implication(s):** Chance of movement, Rot, Leakage

**Location:** Basement

183. Active water leak detected

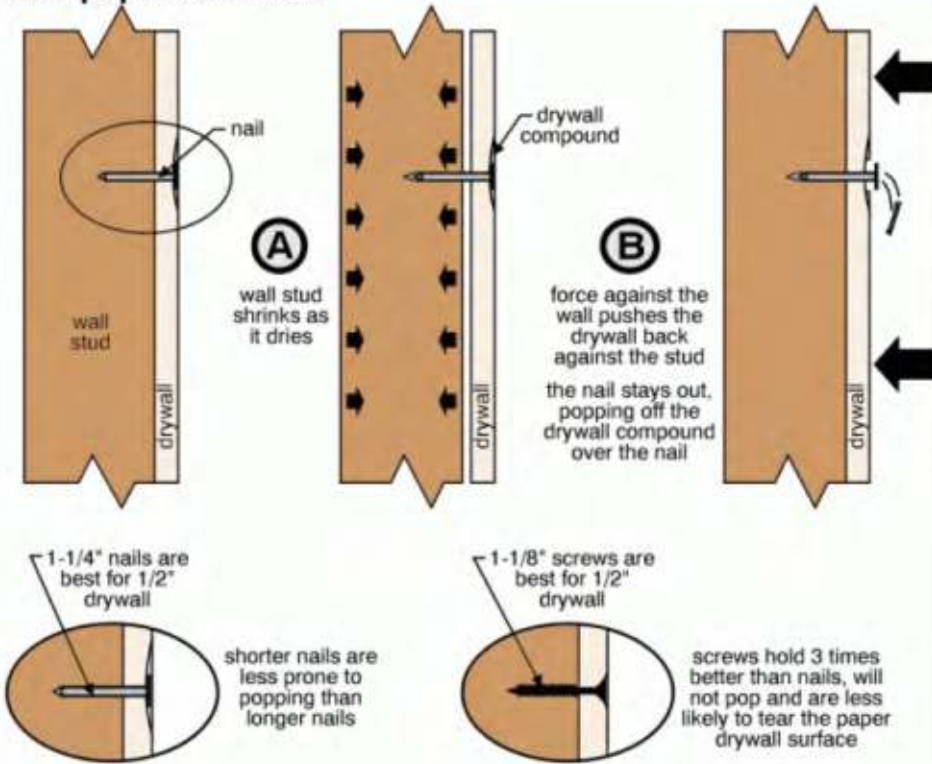
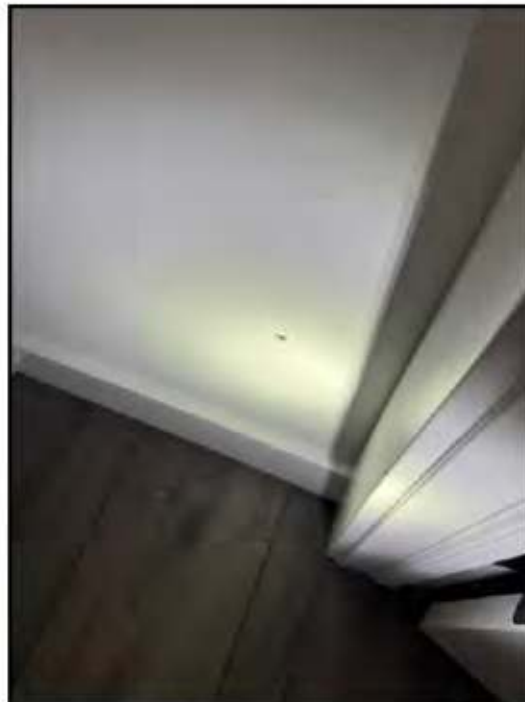
88. Condition: • [Nail pops](#)

Nail pops or damaged spackle over drywall screws

Location: Various

190. Nail pops

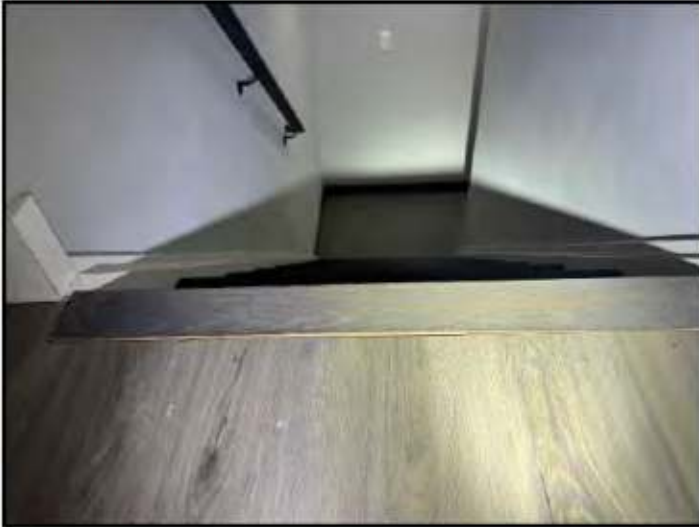
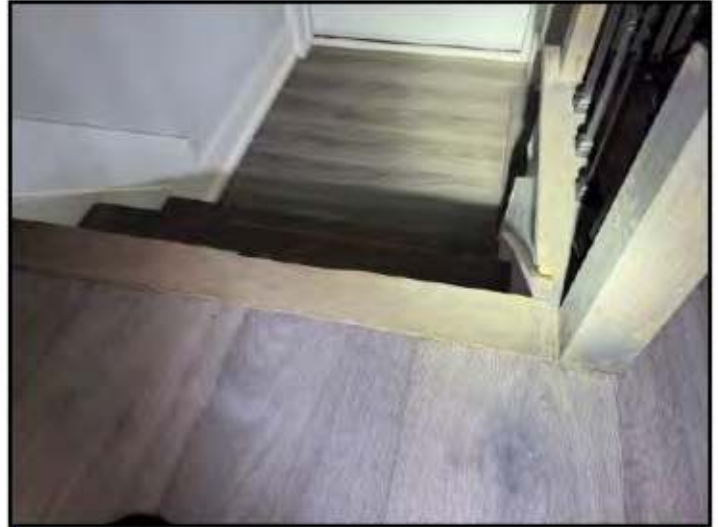
89. Condition: • [Trip hazard](#)

Implication(s): Physical injury

Location: Various

191. Trip hazard

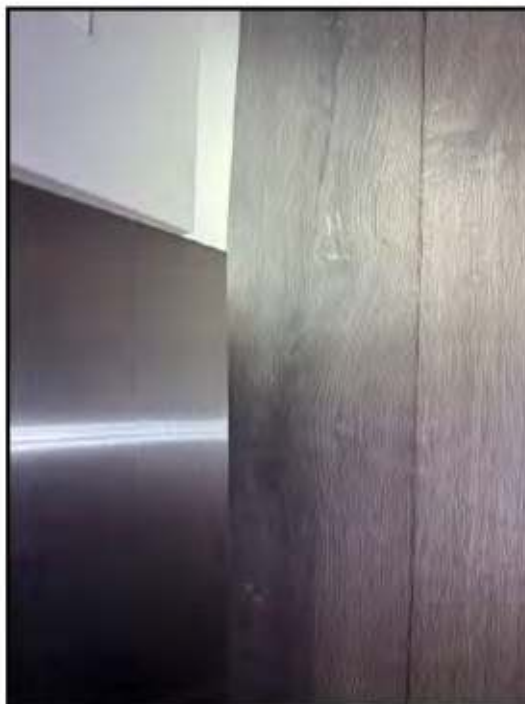
90. Condition: • Wear

Implication(s): Material deterioration

193. Wear

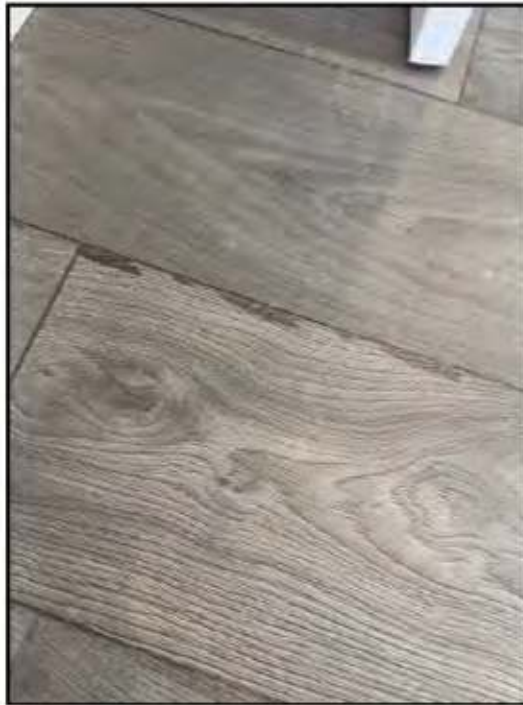
**91. Condition:** • Stained

**194.** *Stained*

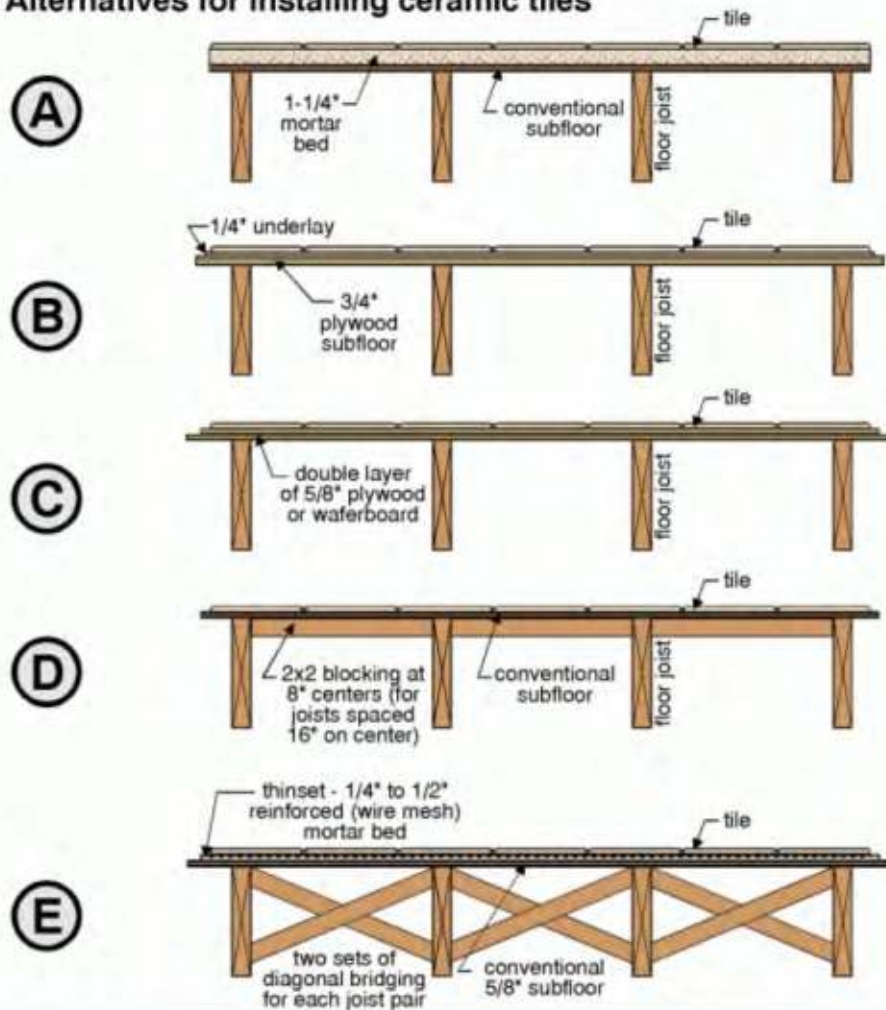
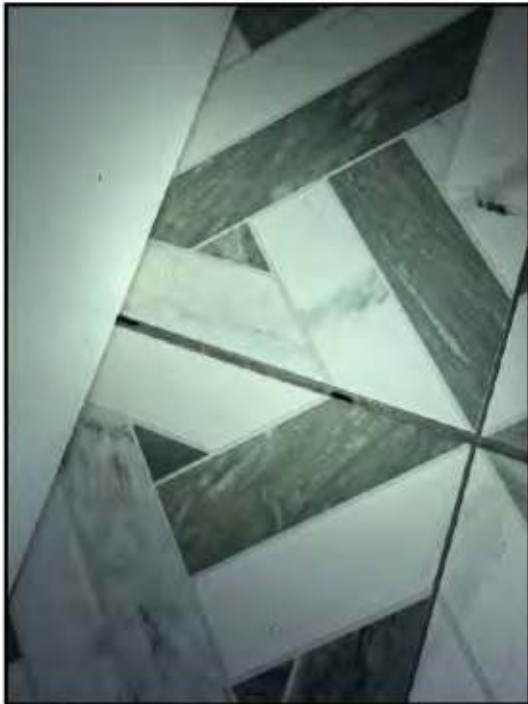
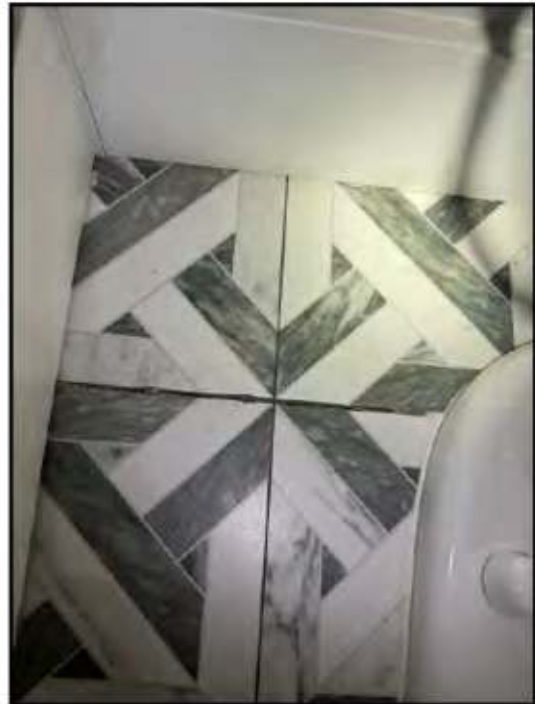
**92. Condition:** • [Grout missing](#)

**Implication(s):** Trip or fall hazard

**Location:** First Floor Bathroom

195. Grout missing

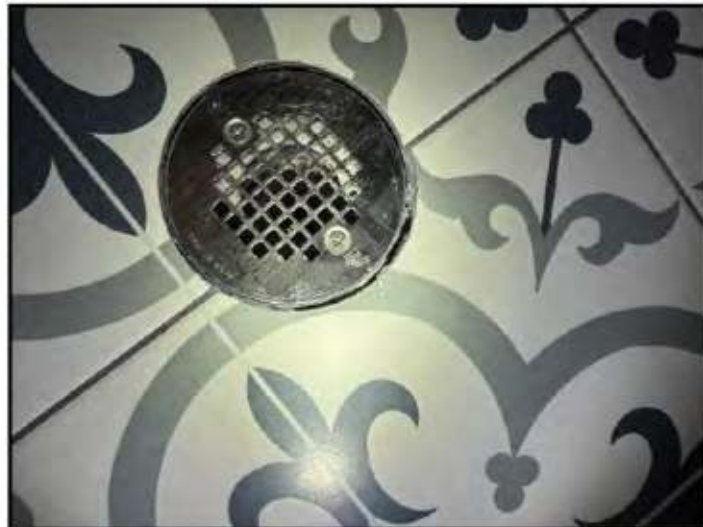
93. Condition: • [Grout missing](#)

Implication(s): Trip or fall hazard

Location: Laundry Area

197. Grout missing

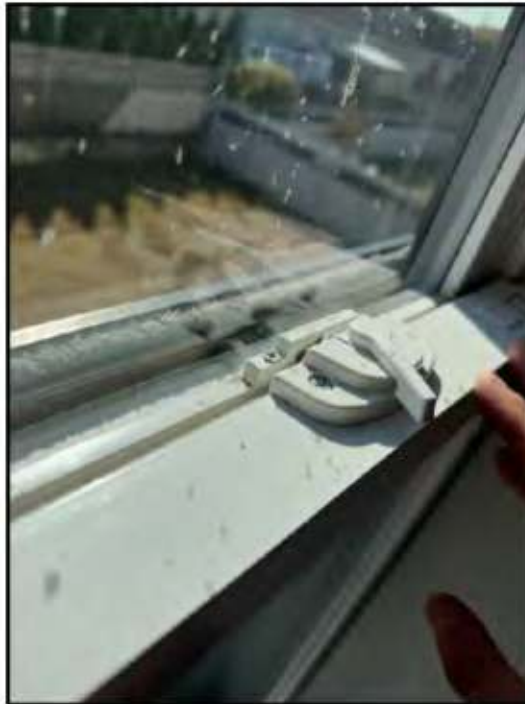
94. Condition: • Lower quality units

Implication(s): Increased heating costs | Increased maintenance costs

198. Lower quality units

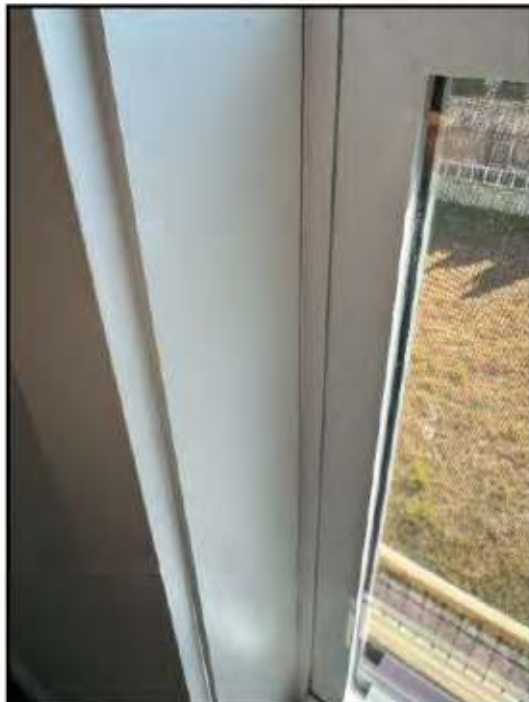
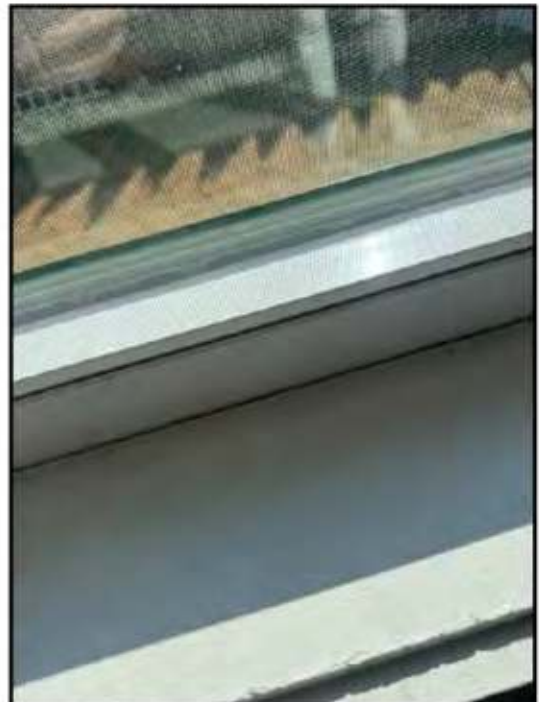
95. **Condition:** • Caulking missing, loose or deteriorated

199. Caulking missing, loose or deteriorated

**Task:** Recommend caulking around window frame
