# Your Inspection Report

Tuesday, October 22, 2024

Leonardo Betancor, CMI, 24GI00182600, HOI.0001093

Smart Choice Inspections LLC  
173 Ridge Road, Suite H1  
Cedar Grove, NJ 07009

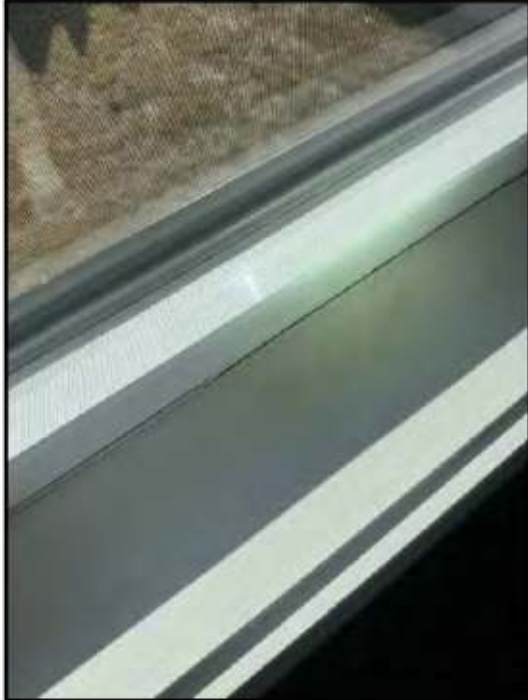
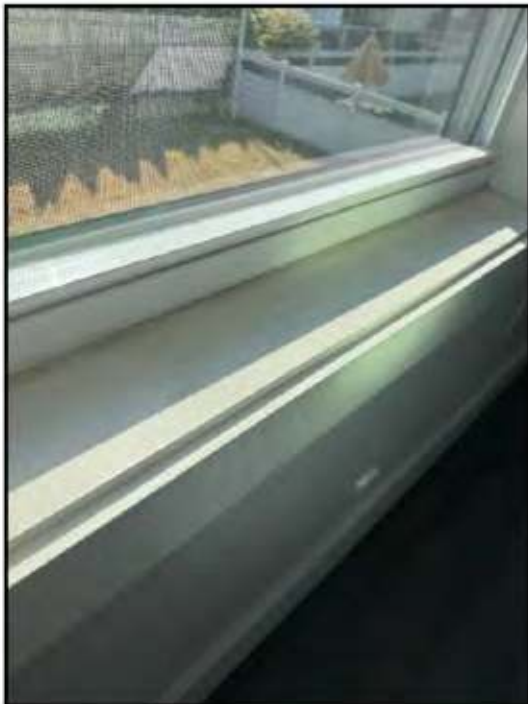
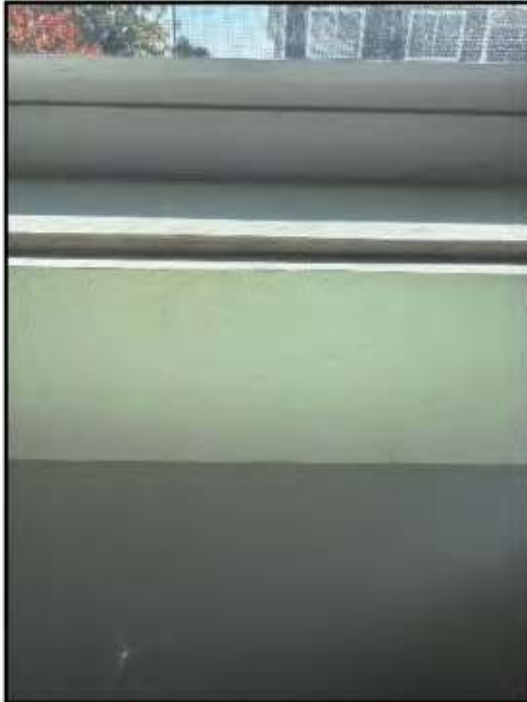
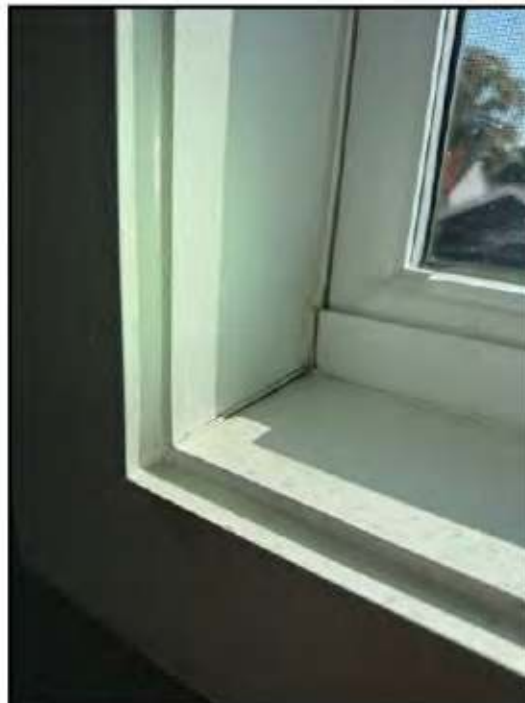
**96. Condition:** • Water stains

**Location:** Throughout Second Floor Bedrooms

**201. Water stains**

**Task:** Further evaluation

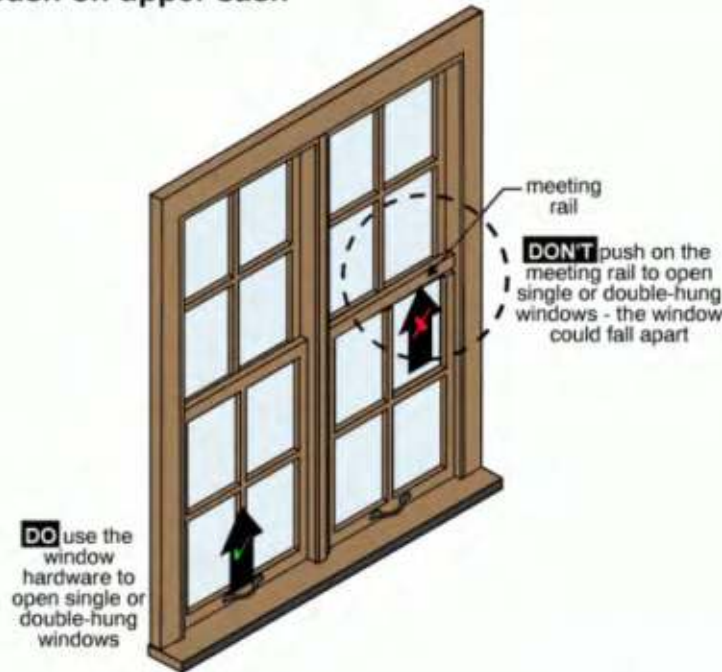
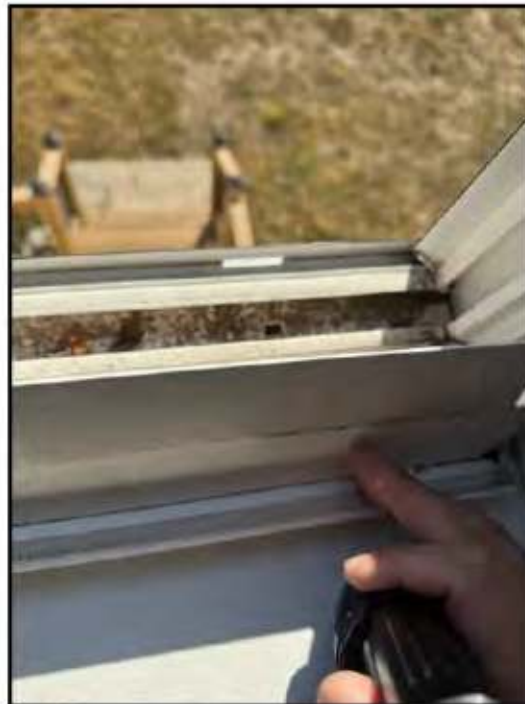
208. Sash coming apart

97. Condition: • [Sash coming apart](#)

Implication(s): Chance of damage to finishes and structure | Glass breaking

## Don't push on upper sash

**Task:** Further evaluation

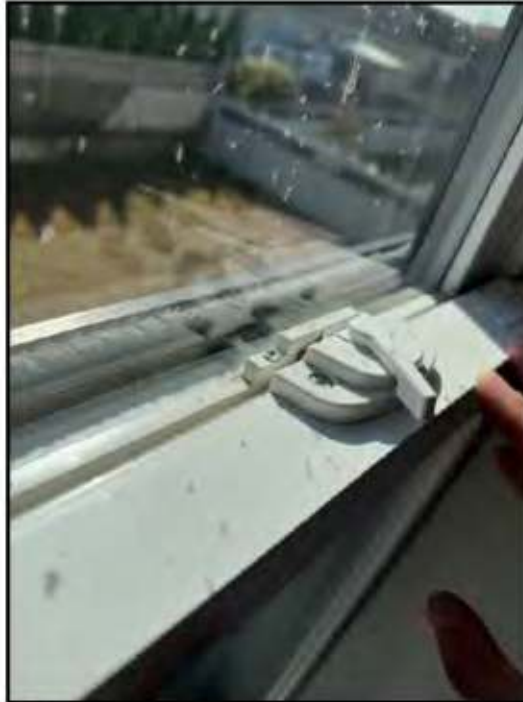
209. *Difficult to operate*

98. Condition: • Difficult to operate

Location: Second Floor

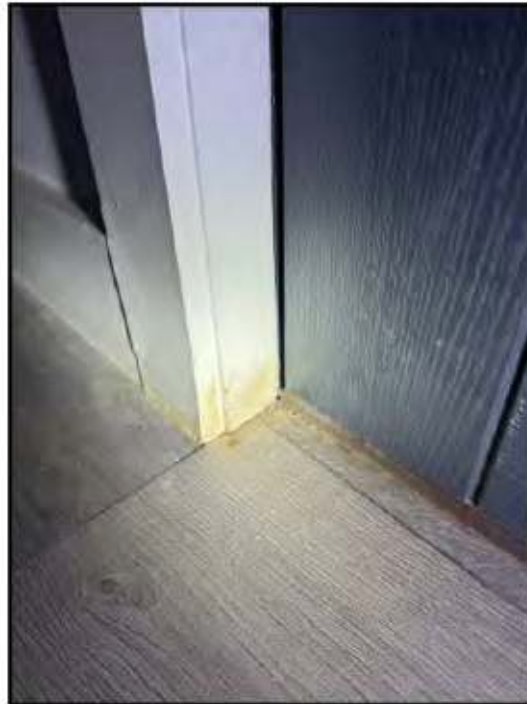
210. Water stains

99. Condition: • Water stains

Location: Front

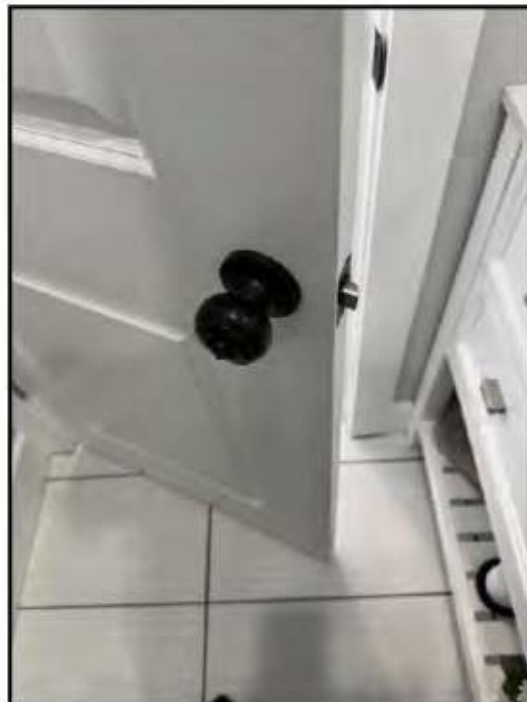
211. Loose

100. Condition: • [Loose](#)

Implication(s): Equipment failure

Location: First Floor Bathroom

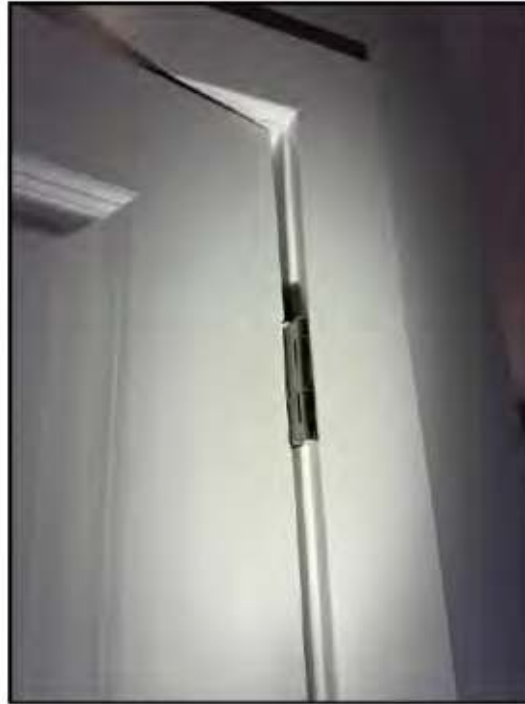
*212. Loose hinge*

**101. Condition:** • Loose hinge

**Location:** Second Floor Bedroom Closet

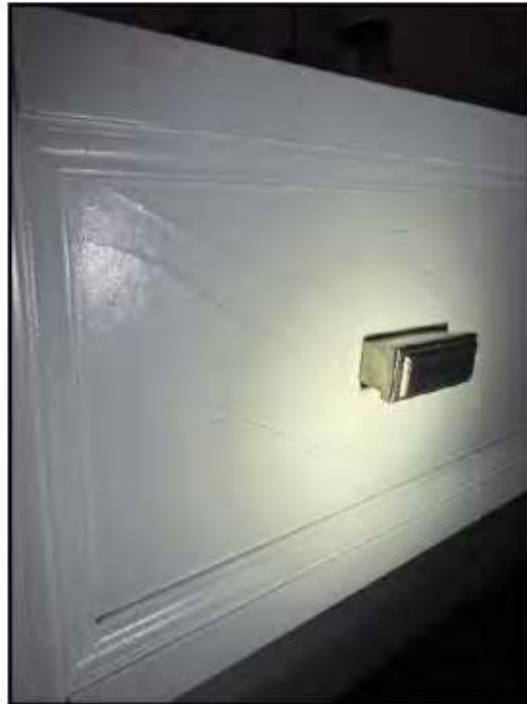
213. Stained, worn, damaged

**102. Condition:** • [Stained, worn, damaged](#)

**Implication(s):** Material deterioration

**Location:** Basement Bathroom

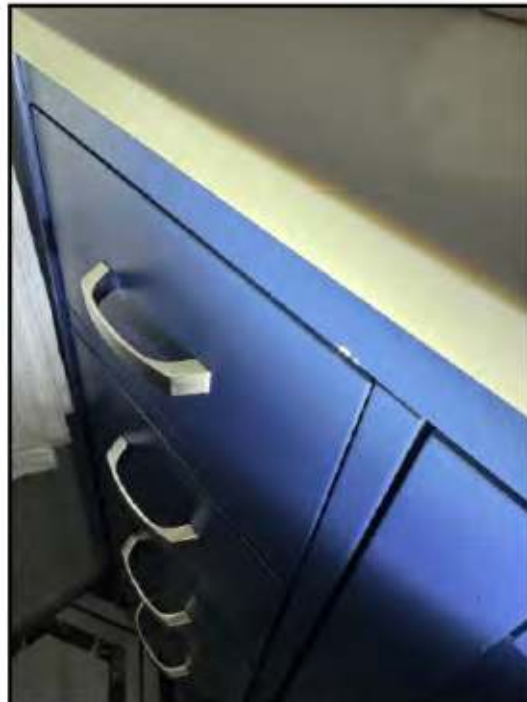
214. Stained, worn, damaged

103. Condition: • [Stained, worn, damaged](#)

Implication(s): Material deterioration

Location: Master Bathroom

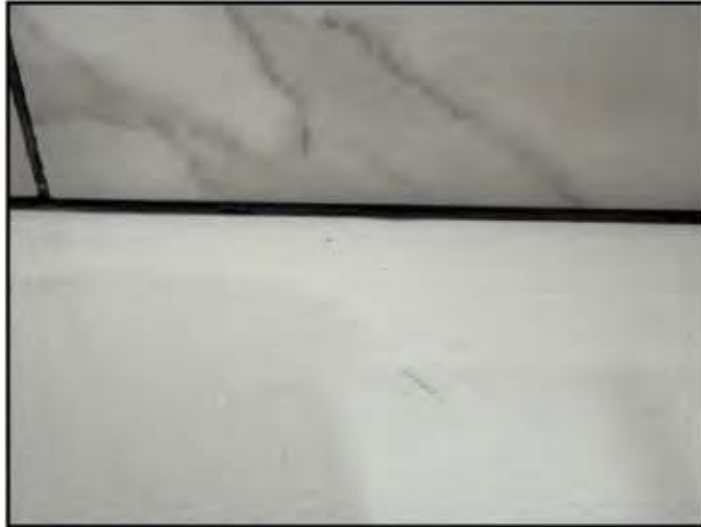
**215.** *Caulking cracked or deteriorating*

**104. Condition:** • Caulking cracked or deteriorating

**Location:** Kitchen

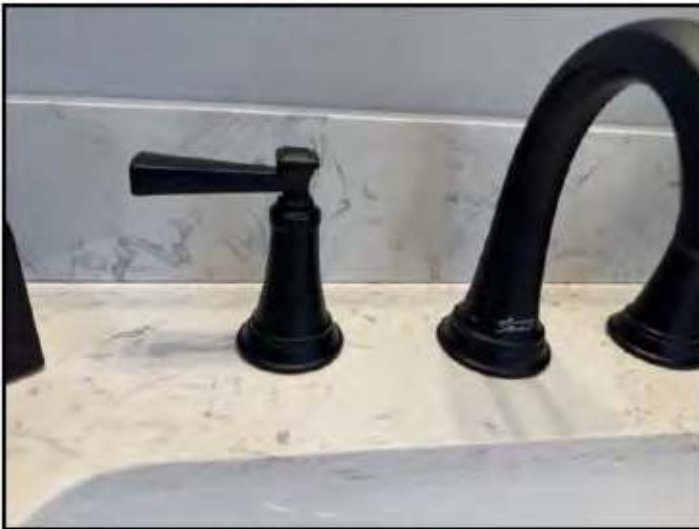
**216.** *Caulking cracked or deteriorating*

**105. Condition:** • Caulking cracked or deteriorating

**Location:** First Floor Bathroom

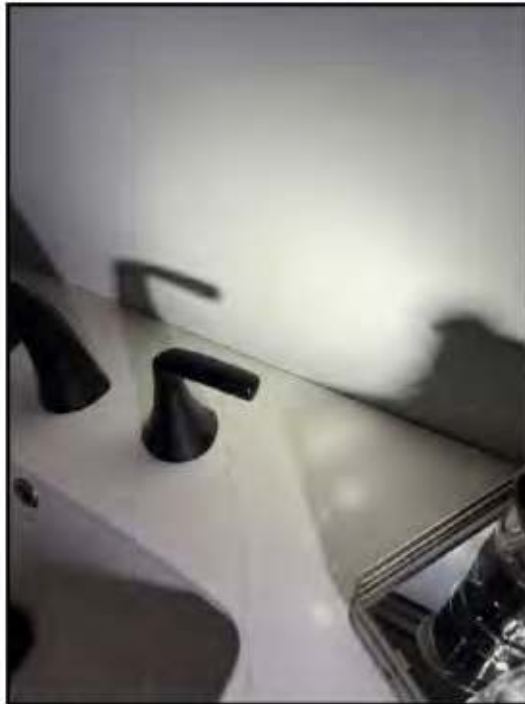
218. *Caulking cracked or deteriorating*

**106. Condition:** • Caulking cracked or deteriorating

**Location:** Master Bathroom

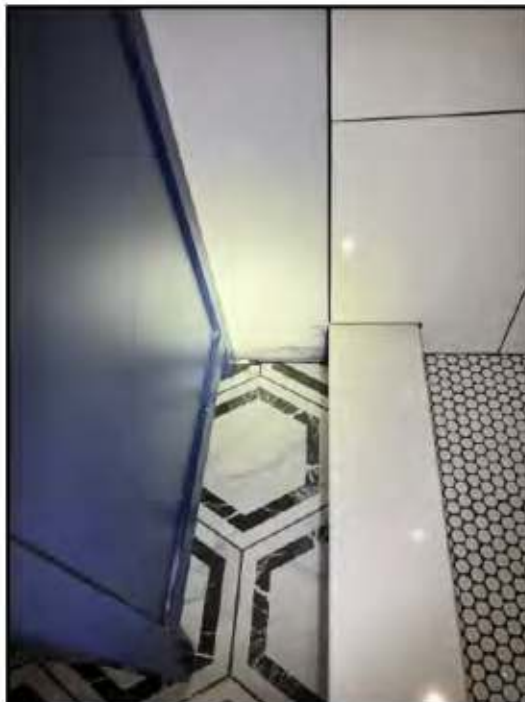
219. *Missing*

107. Condition: • [Missing](#)

Implication(s): Nuisance

Location: Master Bathroom

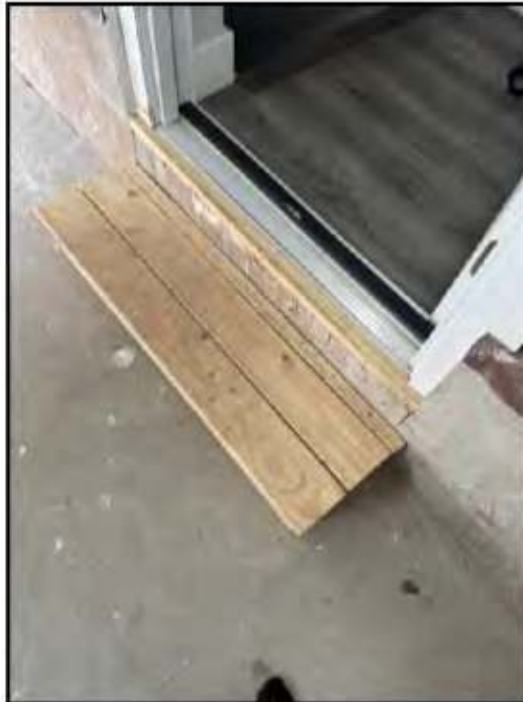
220. Loose

108. Condition: • [Loose](#)

Implication(s): Chance of movement

Location: Garage

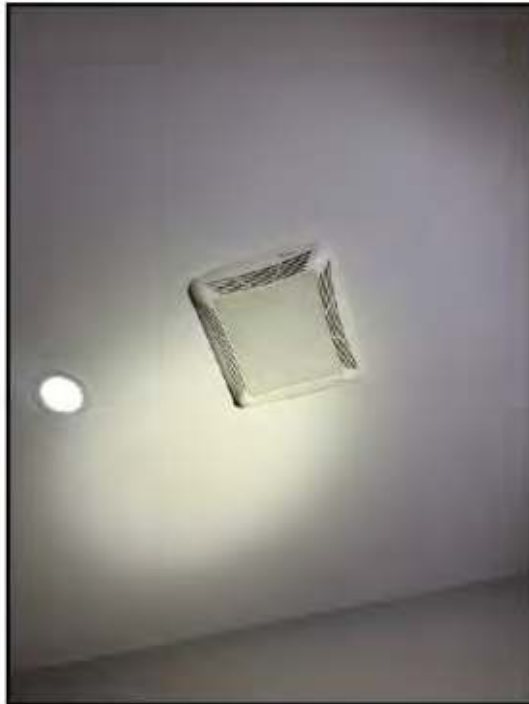
221. Light inoperative

109. Condition: • Light inoperative

Location: Various Bathrooms

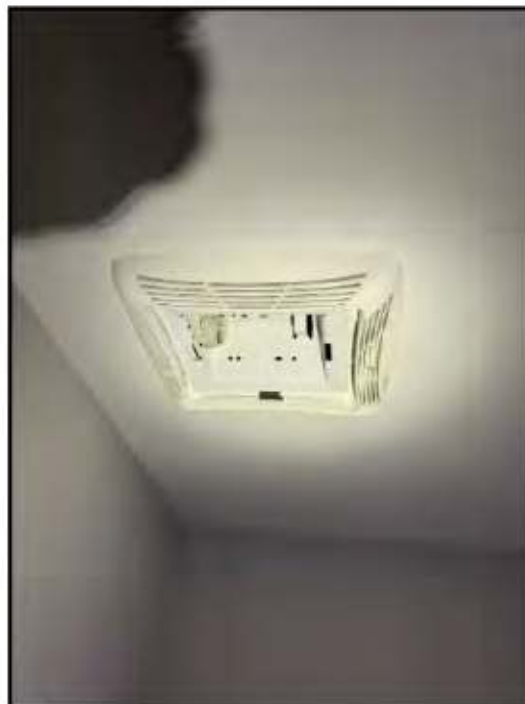
223.

110. Condition: • Missing light cover

Location: Basement bathroom

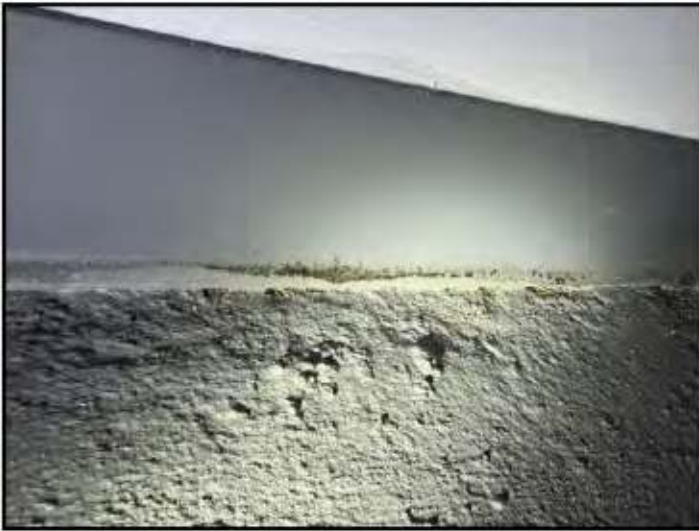
224. Mold

111. Condition: • [Mold](#)

Implication(s): Chance of water damage to structure, finishes and contents | Contaminants may enter building air

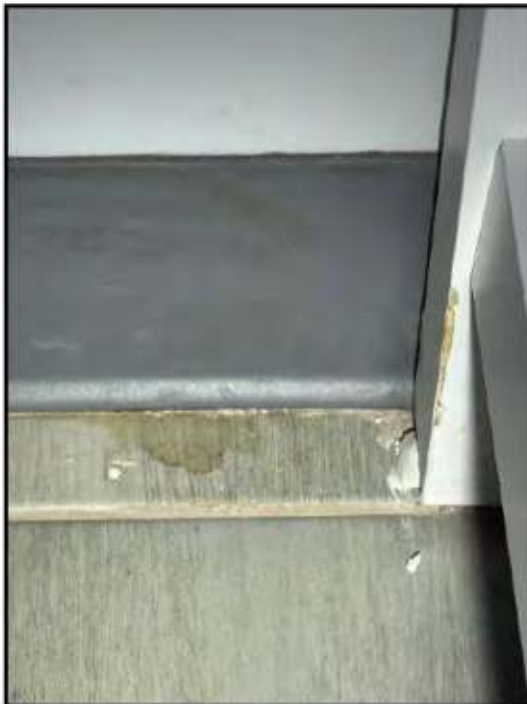
227. Water marks

112. Condition: • [Water marks](#)

Implication(s): Chance of water damage to structure, finishes and contents

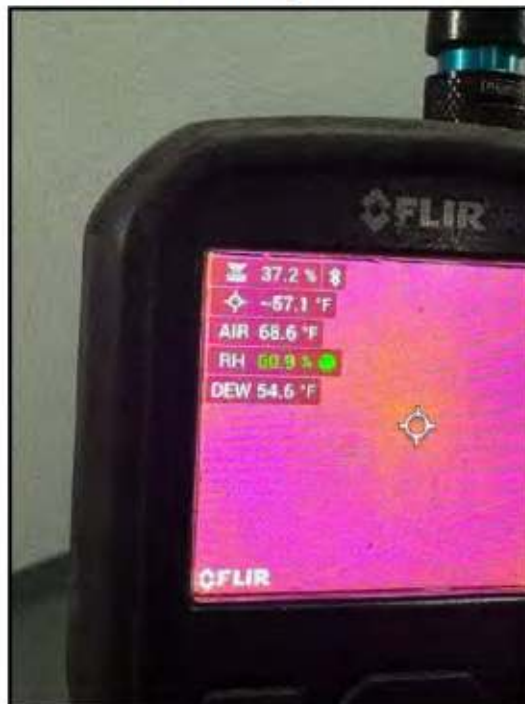
235. Humidity levels over 60%

**113. Condition:** • Humidity levels over 60%

60.9% of relative humidity was detected in basement. Humidity levels over 60% inhibit mold growth.

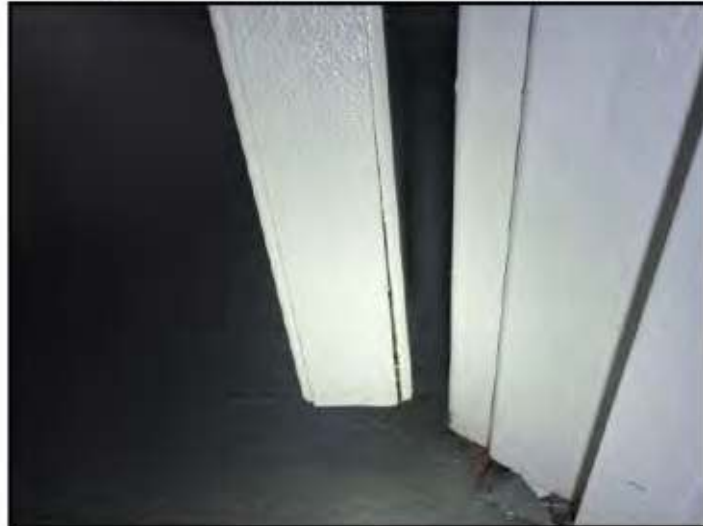
236. Water damage

**114. Condition:** • Water damage

**Implication(s):** Chance of water damage to structure, finishes and contents, Material deterioration

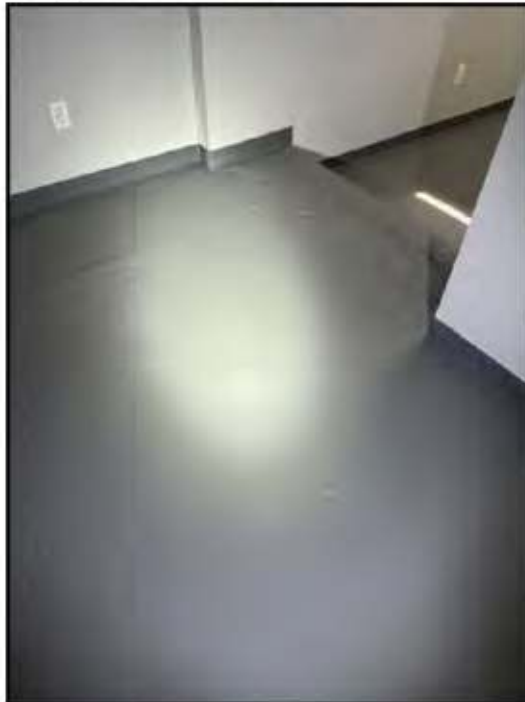
237.

**115. Condition:** • Flooring material missing over the concrete slab.

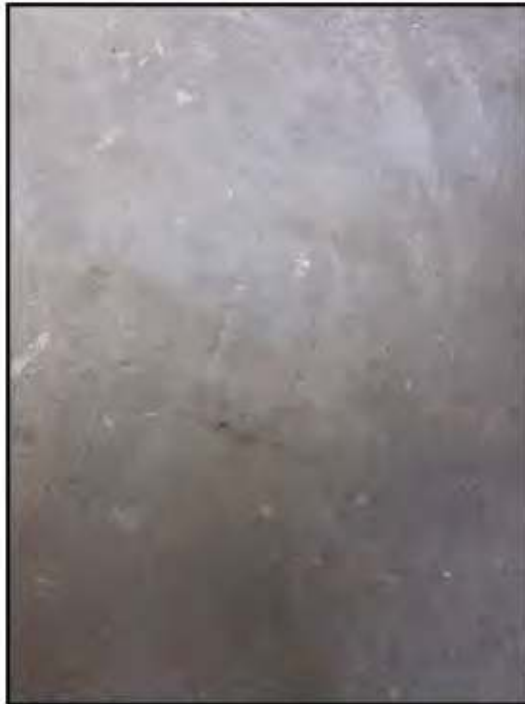
238. *Cracked*

**116. Condition:** • [Cracked](#)

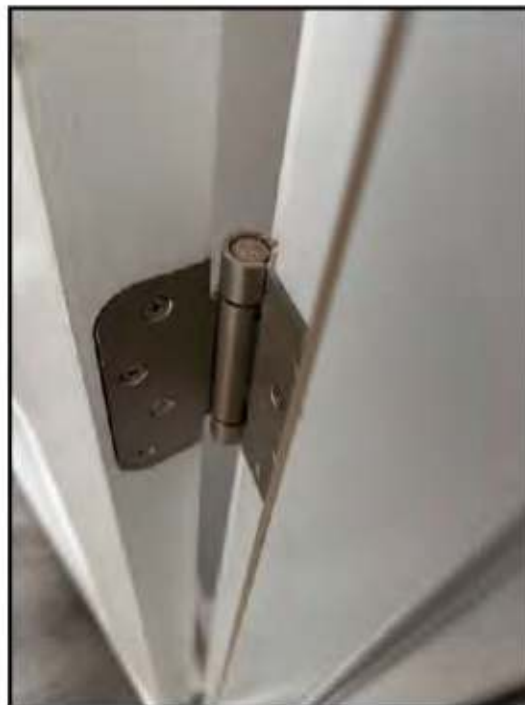
239. No self closer

117. Condition: • [No self closer](#)

**Implication(s):** Hazardous combustion products entering home

**Location:** Garage

Recommend adjusting the self-closing hinge pre-installed with the fire rated door

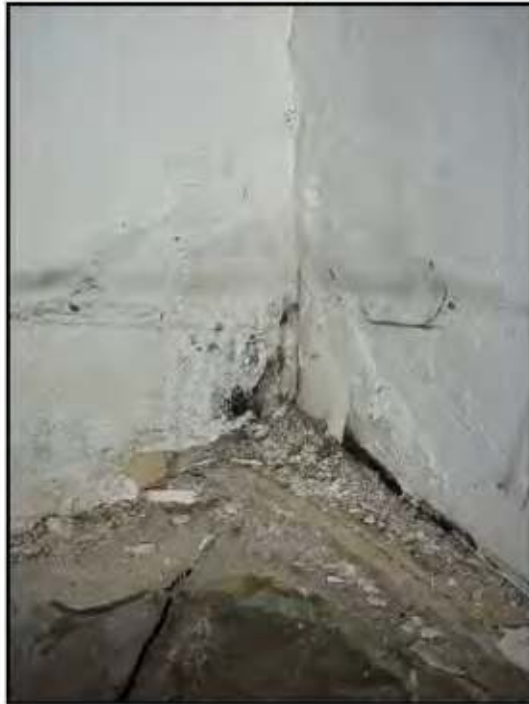
240. Mold

118. Condition: • Mold

**Implication(s):** Health hazard

**Location:** Garage

**Task:** Further evaluation and repair

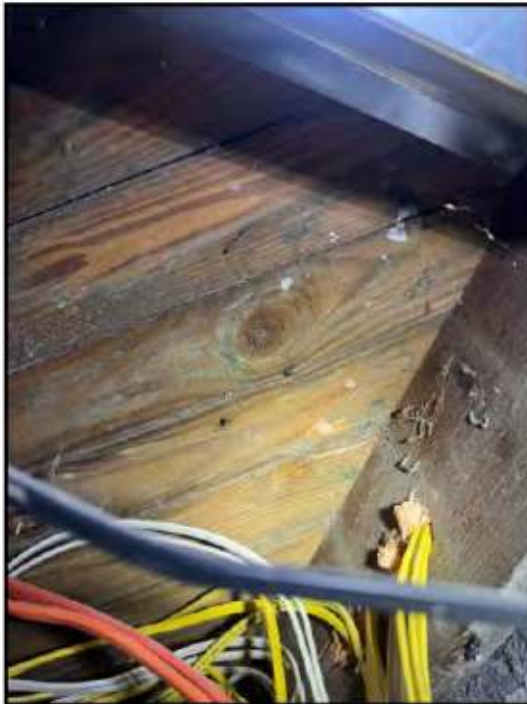
242. Positive mold test swab

**119. Condition:** • Positive mold test swab

Our test kit (SPDN0300) detects protein residues that are on a surface after water damage or due to microbial growth in less than a minute. It detects viable (living) and non-viable (dead) mold spores.

**Implication(s):** Health Hazard

**Location:** Throughout basement

**Task:** It is recommended to have a mold remediation company properly clean the mold seen throughout the basement. Given the extent of the issue, some drywall may need to be removed during this process.

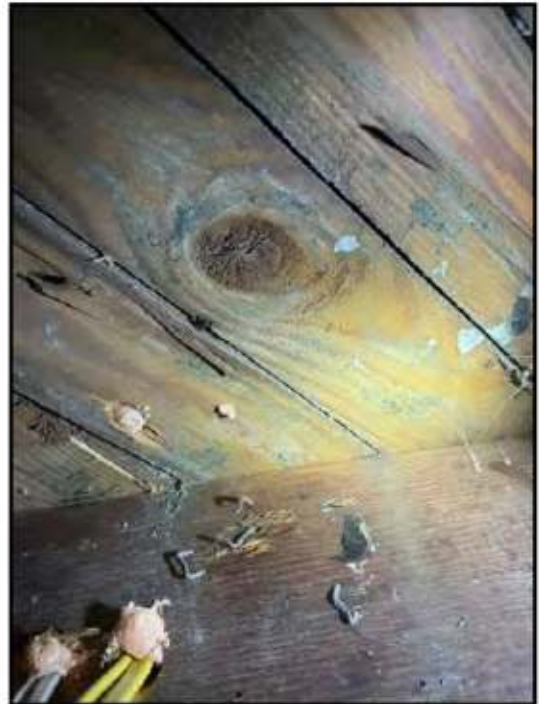
243. Positive mold test swab

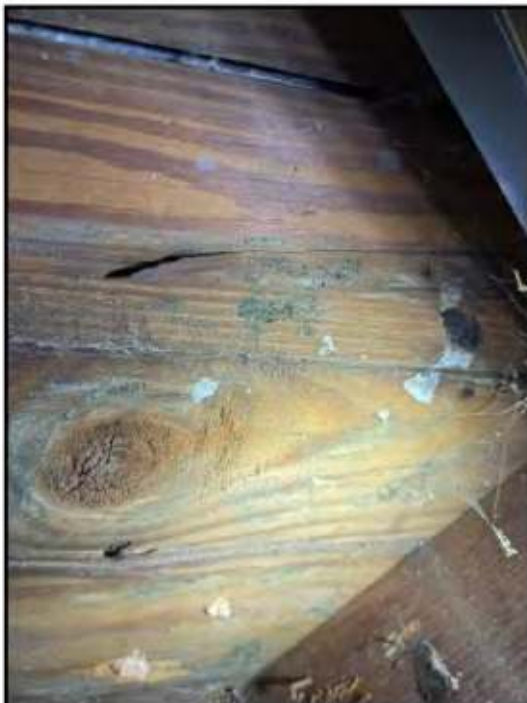
244. Positive mold test swab

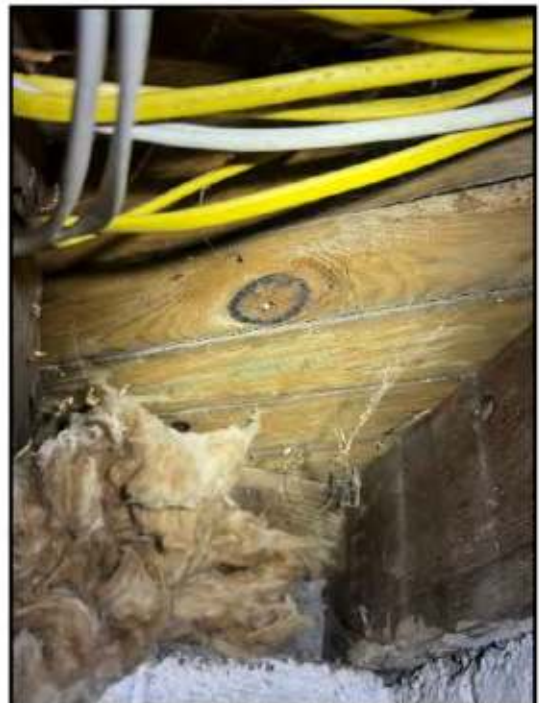
245. Positive mold test swab

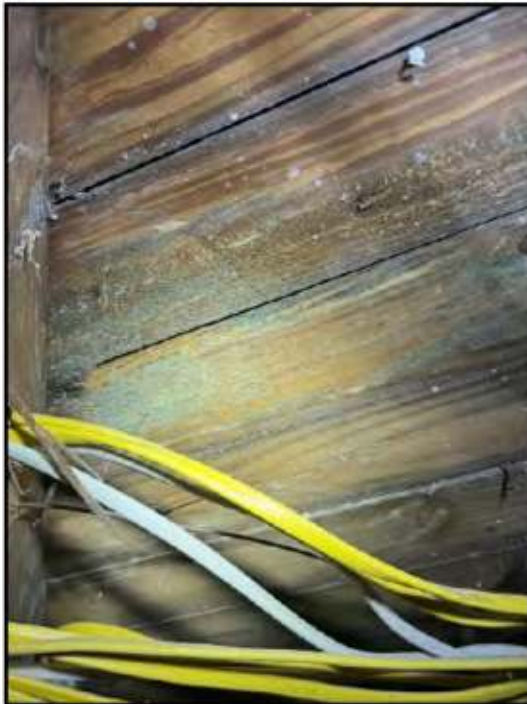
246. Positive mold test swab

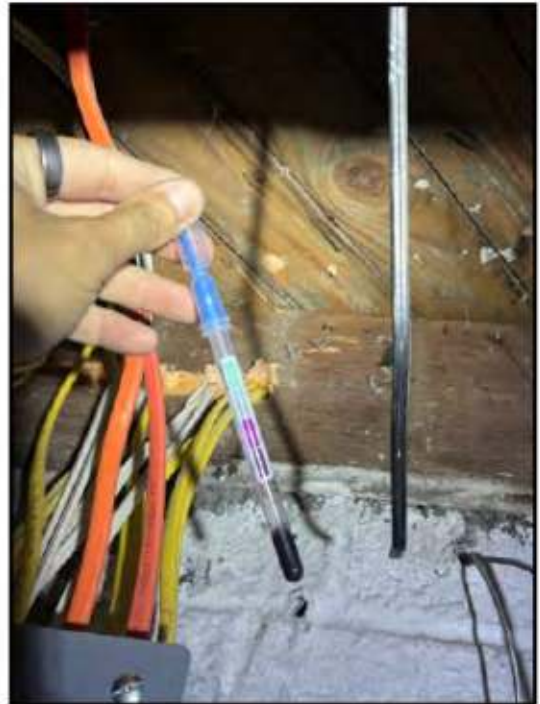
247. Positive mold test swab

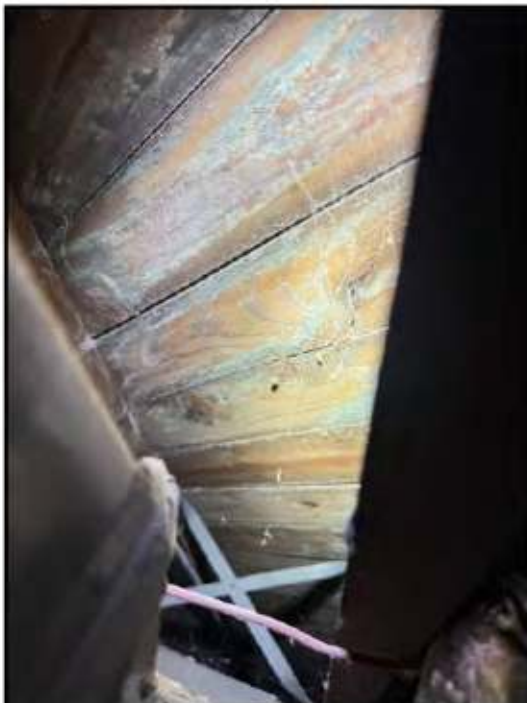
248. Positive mold test swab

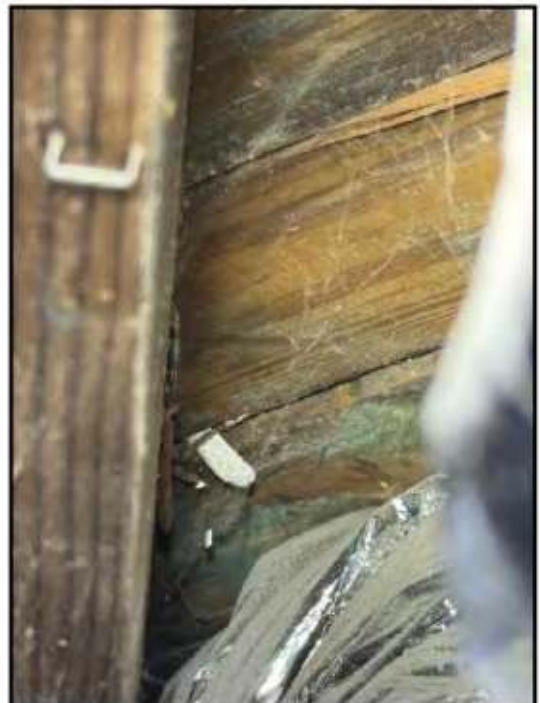
249. Positive mold test swab
