# Your Inspection Report

Tuesday, November 5, 2024

Leonardo Betancor, CMI, 24GI00182600, HOI.0001093

Smart Choice Inspections LLC  
173 Ridge Road, Suite H1  
Cedar Grove, NJ 07009

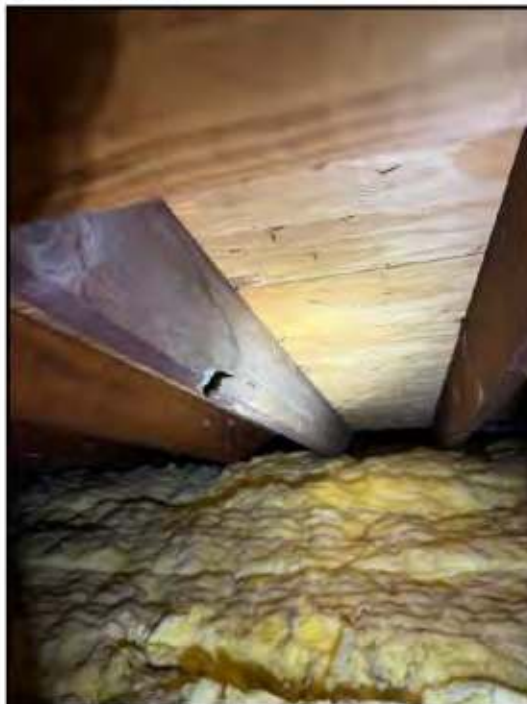
**Condition:** • Split or damage

**Implication(s):** Weakened structure | Chance of structural movement

**Location:** Attic Garage

1. Split or damage

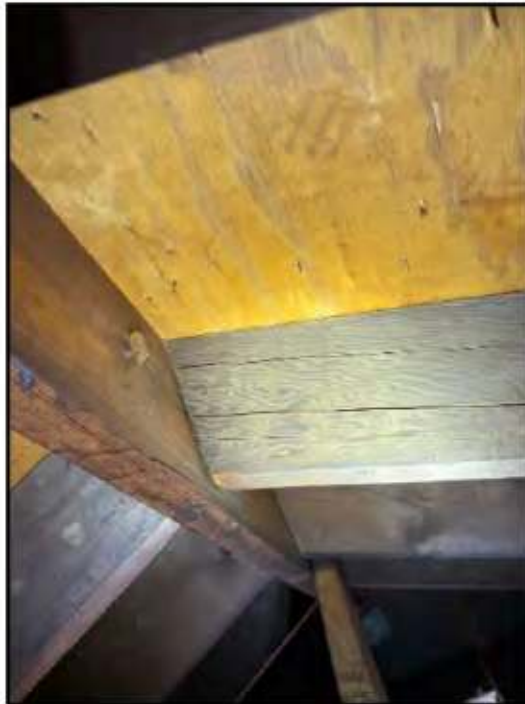
3. Split or damage

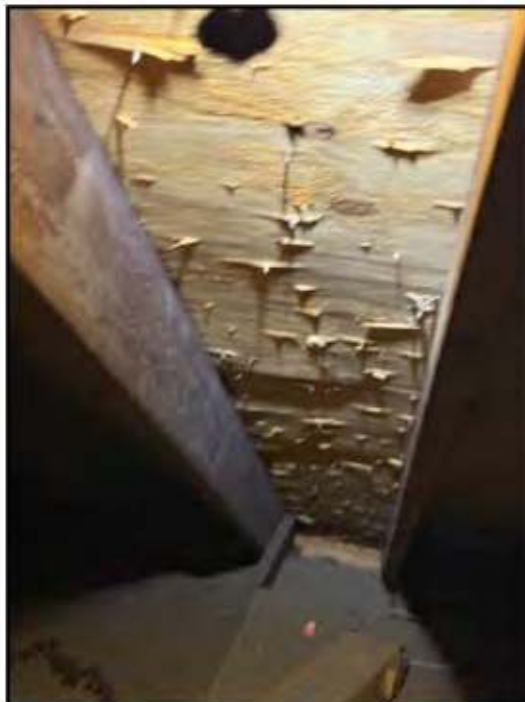
Condition: • [Buckled](#)

Implication(s): Weakened structure | Chance of structural movement

4. Buckled

Task: Further evaluation

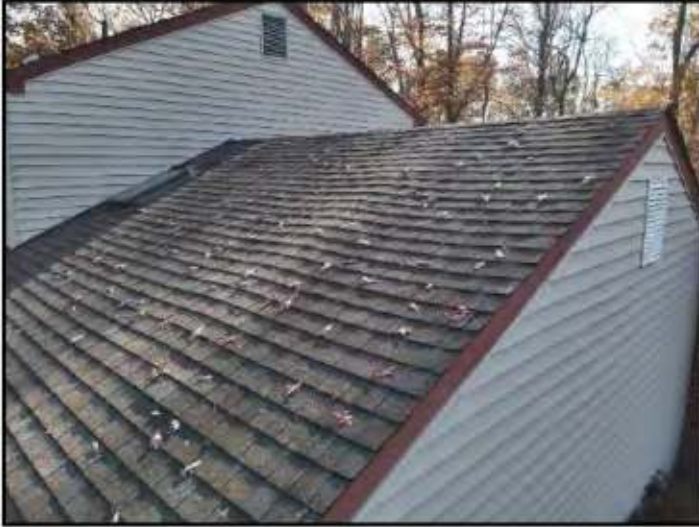
Condition: • [Buckled](#)

Implication(s): Weakened structure | Chance of structural movement

5. Buckled

Task: Further evaluation

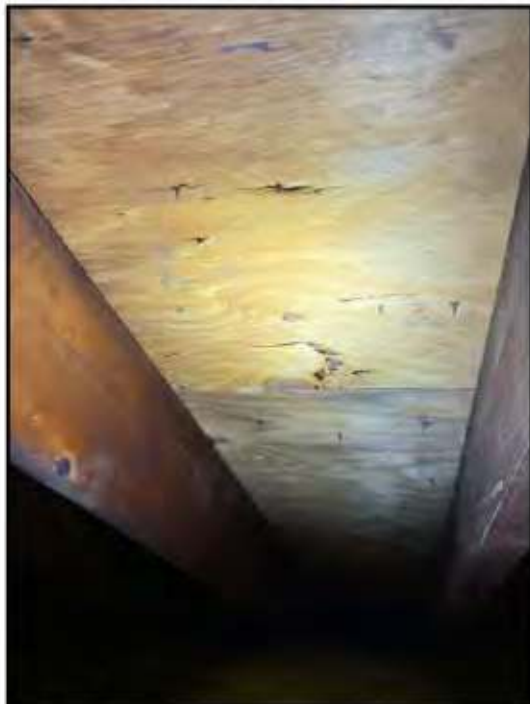
Condition: • Damage

Implication(s): Chance of water damage to structure, finishes and contents | Weakened structure

7. Damage

Task: Further evaluation and repair

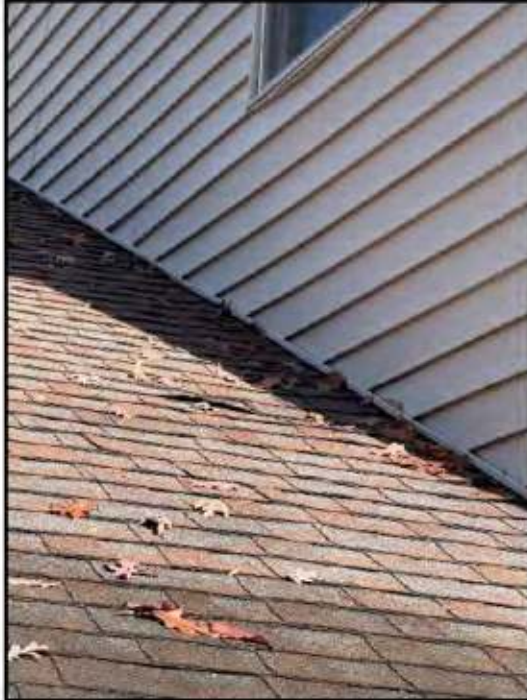
Condition: • [Sagging](#)

Implication(s): Weakened structure | Chance of structural movement

Location: Rear Garage

9. Sagging

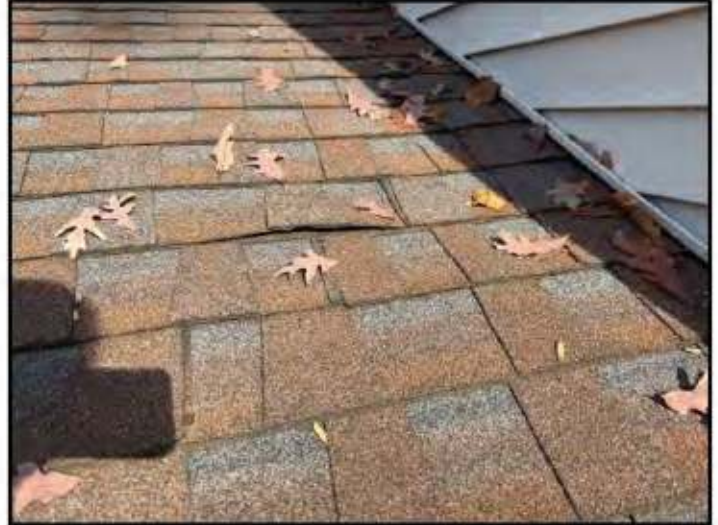
10. Sagging

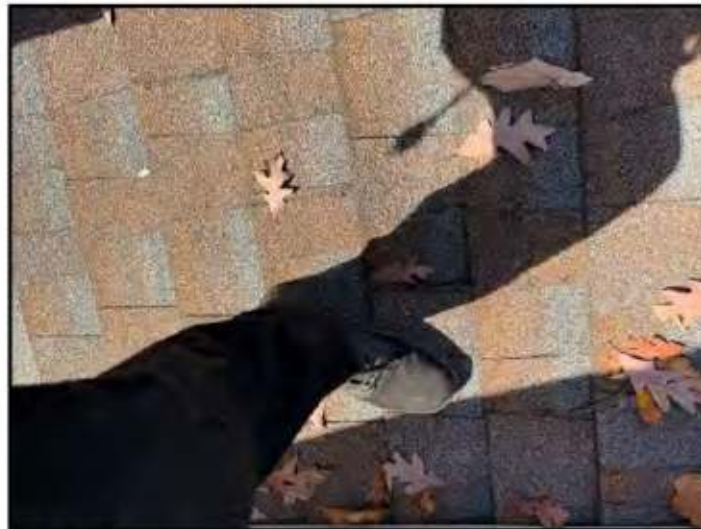
11. Sagging

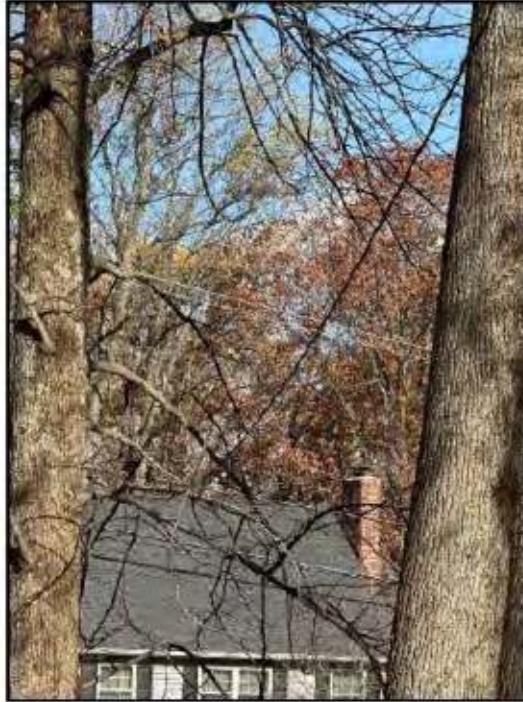
Condition: • [Branches / vines interfering with wires](#)

Implication(s): Damage to wire | Electric shock | Interruption of electrical service

12. Branches / vines interfering with wires

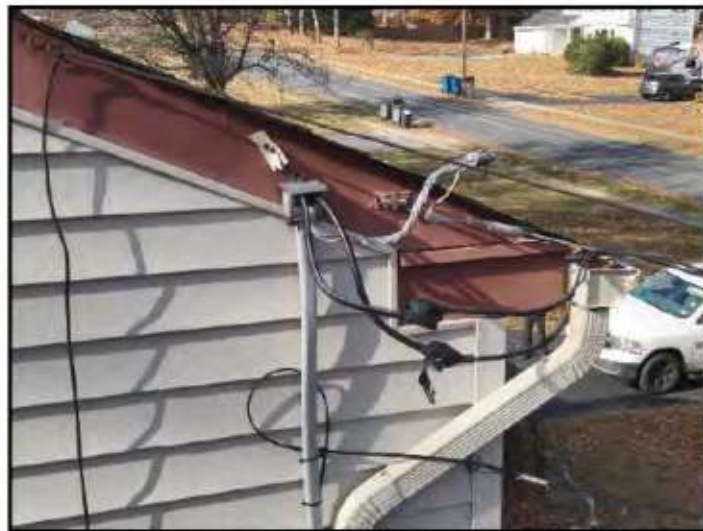
Condition: • Poorly installed drip loop

Implication(s): Shock hazard or interruption of electrical service

13. Poorly installed drip loop

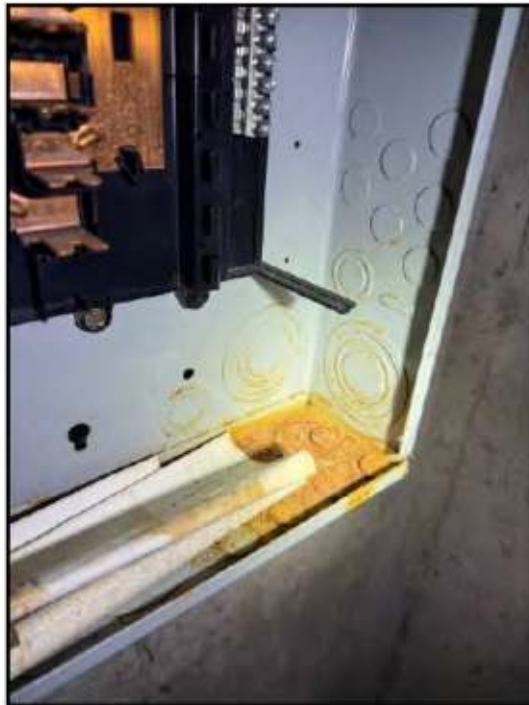
Condition: • [Rust or water in panel](#)

Implication(s): Electric shock | Fire hazard

14. Rust or water in panel

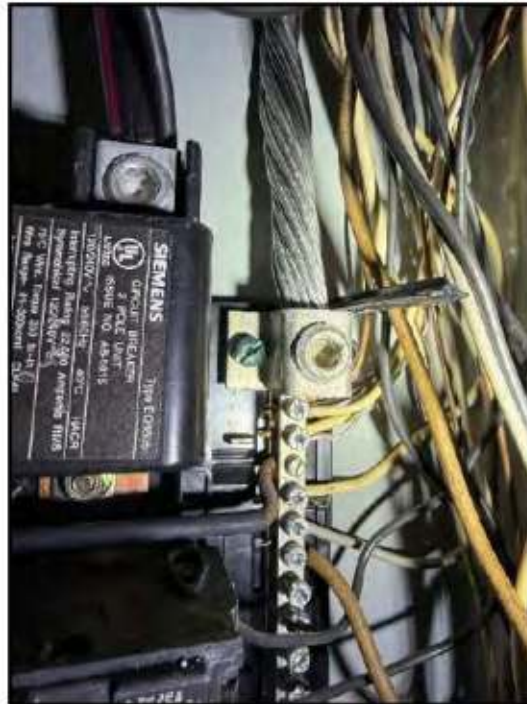
16. Rust or water in panel

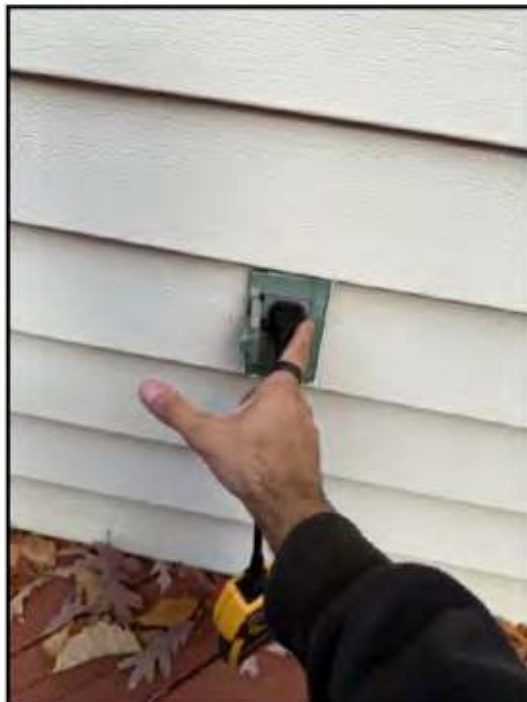
**DISTRIBUTION SYSTEM \ Outlets (receptacles)**Condition: • Loose

Implication(s): Electric shock | Fire hazard

17. Loose

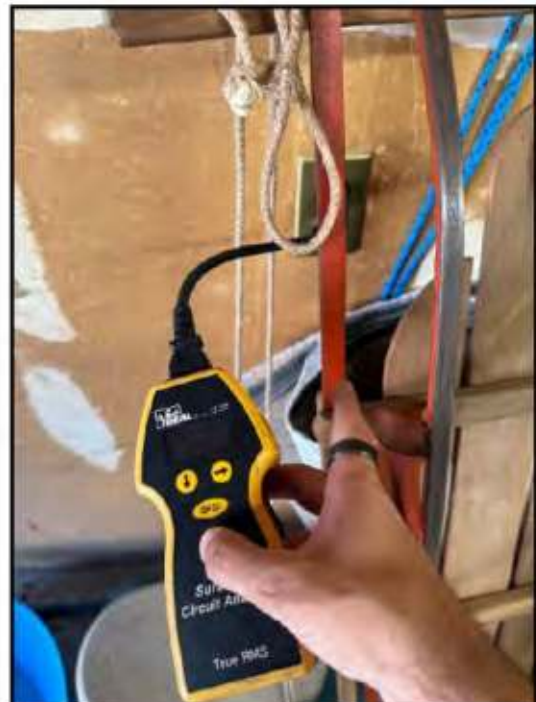
18. Loose

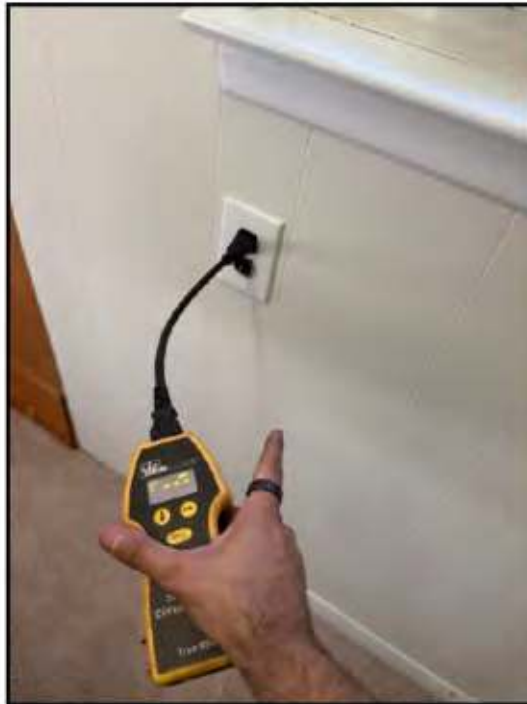
19. Loose

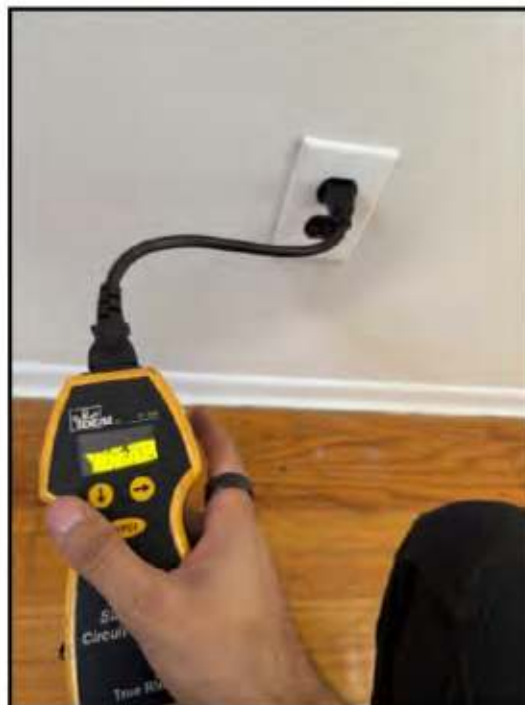
21. Loose

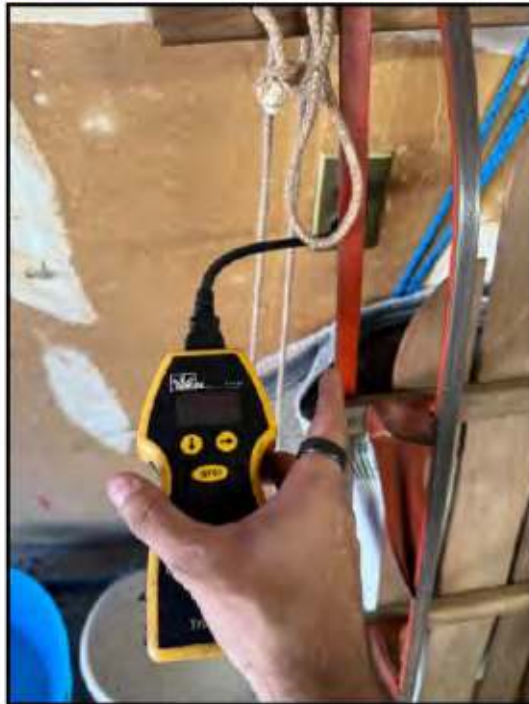
**Condition:** • Loose connections

**Implication(s):** Electric shock, Fire hazard

22. Loose connections

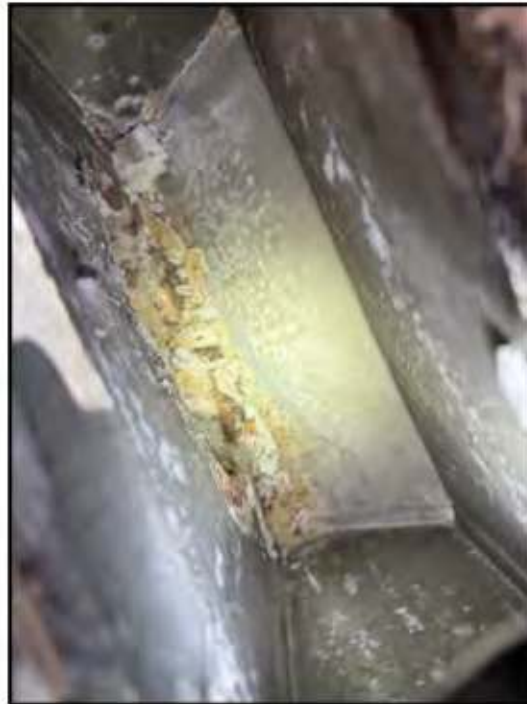
**Condition:** • [Dirty](#)

Debris from old vinyl flooring was found inside, possibly containing asbestos.

**Implication(s):** Increased heating and cooling costs | Reduced comfort

24. Dirty

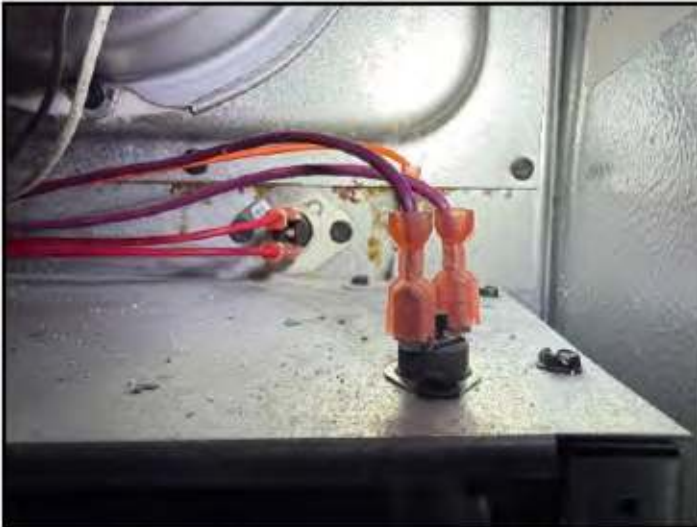
**GAS FURNACE \ Venting system**Condition: • [Rust, dirty, obstructed](#)

Implication(s): Equipment not operating properly | Hazardous combustion products entering home

25. Rust, dirty, obstructed

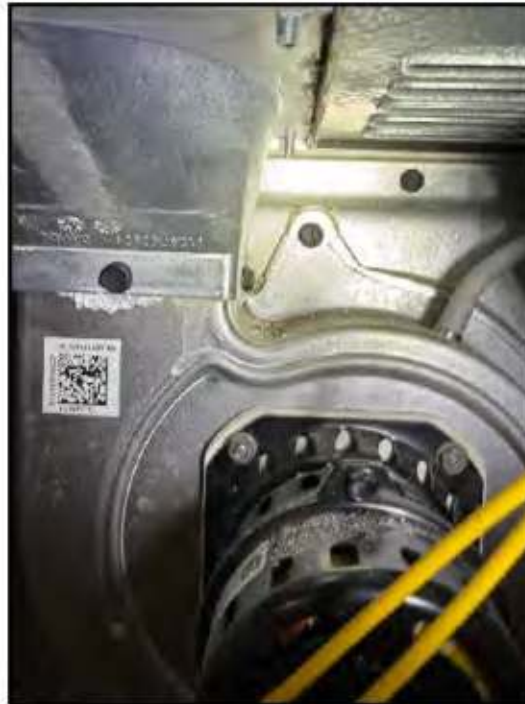
27. Rust, dirty, obstructed

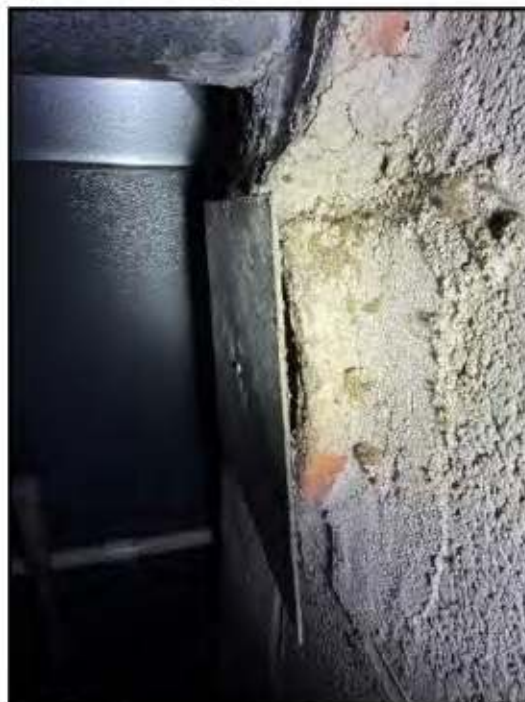
Condition: • [Abandoned openings for flue connections](#)

Implication(s): Hazardous combustion products entering home

28. Abandoned openings for flue connections

Recommend sealing opening properly

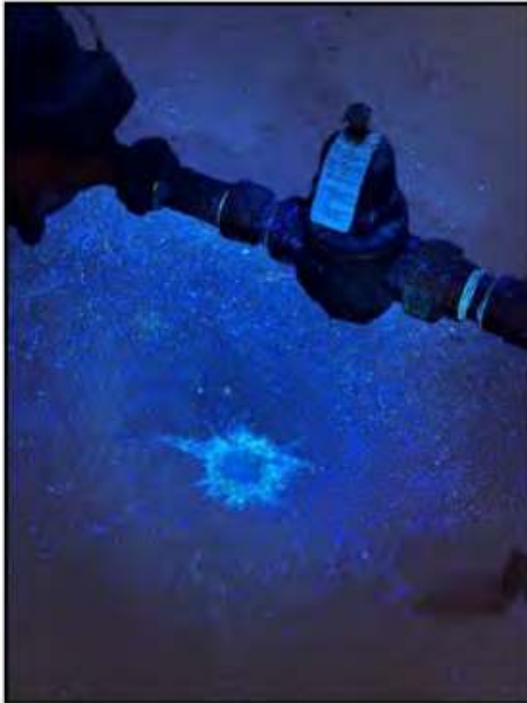
Condition: • [Leak](#)

Implication(s): Chance of water damage to structure, finishes and contents | Damage to equipment

Location: Basement

29. Leak

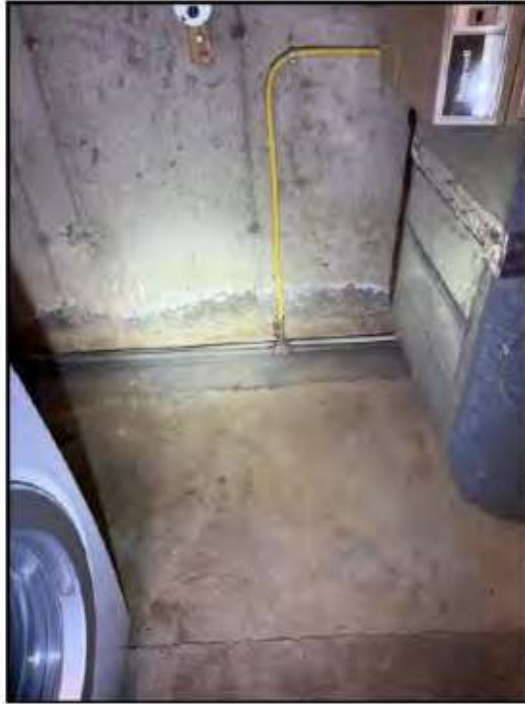
Condition: • Piping not protected from corrosion

Location: Basement

31. Piping not protected from corrosion

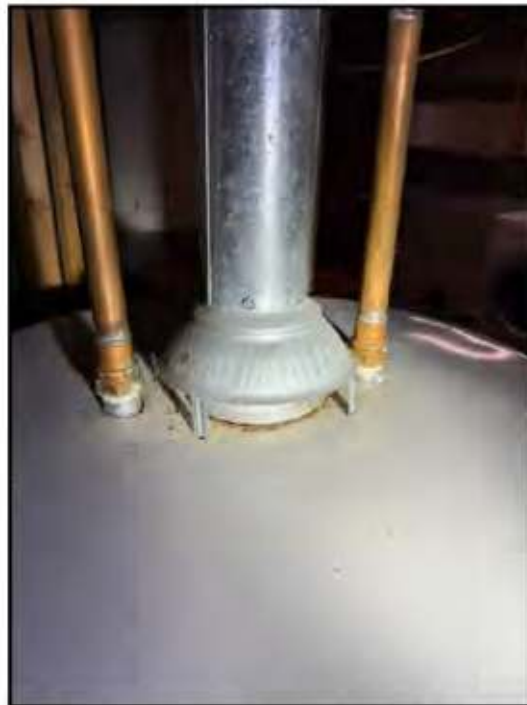
**Condition:** • [Vent connector too small, too big for water heater](#)

**Implication(s):** Equipment not operating properly | Hazardous combustion products entering home

32. Vent connector too small, too big for water...

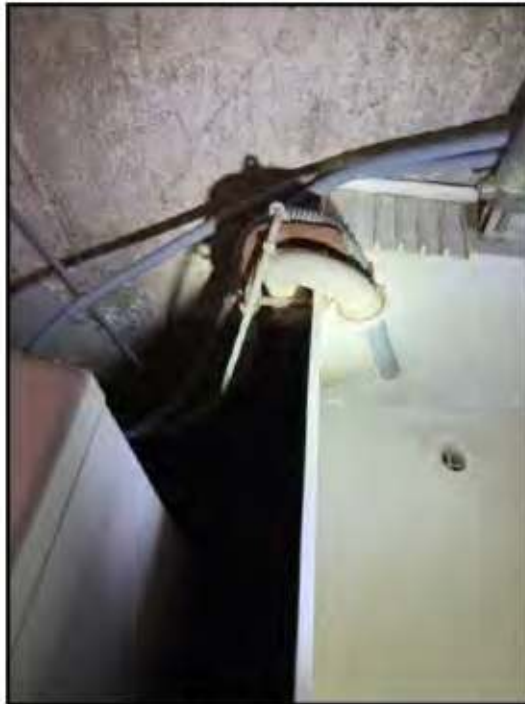
**Condition:** • Discharges into sewer

**Implication(s):** Chance of water damage to structure, finishes and contents

33. Discharges into sewer

**Task:** Discharge pipe be routed towards the exterior and extended 10 feet away from the foundation.

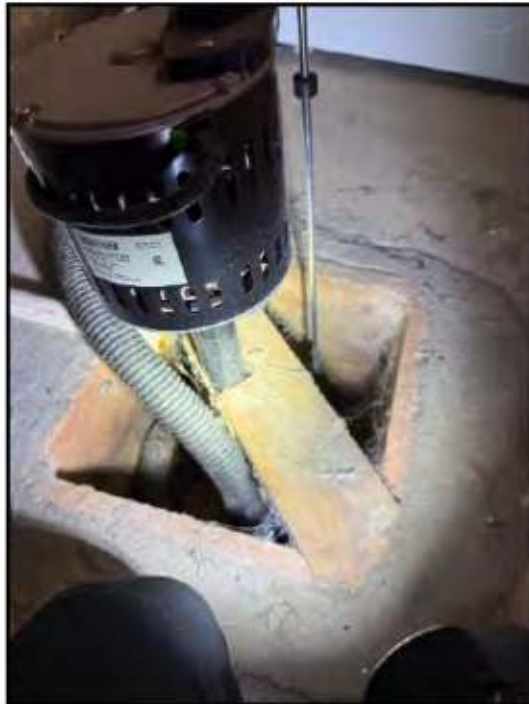
**Condition:** • Questionable installation

A section of chimney flue liner has been repurposed as a makeshift sump pump basin. This approach was sometimes used in the 1950s-1970s but is not as effective as a modern sump basin. The sump pump in this setup is intended to remove any water that rises from the water table beneath the slab, helping to reduce water pressure under the foundation. It appears that a French drain may have been installed along portions of the basement perimeter (although we cannot confirm if perforated pipe is present, as it is not visible), but it does not connect to this sump basin, which limits the drainage system's effectiveness.

34. Questionable installation

For optimal performance, it is recommended to replace this flue liner with a properly sized polyethylene basin (16x22 inches) and connect it directly to the French drain piping. This setup would improve water collection and ensure efficient drainage. Additionally, the sump pump discharge should be directed to an exterior point at least 6-10 feet away from the home, rather than into the sewer system, to prevent rainwater from overloading the sewer infrastructure.

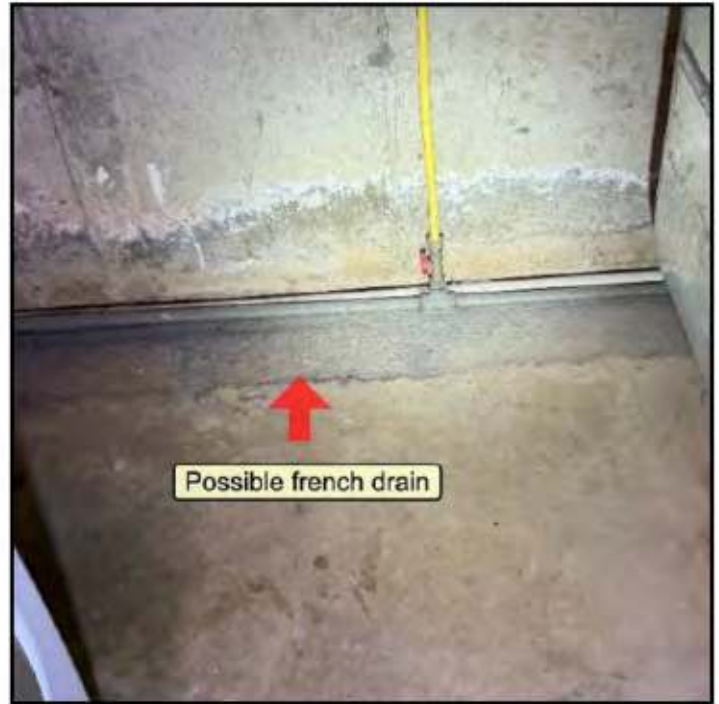
35. Questionable installation

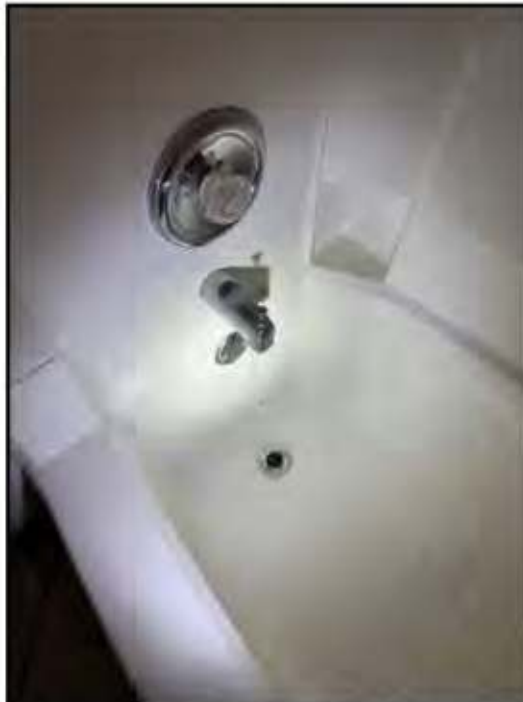
**Condition:** • Loose shower valves/mixer piping

Over time, even well-secured plumbing components can loosen, emphasizing the importance of proper installation and regular maintenance. The plumbing should have been properly secured before the wall covering was installed. Continuous movement of unsecured plumbing can loosen or damage components, increasing the risk of a hidden leak that could go unnoticed until significant damage occurs. If not addressed, this can lead to water damage, mold growth, and costly repairs, compromising the integrity of the structure and surrounding materials, whether behind tile or plastic surrounds.

**Implication(s):** Chance of water damage to structure, finishes and contents. Equipment failure.

**Location:** Second Floor Bathroom

37. Loose shower valves/mixer piping

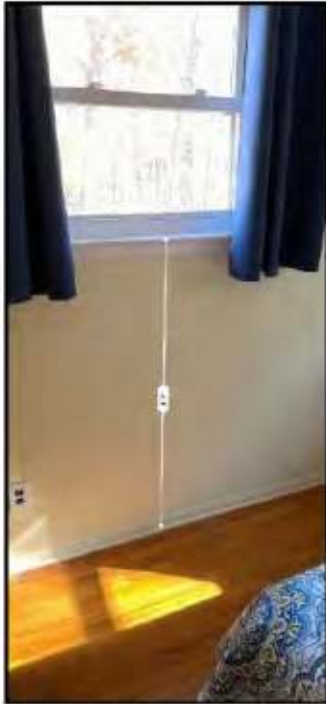
**Condition:** • Ineffective

- Window wells deeper than 44" must have permanent steps or a ladder that do not impede the opening of the window.

Location: Most Bedrooms

38. Ineffective

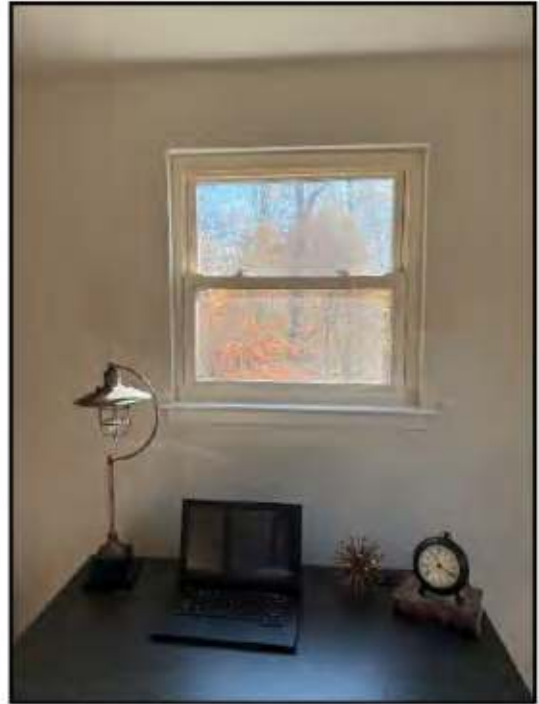
39. Ineffective

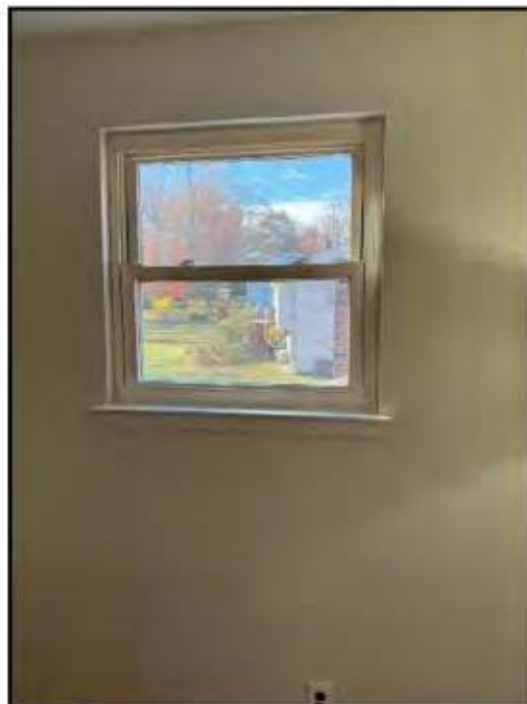
40. Ineffective

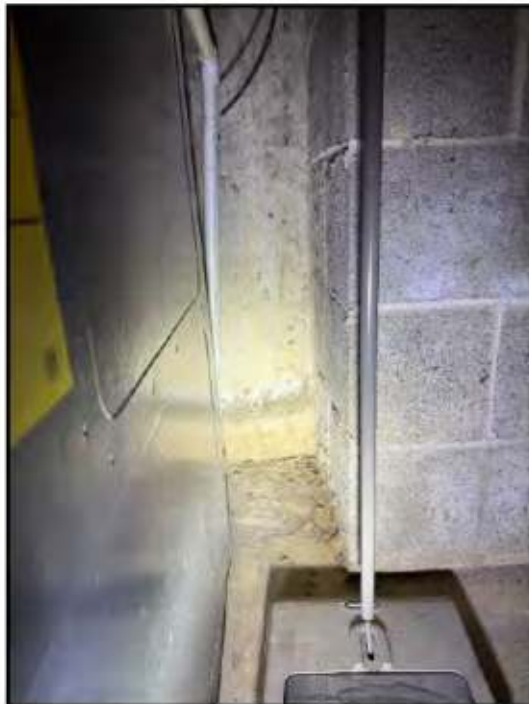
**BASEMENT \ Wet basement - evidence**Condition: • [Efflorescence](#)

Implication(s): Chance of water damage to structure, finishes and contents

41. Efflorescence

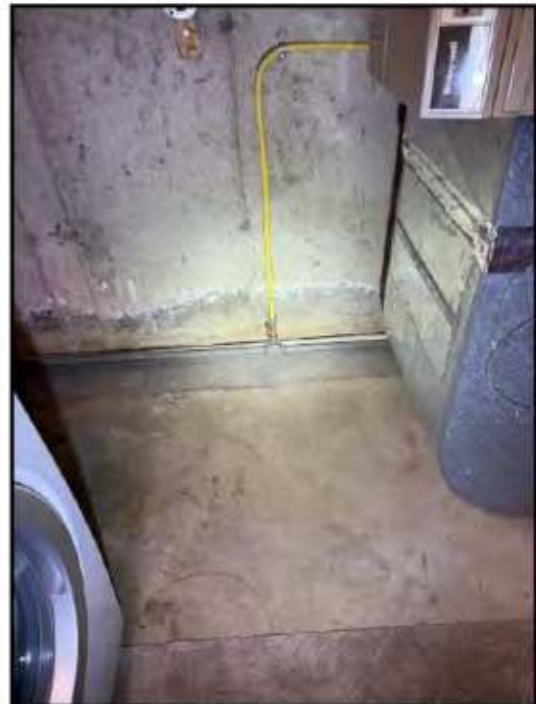
42. Efflorescence

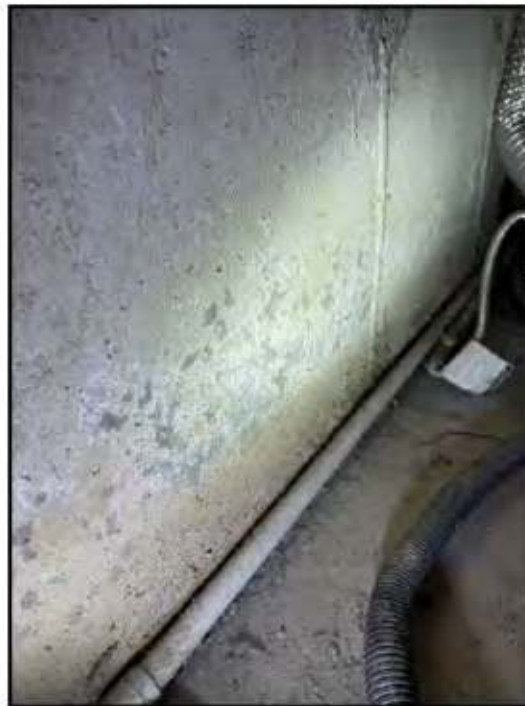
43. Efflorescence

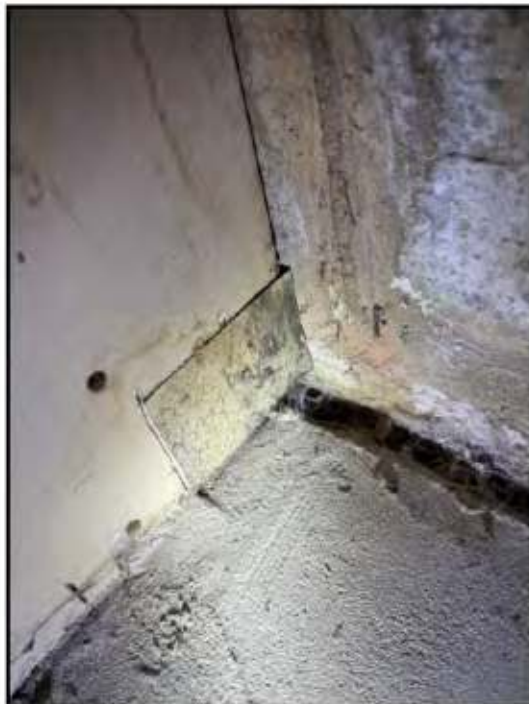
Condition: • [Mold](#)

Implication(s): Chance of water damage to structure, finishes and contents | Contaminants may enter building air

44. Mold

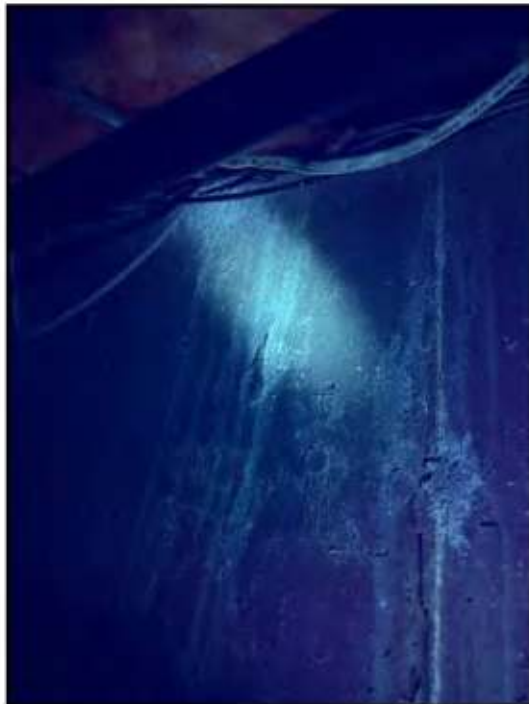
Condition: • [Water marks](#)

Implication(s): Chance of water damage to structure, finishes and contents

Location: Basement

46. Water marks

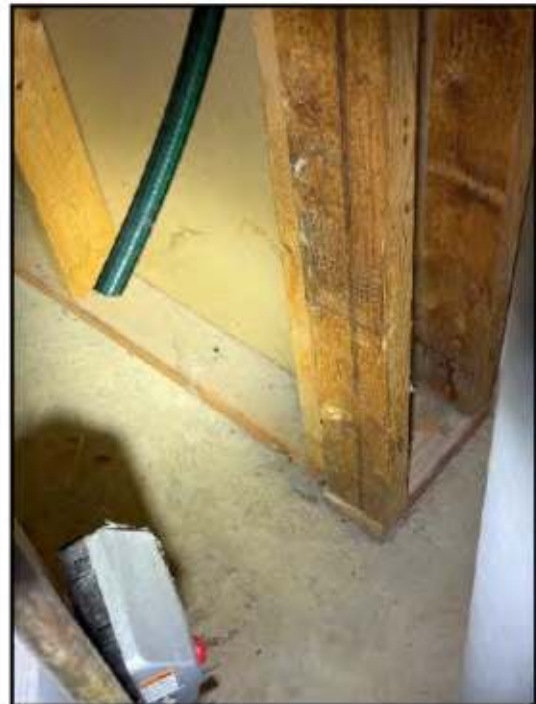
47. Water marks

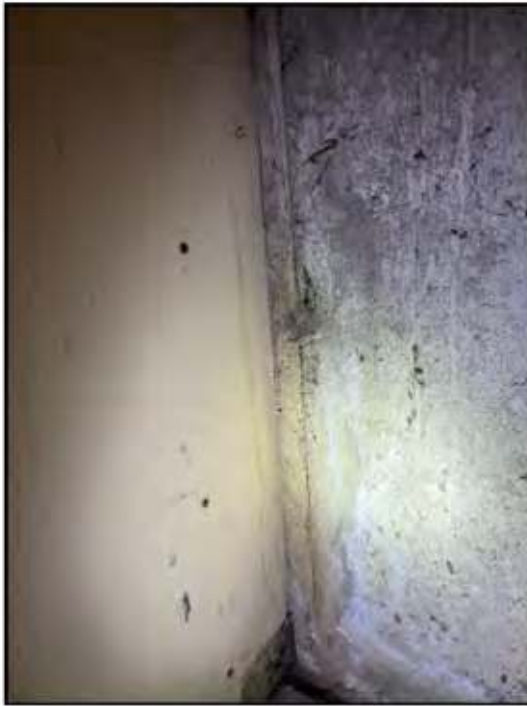
48. Water marks

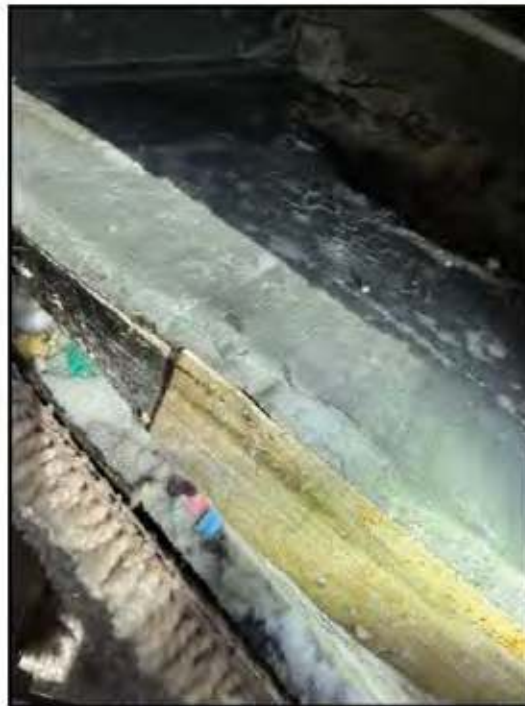
**Condition:** • Possible asbestos containing materials

Nine-inch vinyl tiles containing probable asbestos fibers were observed under the ground floor carpet. It is recommended to have a licensed asbestos removal company remove these tiles, as particles from damaged asbestos can cause lung cancer.

**Implication(s):** Health hazard

**Location:** Fireplace room

50. Possible asbestos containing materials

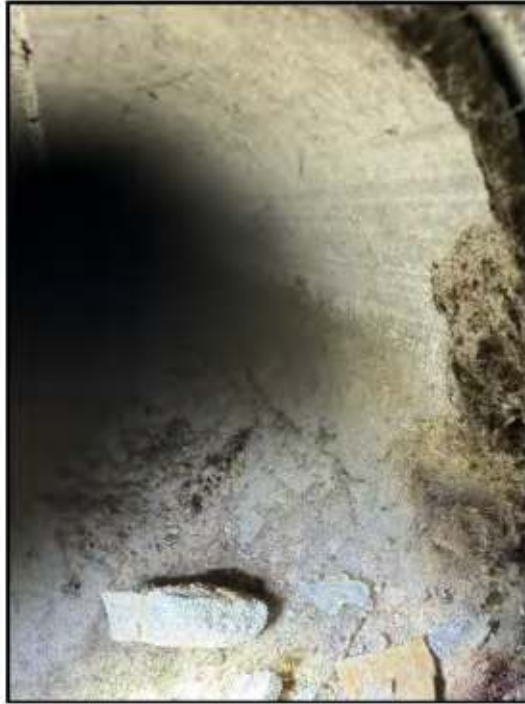
**Condition:** • Possible asbestos containing materials

In-slab ducts were discovered in the fireplace room, which appear to be constructed from transite-a material commonly known to contain asbestos fibers. A sample from the ducts has been sent for lab testing to confirm the presence of asbestos. Once results are available, further assessment by a licensed asbestos professional is recommended if asbestos is confirmed, to determine the best course of action for safe management or removal.

**Implication(s):** Health hazard

51. Possible asbestos containing materials

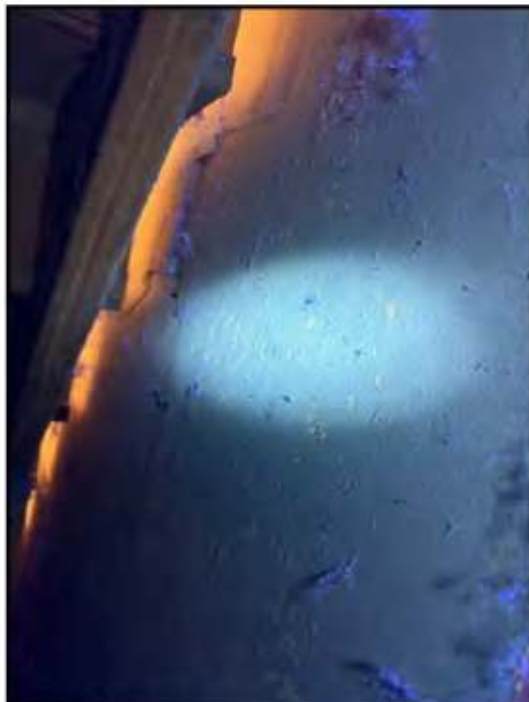
**Condition:** • Mold

**Implication(s):** Health hazard

**Location:** Basement

52. Mold

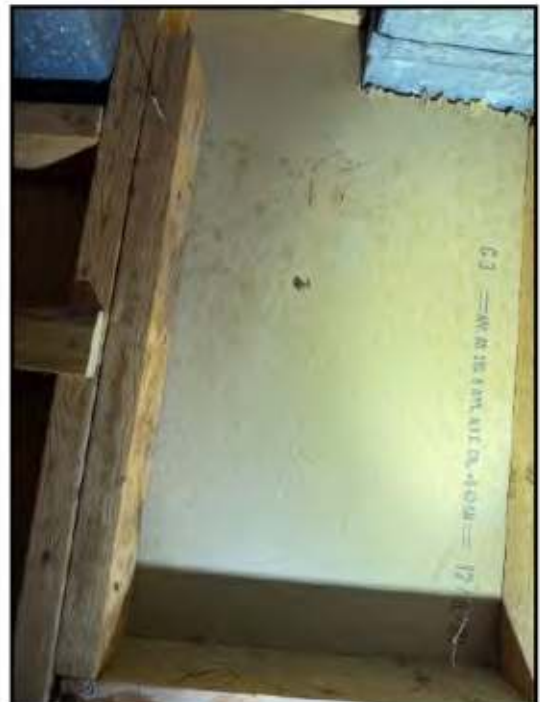
53. Mold

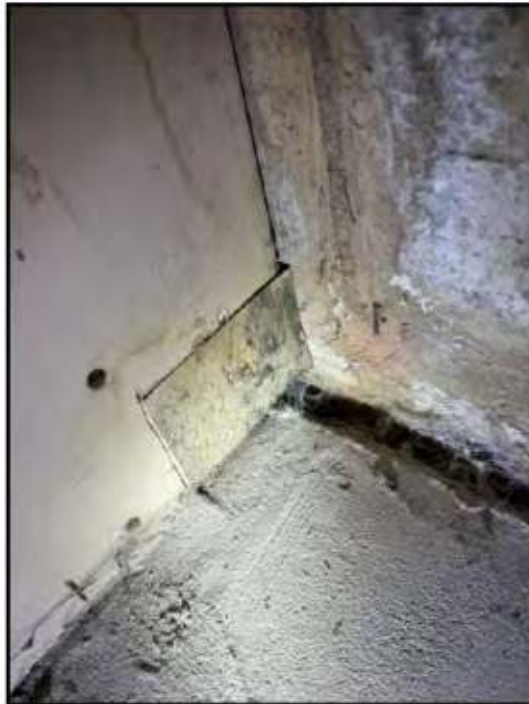
54. Mold

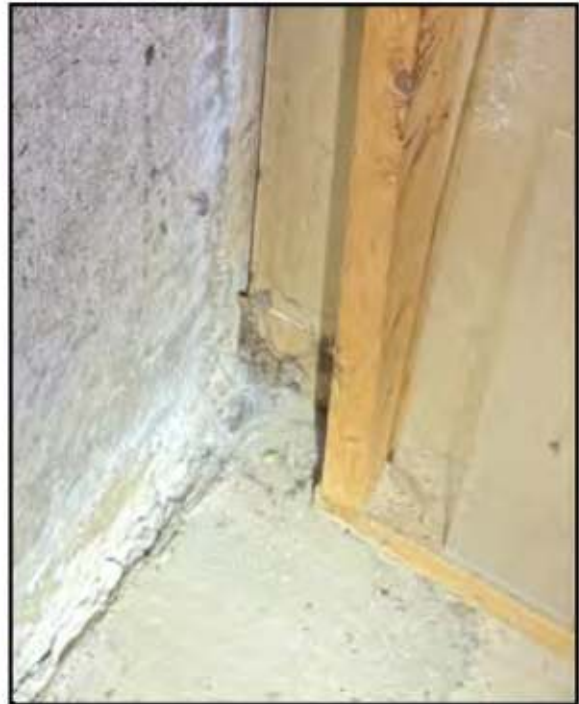
55. Mold

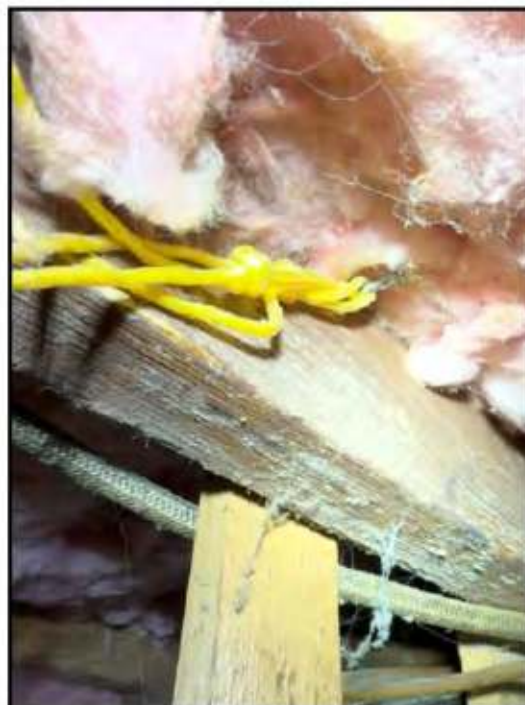
56. Mold

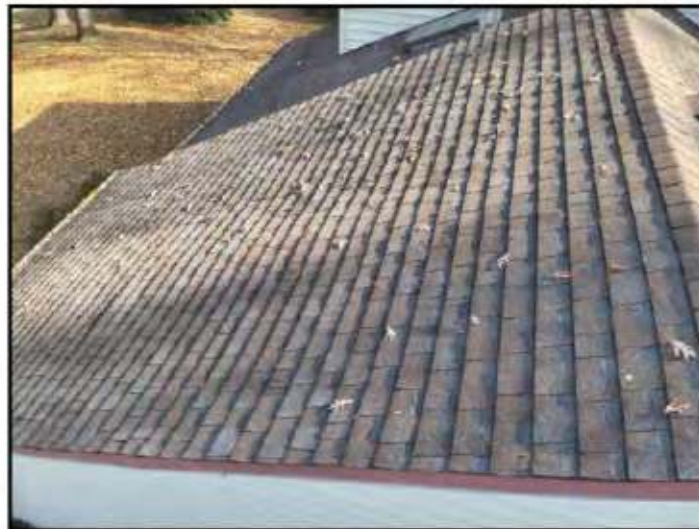
3. Condition: • [Granule loss](#)

Implication(s): Chance of water damage to structure, finishes and contents

58. Granule loss

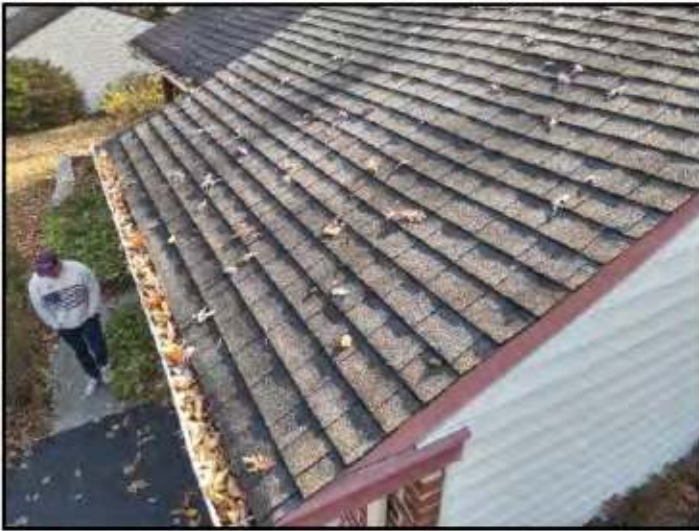
**4. Condition:** • Debris/moss

**Implication(s):** Shortened life expectancy of material

59. Debris/moss

**Task:** Recommend treating with "Wet & Forget" moss/algae removal solution

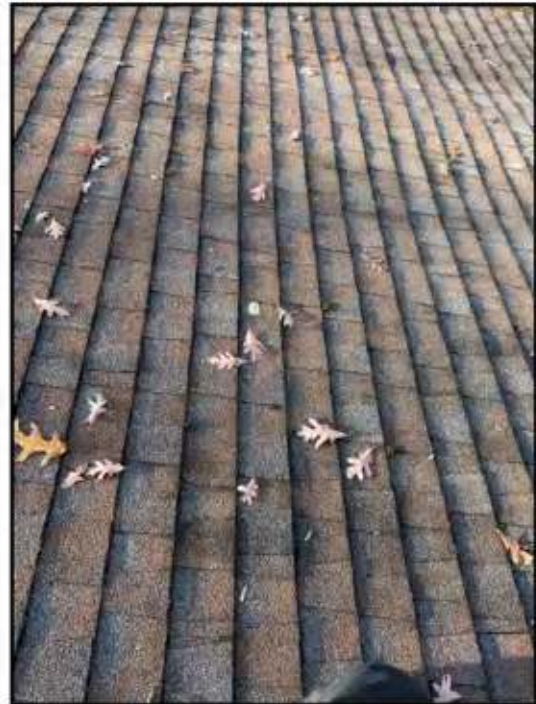
60. Debris/moss

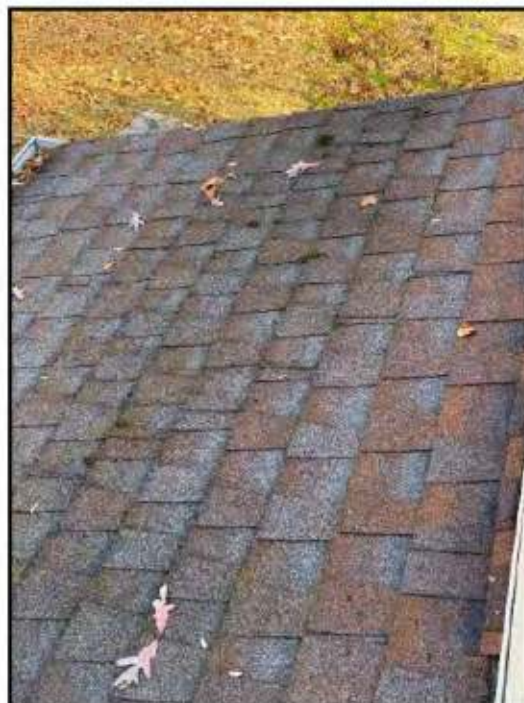
61. Debris/moss

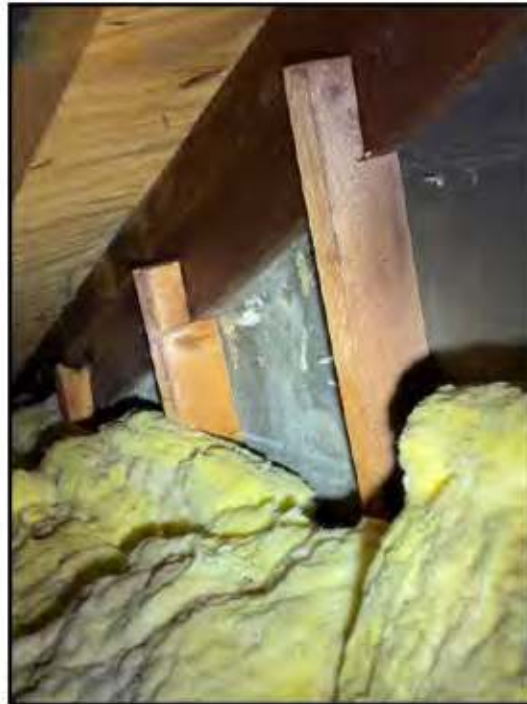
5. Condition: • [Leak](#)

Implication(s): Chance of water damage to structure, finishes and contents

62. Leak

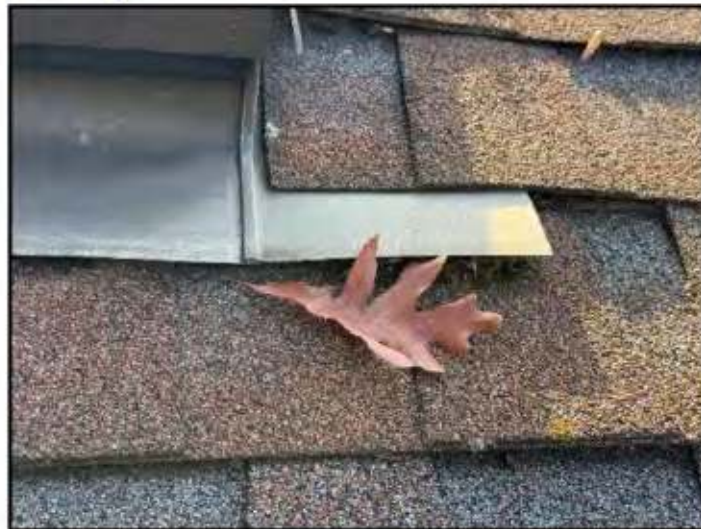
6. Condition: • Open seams at flashings

63. Open seams at flashings

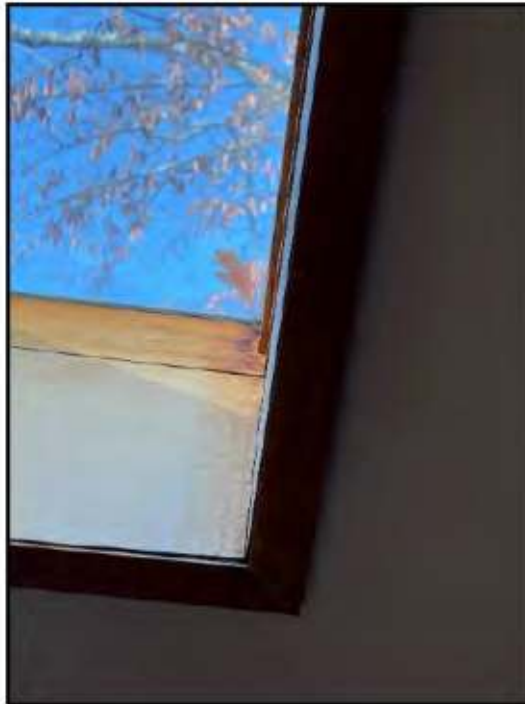
64.

7. Condition: • Water stains

Location: Foyer

Task: Monitor

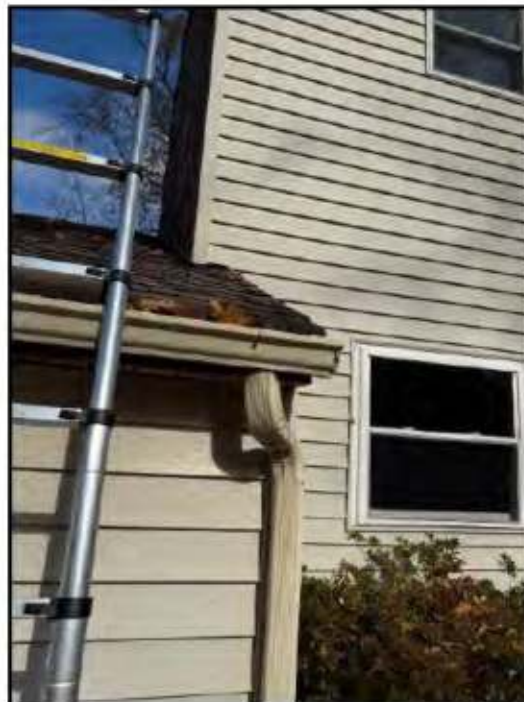
8. Condition: • Loose

65. Loose

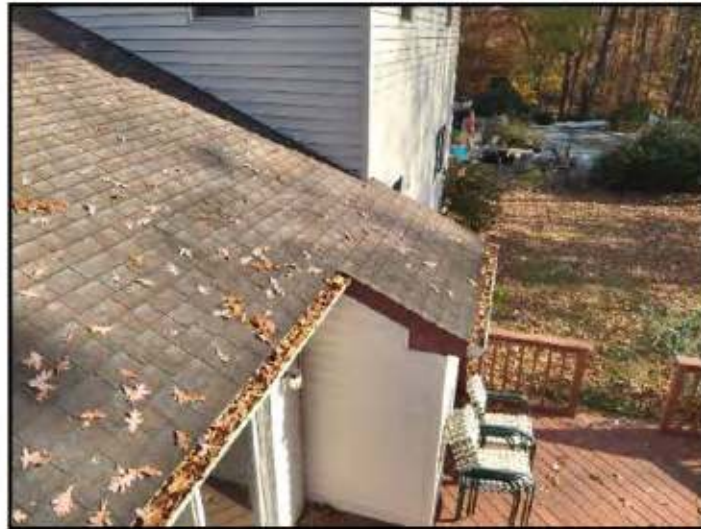
9. Condition: • Dirty/debris

66. Dirty/debris

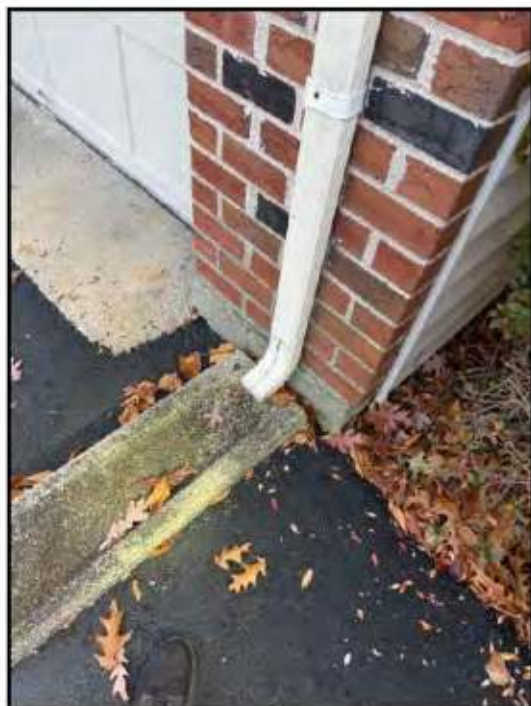
10. Condition: • [Discharge too close to building](#)

Implication(s): Chance of water damage to structure, finishes and contents

67. Discharge too close to building

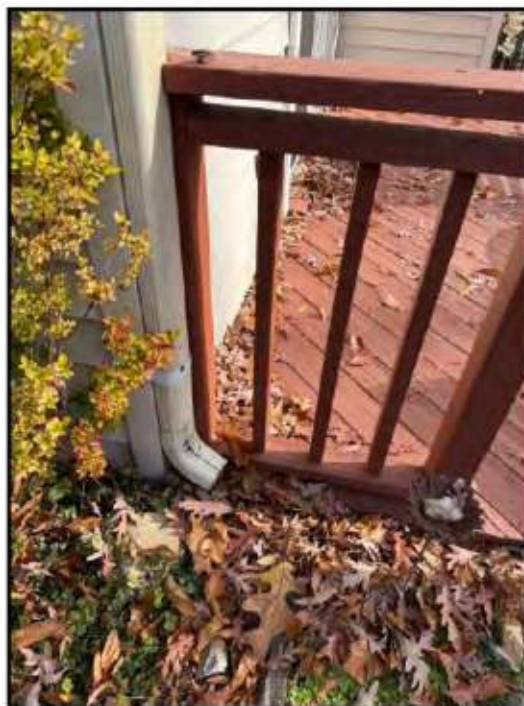
68. Discharge too close to building
