# Your Inspection Report

Tuesday, November 5, 2024

Leonardo Betancor, CMI, 24GI00182600, HOI.0001093

Smart Choice Inspections LLC  
173 Ridge Road, Suite H1  
Cedar Grove, NJ 07009

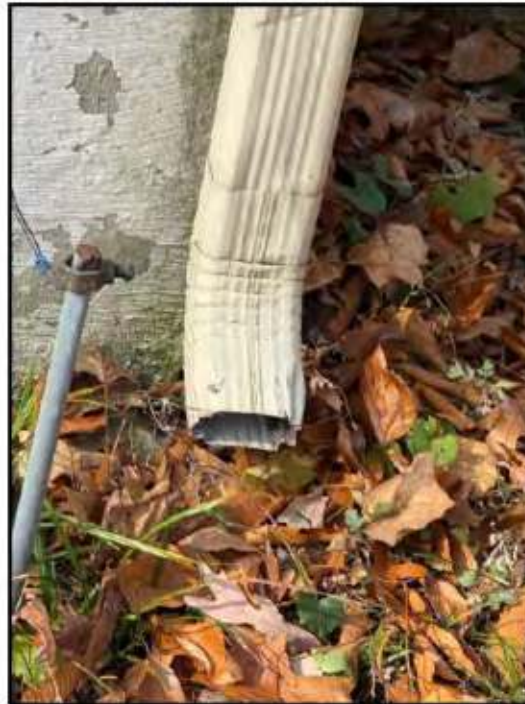
10. Condition: • [Discharge too close to building](#)

69. Discharge too close to building

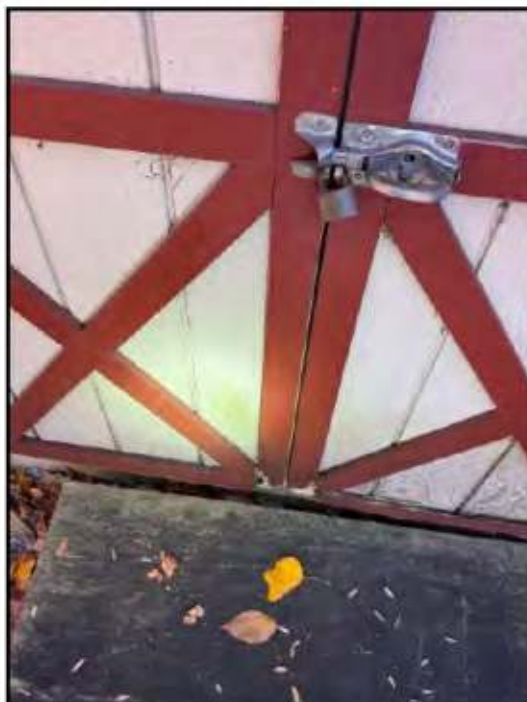
11. Condition: • [Rot](#)

Implication(s): Weakened structure | Material deterioration

Location: Shed

70. Rot

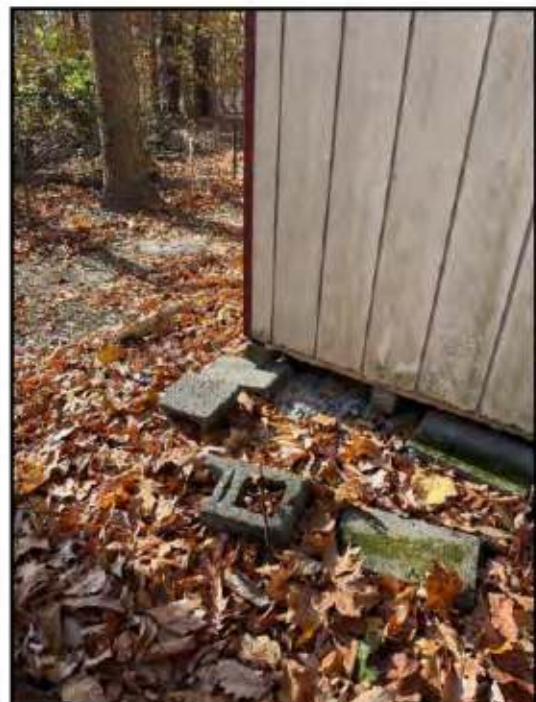
71. Rot

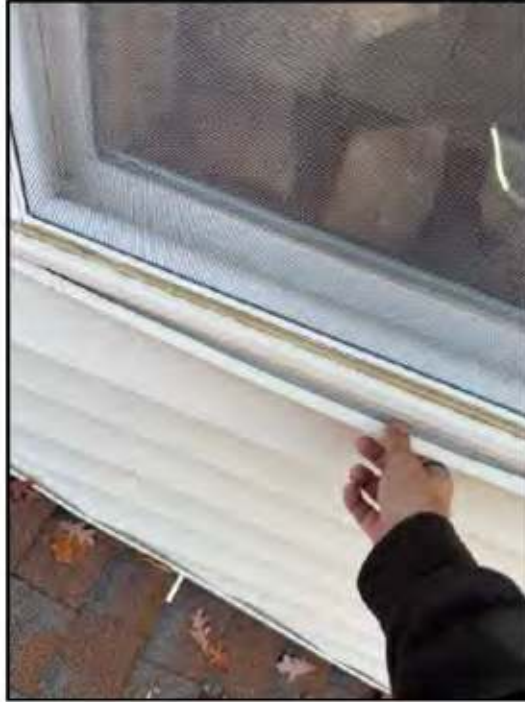
**12. Condition:** • Loose or missing pieces

**Implication(s):** Chance of water damage to structure, finishes and contents

*72. Loose or missing pieces*

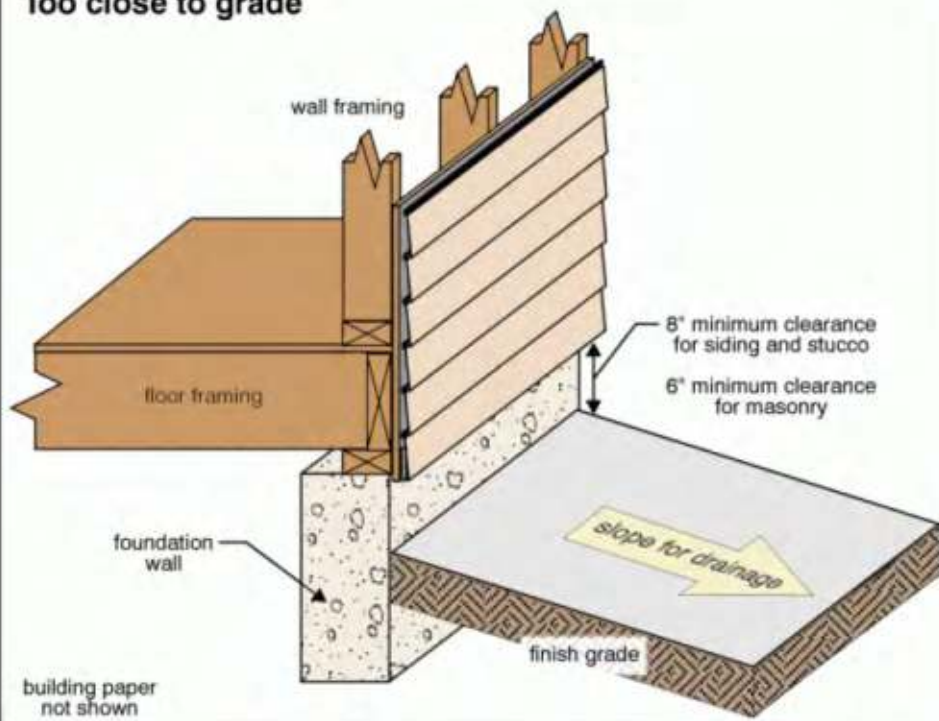
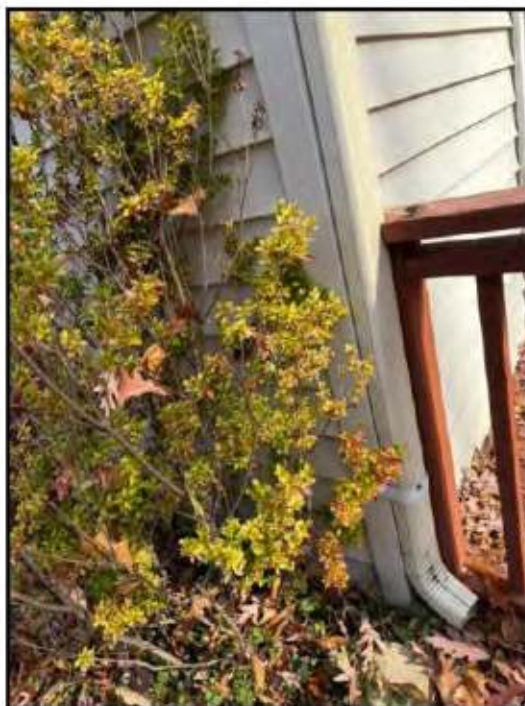
**13. Condition:** • [Too close to grade](#)

**Implication(s):** Chance of water damage to structure, finishes and contents

73. Too close to grade

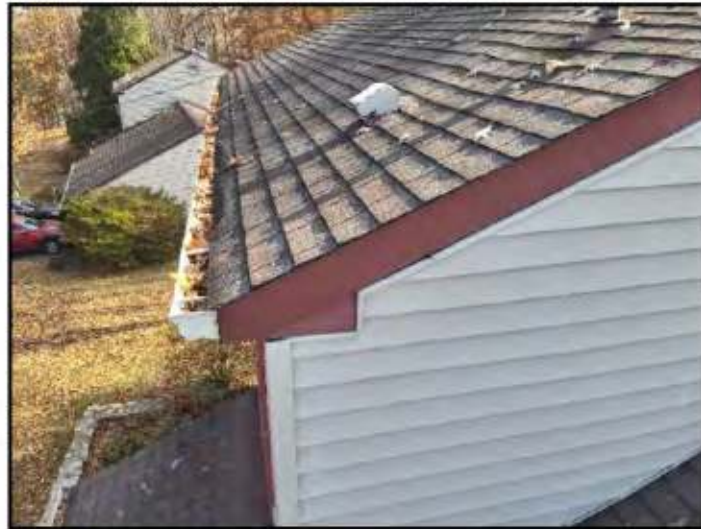
14. Condition: • Unsealed openings

74. Unsealed openings

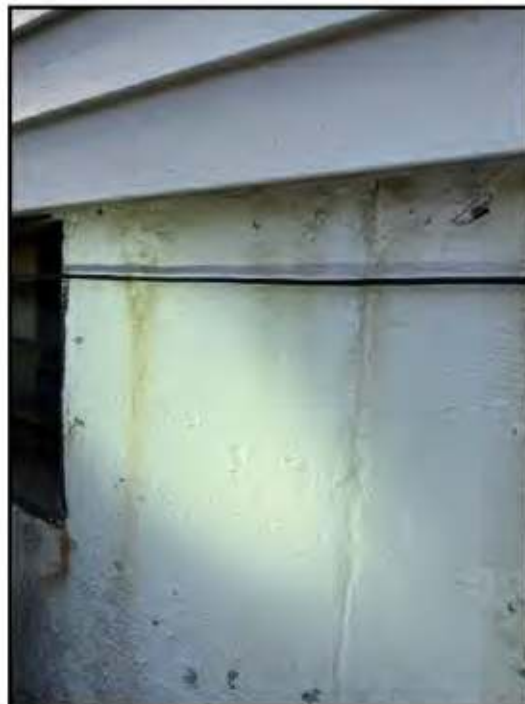
15. Condition: • Possible signs of water intrusion behind siding

75. Possible signs of water intrusion behind...

Task: Further evaluation

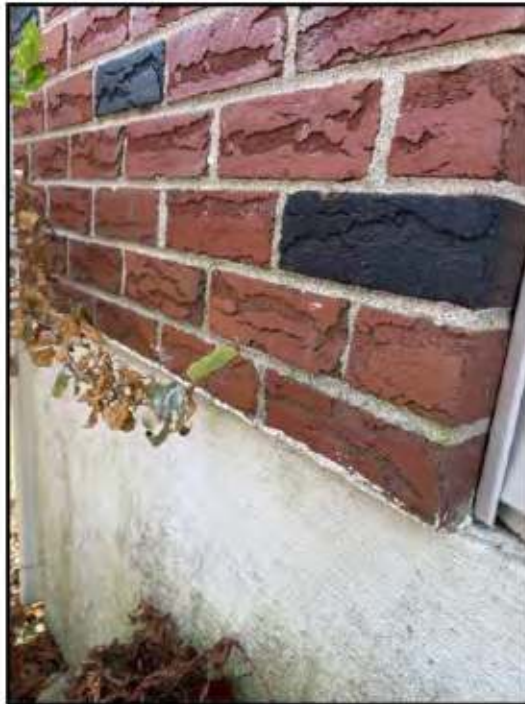
16. Condition: • [Missing, ineffective weep holes or flashings](#)

Implication(s): Chance of water damage to structure, finishes and contents | Material deterioration

76. Missing, ineffective weep holes or flashings

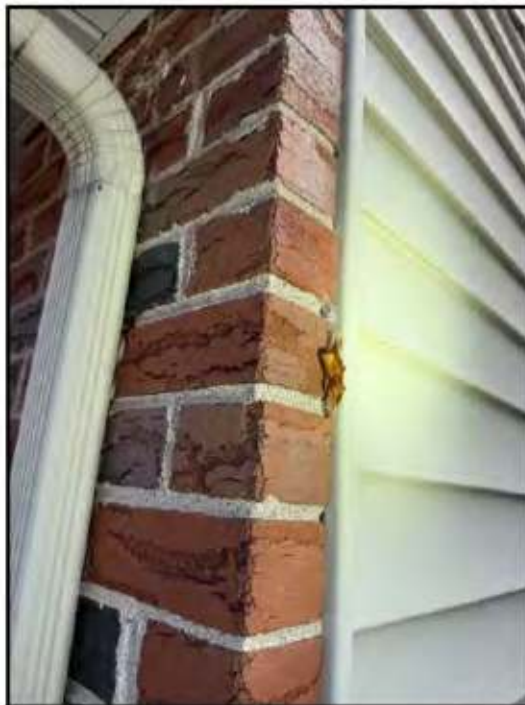
17. Condition: • Loose brick veneer

77. Loose brick veneer

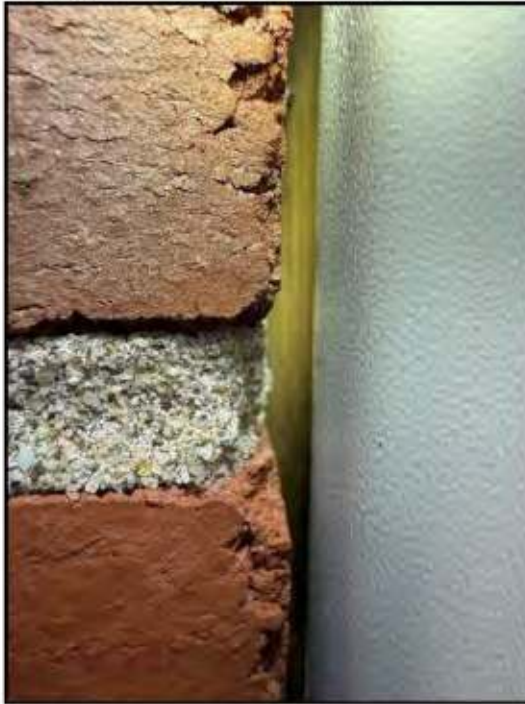
18. Condition: • Openings between brick veneer and siding

Implication(s): Chance of water damage to structure, finishes and contents

78. Openings between stone veneer and siding

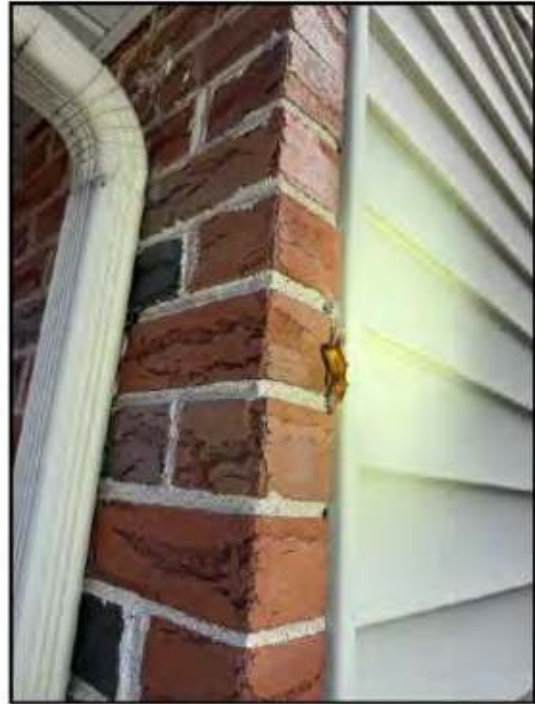
79. Openings between stone veneer and siding

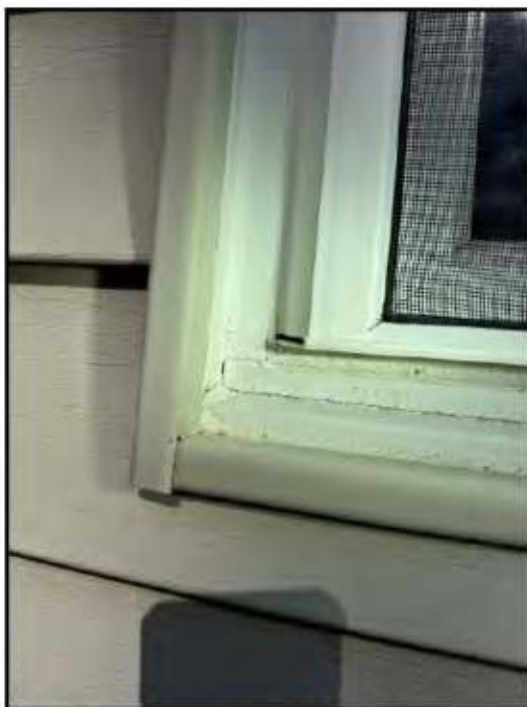
19. Condition: • [Caulking missing, loose or deteriorated](#)

Implication(s): Chance of water damage to structure, finishes and contents

80. Caulking missing, loose or deteriorated

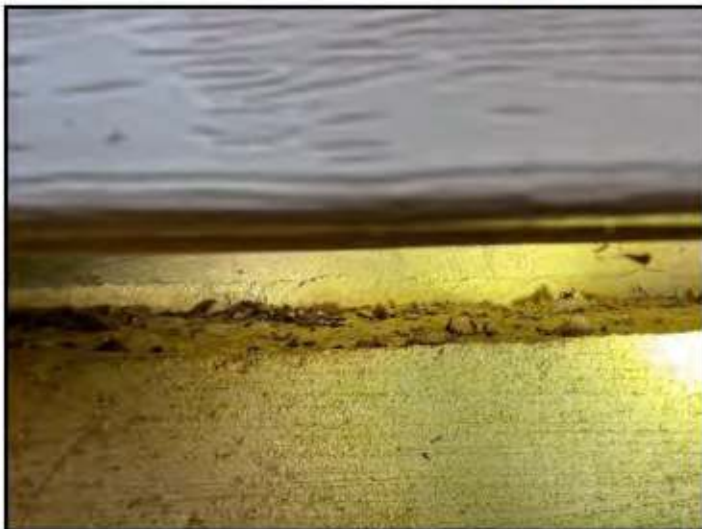
81.

20. Condition: • Unsealed opening under front bay window (bump out section)

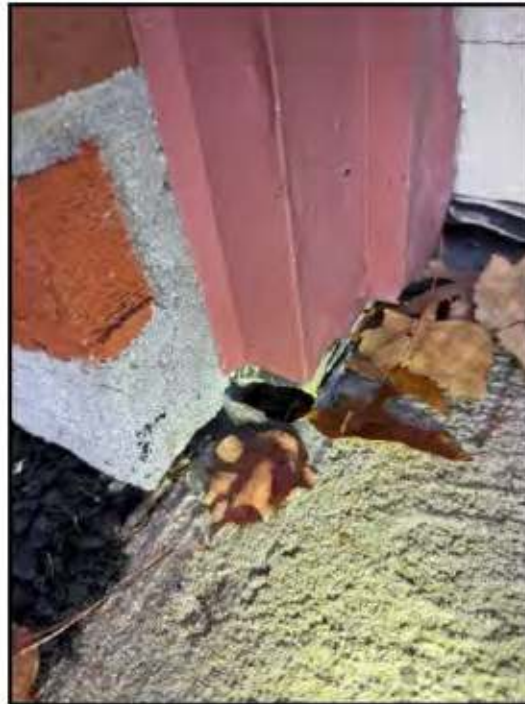
21. Condition: • [Rot](#)

Implication(s): Chance of damage to finishes and structure

Location: Garage

83. Rot

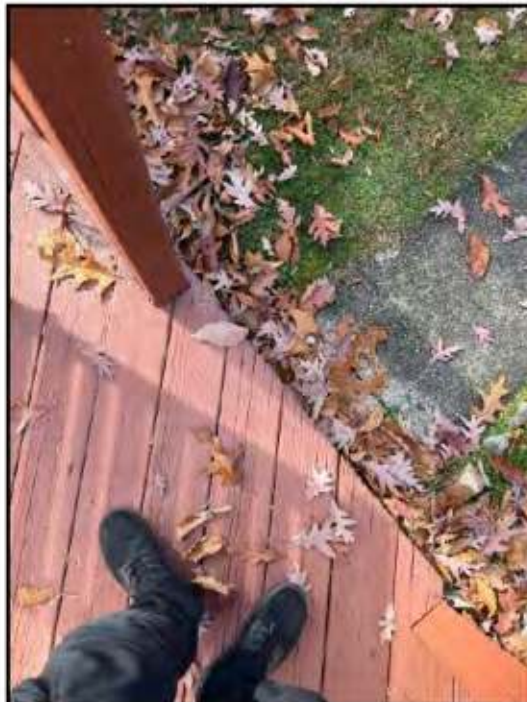
22. Condition: • [Wood/soil contact](#)

Implication(s): Rot | Insect damage

84. Wood/soil contact

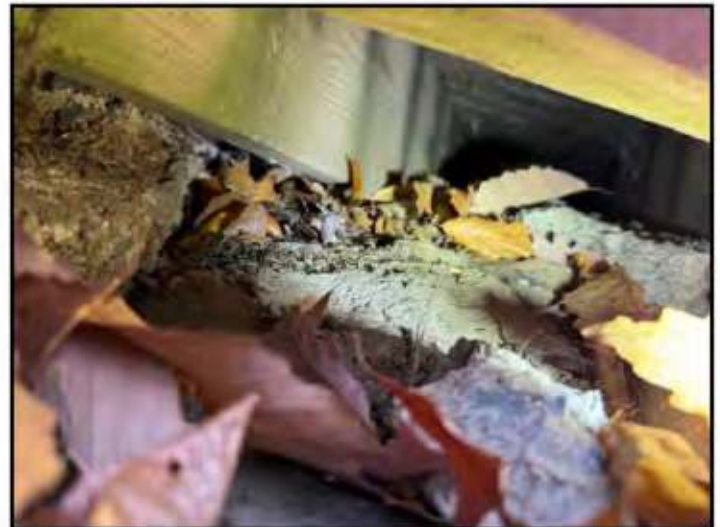
85. Wood/soil contact

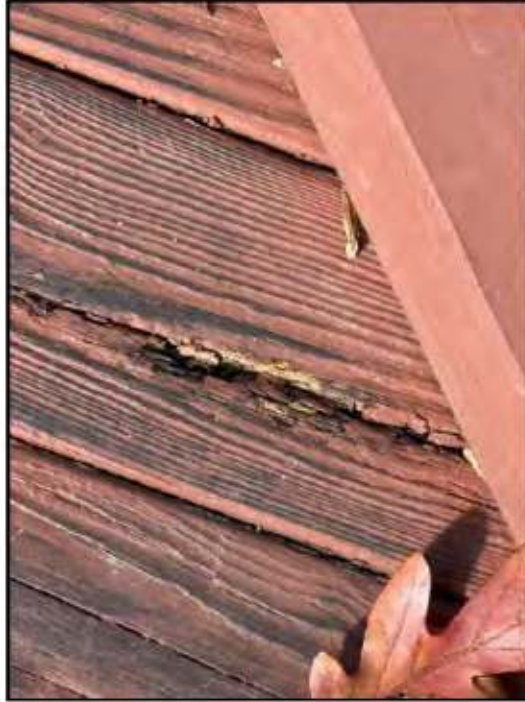
23. Condition: • [Rot](#)

Implication(s): Weakened structure | Chance of movement | Material deterioration

86. Rot

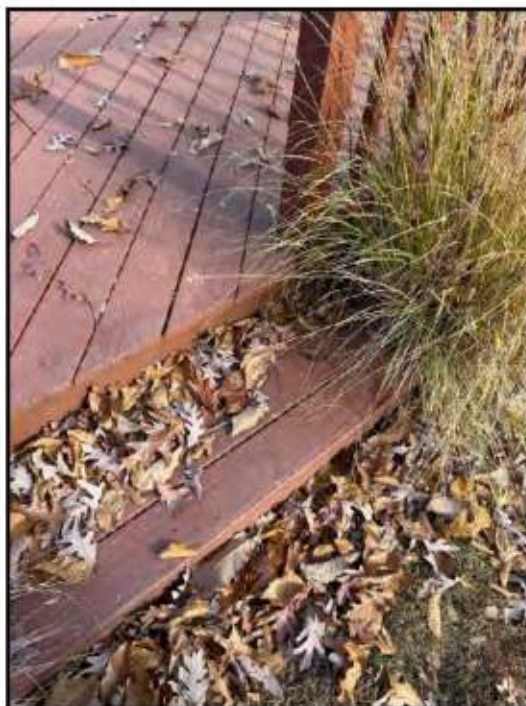
24. Condition: • [Steps slope](#)

Implication(s): Trip or fall hazard

87. Steps slope

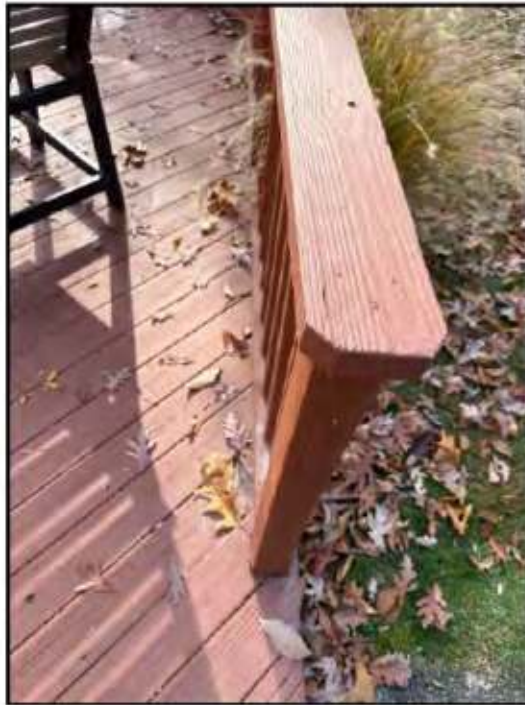
25. Condition: • [Loose](#)

Implication(s): Fall hazard

88. Loose

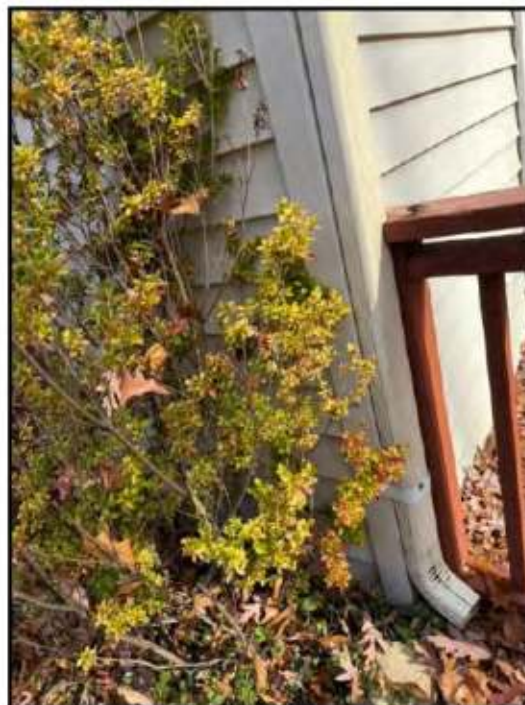
26. Condition: • [Trees or shrubs too close to building](#)

Implication(s): Chance of water damage to structure, finishes and contents | Chance of pests entering building | Material deterioration

89. Trees or shrubs too close to building

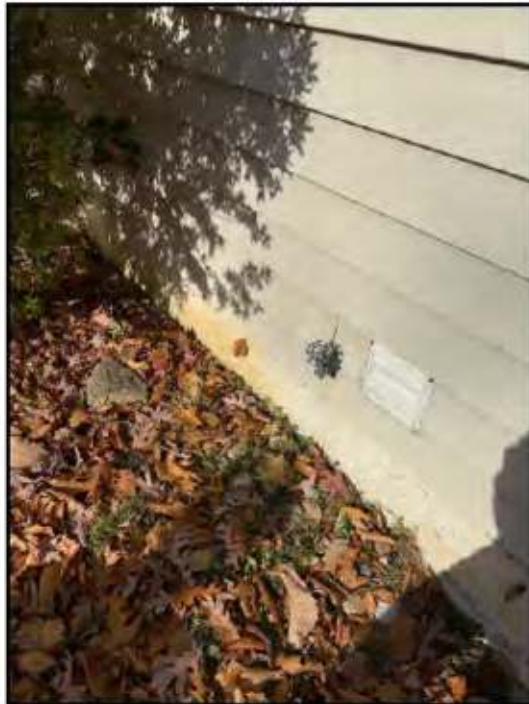
27. Condition: • [Improper slope or drainage](#)

Implication(s): Chance of water damage to structure, finishes and contents

90. Improper slope or drainage

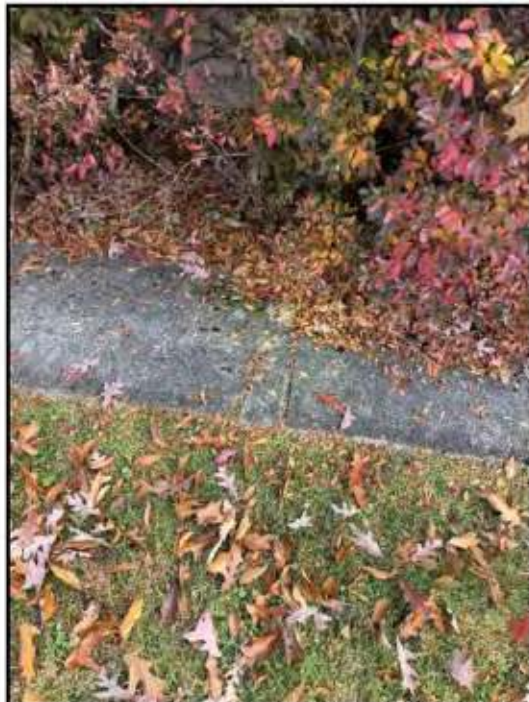
**LANDSCAPING \ Walkway**28. Condition: • [Cracked or damaged surfaces](#)

Implication(s): Trip or fall hazard

92. Cracked or damaged surfaces

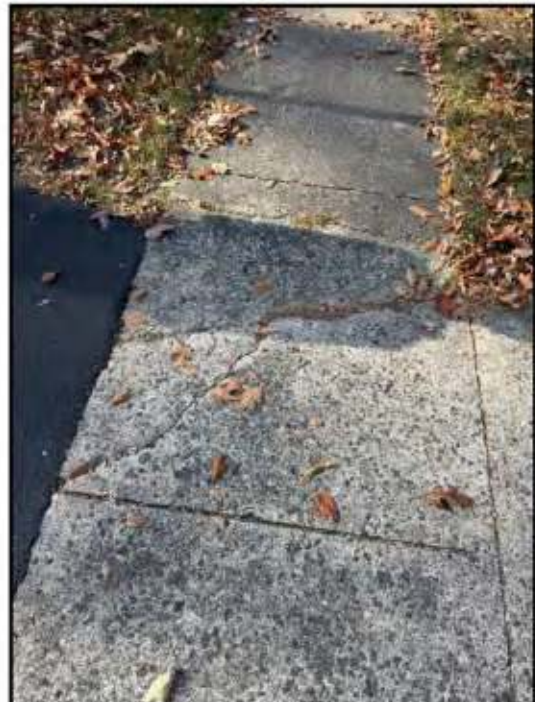
93. Cracked or damaged surfaces

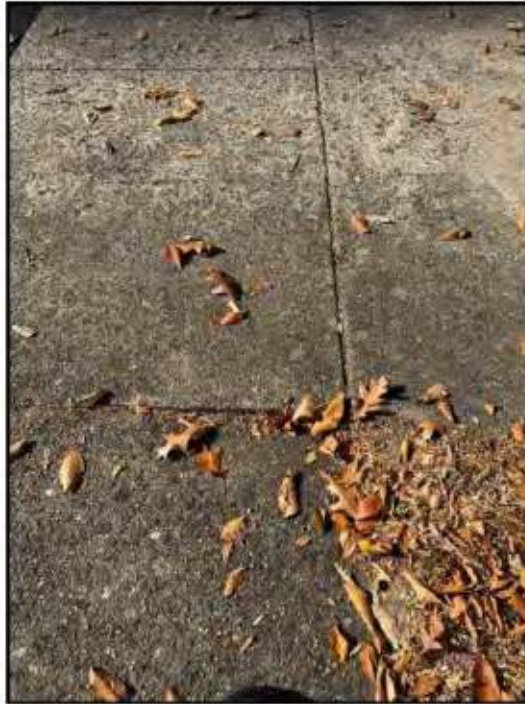
29. Condition: • [Uneven \(trip hazard\)](#)

Implication(s): Physical injury

94. Uneven (trip hazard)

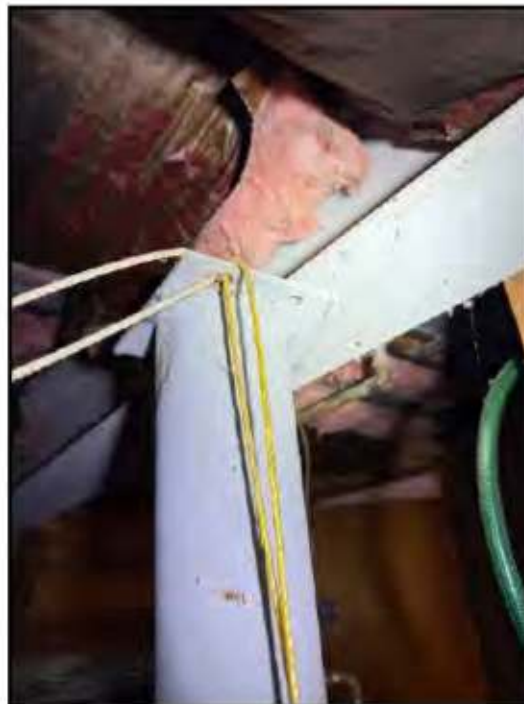
95.

**30. Condition:** • The metal column appears to have been positioned in a less-than-ideal location; however, due to its rigidity and the presence of fasteners, it should remain structurally sound without causing any issues.

**Location:** Basement

**Task:** Monitor

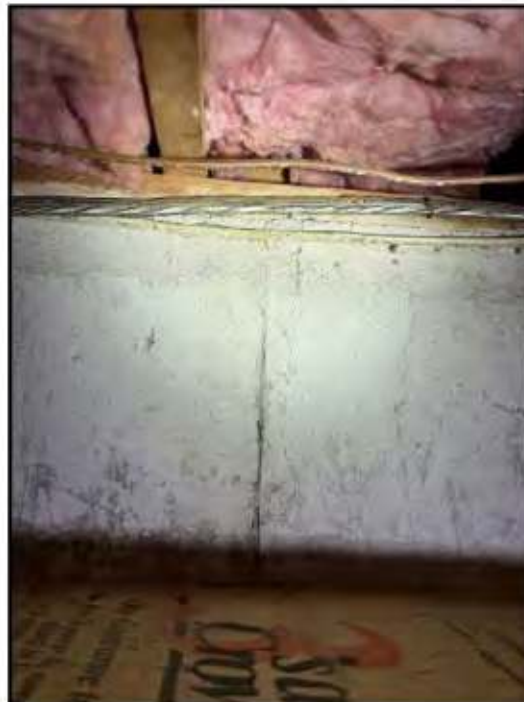
**FOUNDATIONS \ General notes****31. Condition:** • [Cracked](#)**Implication(s):** Chance of water damage to structure, finishes and contents | Weakened structure**Vertical foundation cracks**

96. Cracked

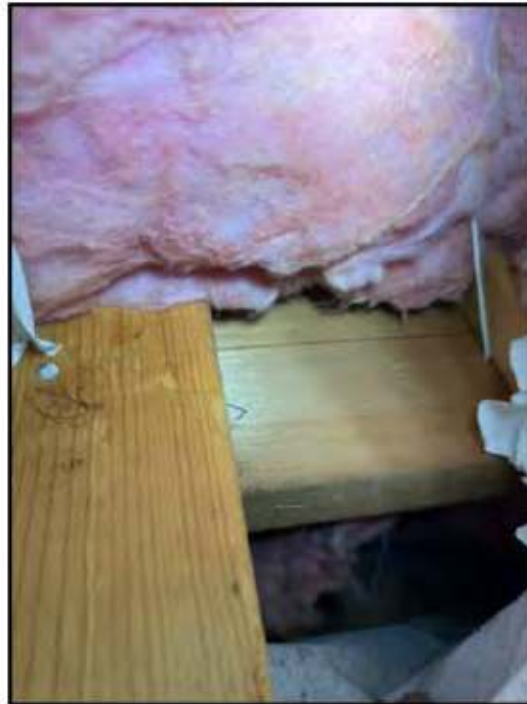
**FLOORS \ Joists****32. Condition:** • [Split or damaged](#)

**Location:** Basement

97. Split or damaged

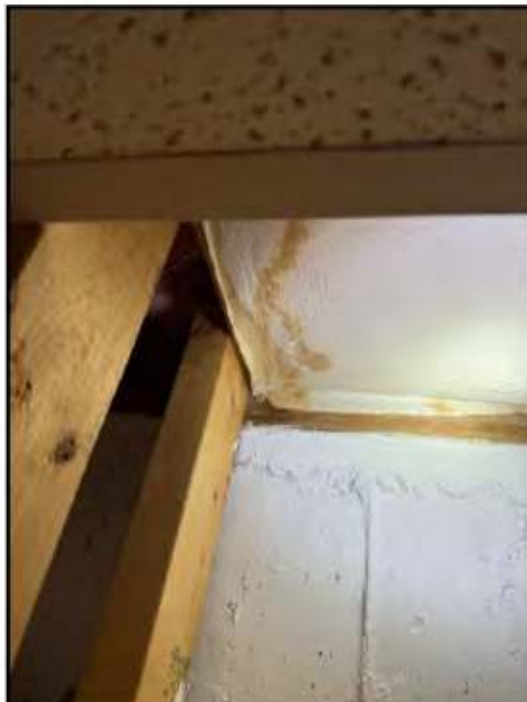
**33. Condition:** • Water Stains

**Implication(s):** Chance of water damage to structure, finishes and contents. Weakened structure, Chance of structural movement.

**Location:** Basement

98. Water Stains

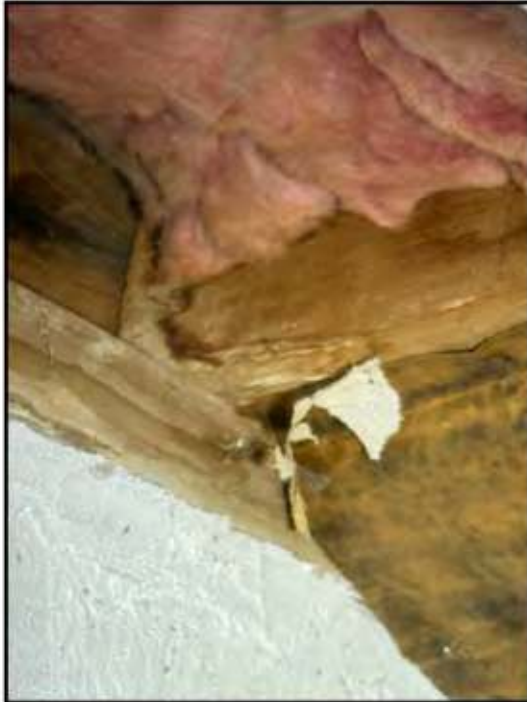
100. Water Stains

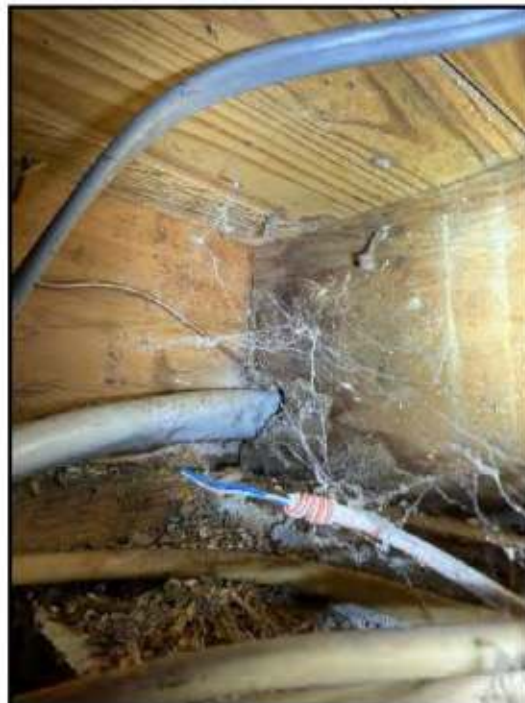
102. Water Stains

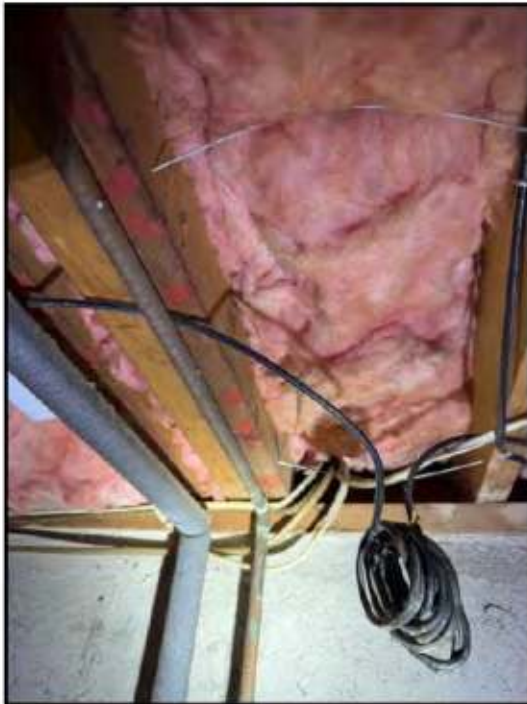
34. Condition: • Rotating

Implication(s): Weakened structure, Chance of structural movement

Location: Basement

103. Rotating

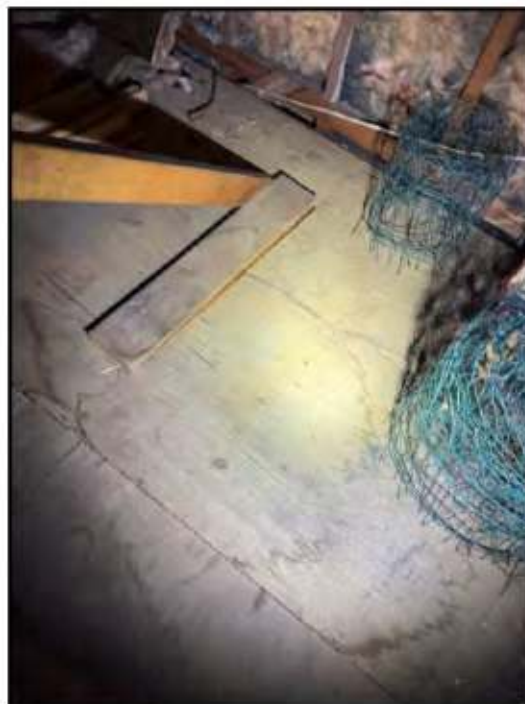
105. Water stains

**FLOORS \ Sheathing/Subflooring****35. Condition:** • Water stains**Implication(s):** Material deterioration**Location:** Attic

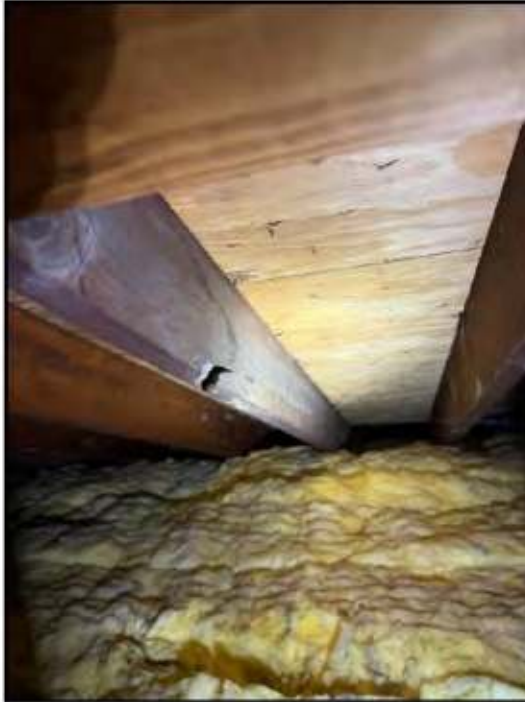
**106.** *Split or damage*

**ROOF FRAMING \ Rafter/trusses****36. Condition:** • Split or damage**Implication(s):** Weakened structure | Chance of structural movement**Location:** Attic Garage

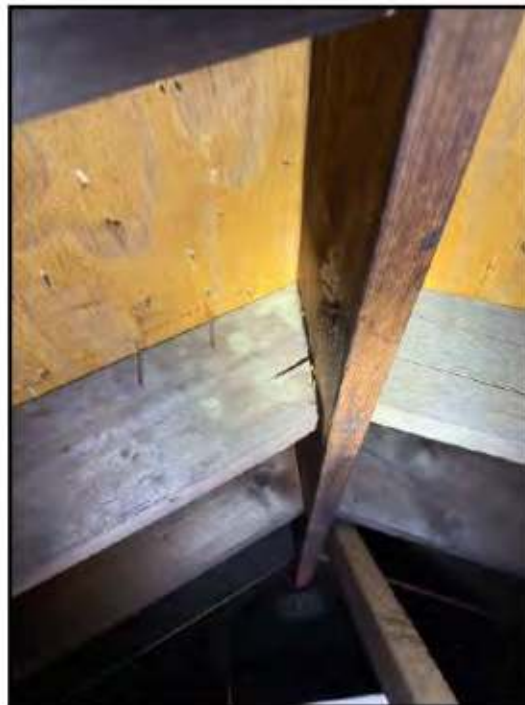
**109. Rafter spread**

**37. Condition:** • [Rafter spread](#)**Implication(s):** Weakened structure | Chance of structural movement

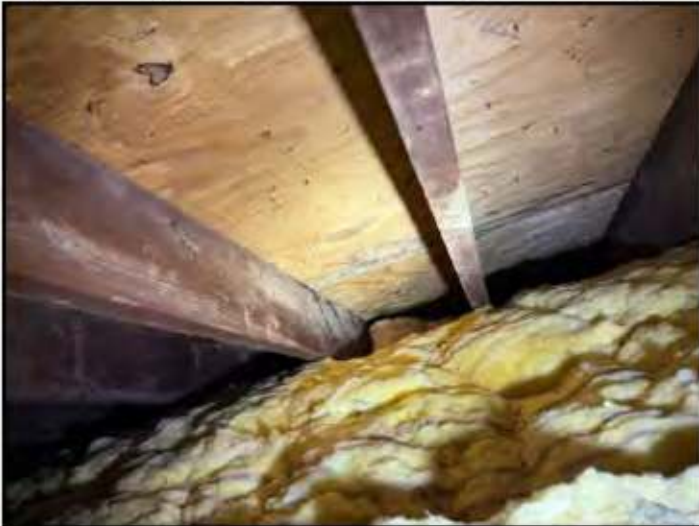
110. Water Stains

**38. Condition:** • Water Stains**Implication(s):** Chance of water damage to structure, finishes and contents

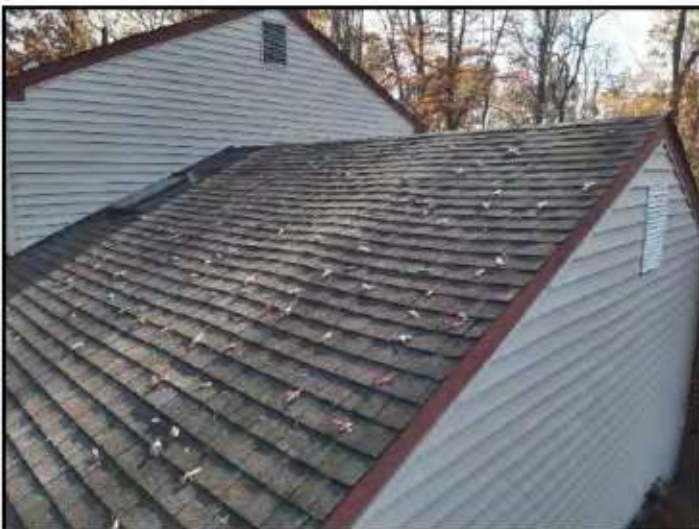
112. Buckled

**ROOF FRAMING \ Sheathing (roof/attic)****39. Condition:** • [Buckled](#)**Implication(s):** Weakened structure | Chance of structural movement**Task:** Further evaluation

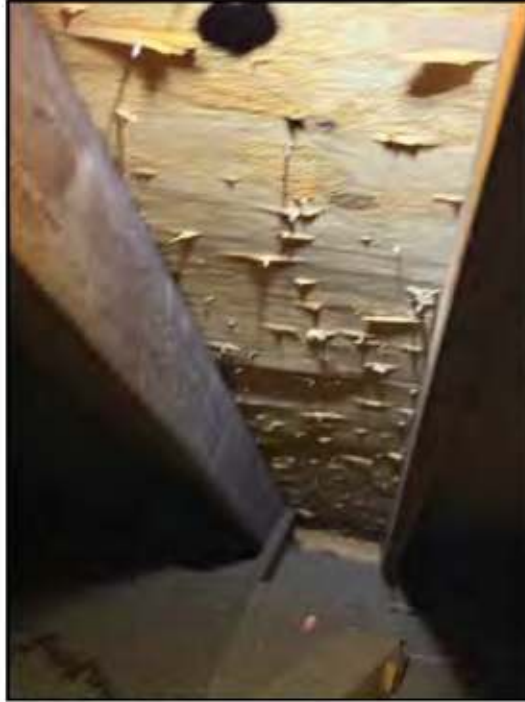
**40. Condition:** • [Buckled](#)**Implication(s):** Weakened structure | Chance of structural movement**Task:** Further evaluation

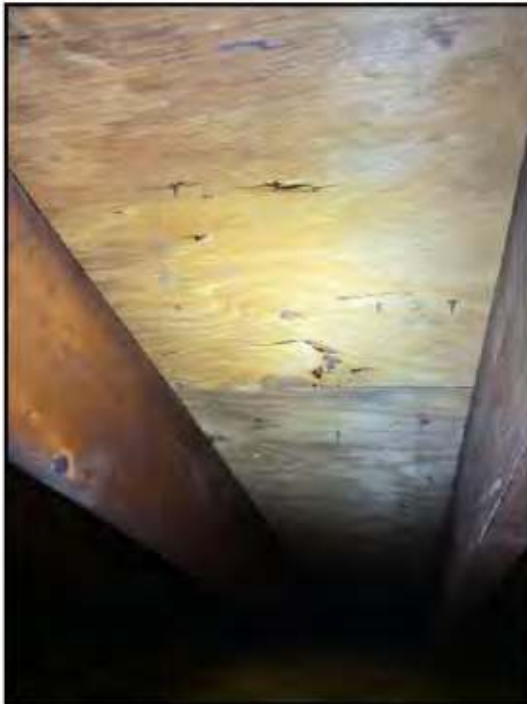
115. Damage

**114.** *Buckled***41. Condition:** • Damage**Implication(s):** Chance of water damage to structure, finishes and contents | Weakened structure**Task:** Further evaluation and repair

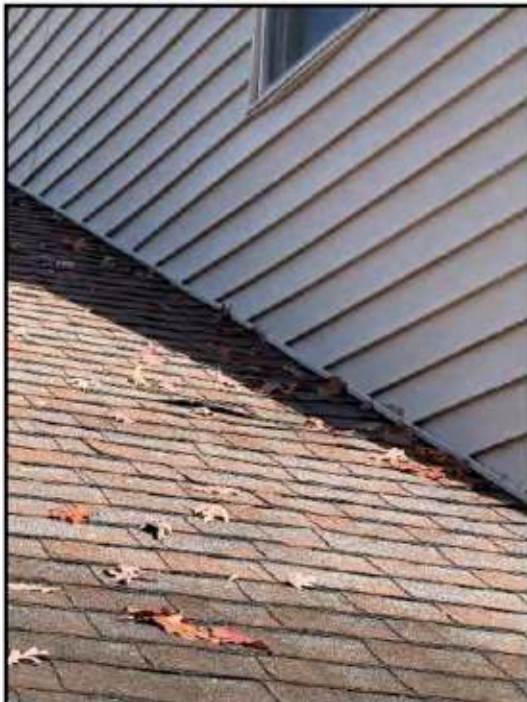
117. Sagging

**42. Condition:** • [Sagging](#)**Implication(s):** Weakened structure | Chance of structural movement**Location:** Rear Garage

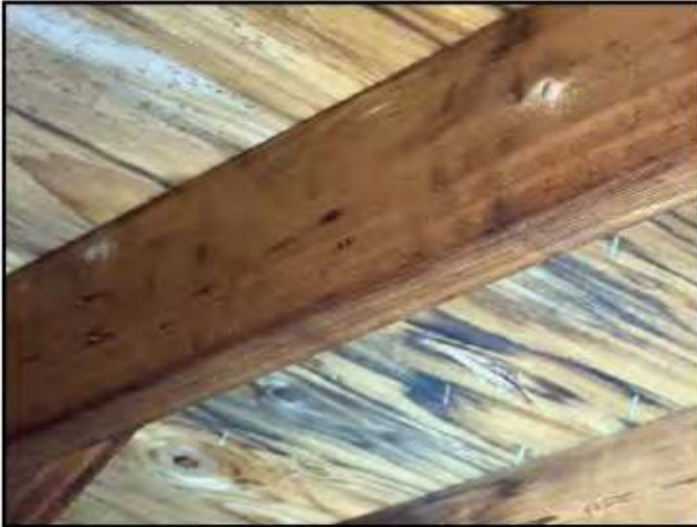
120. Water damage

43. Condition: • Water damage

Implication(s): Chance of water damage to structure, finishes and contents | Weakened structure

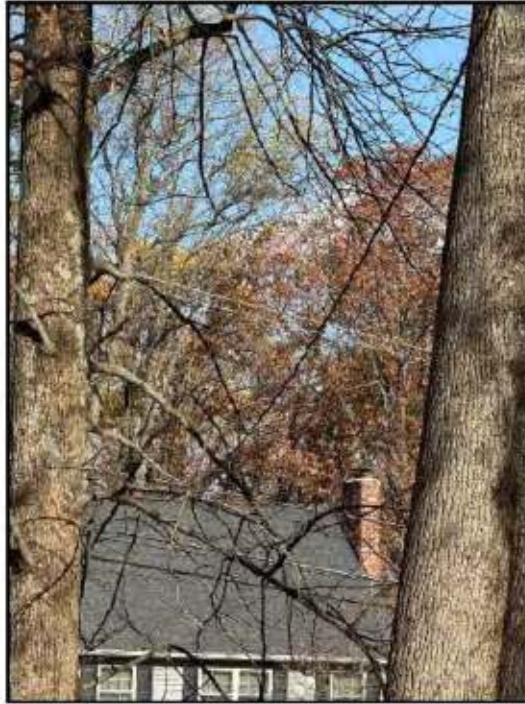
123. Branches / vines interfering with wires

44. Condition: • [Branches / vines interfering with wires](#)

Implication(s): Damage to wire | Electric shock | Interruption of electrical service

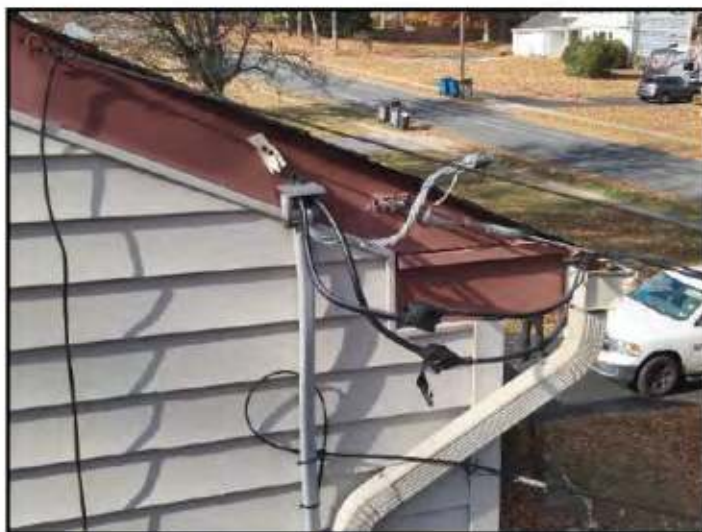
124. Poorly installed drip loop

45. Condition: • Poorly installed drip loop

Implication(s): Shock hazard or interruption of electrical service

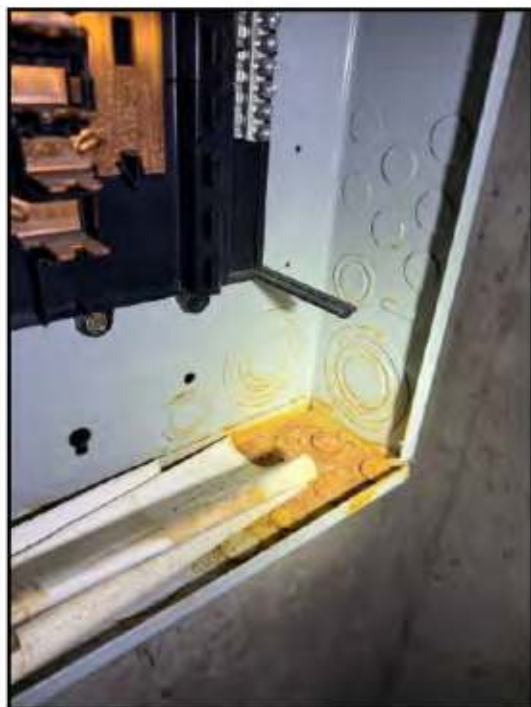
125. Rust or water in panel

46. Condition: • [Rust or water in panel](#)

Implication(s): Electric shock | Fire hazard

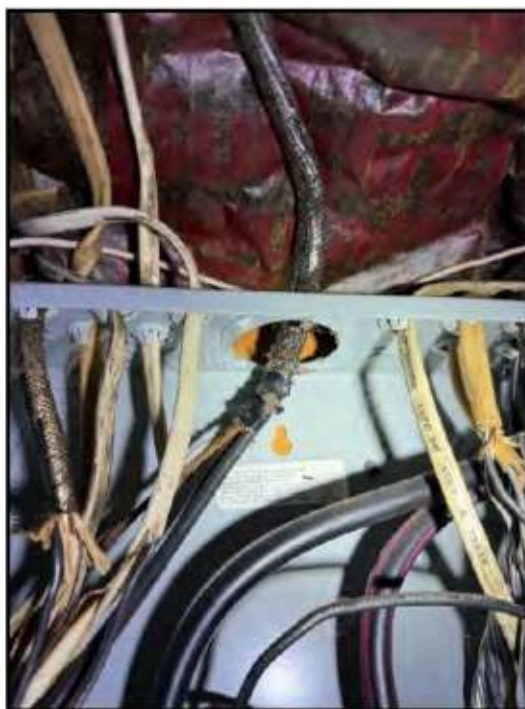
128. Openings in panel

47. Condition: • [Openings in panel](#)

Implication(s): Electric shock | Fire hazard

any exposed panel openings (that would allow access to the inside of the panel) should be fitted with secure covers

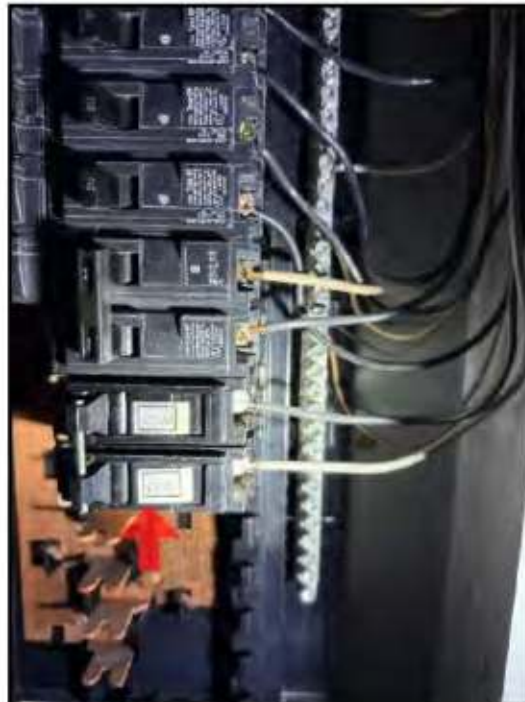
129. Older breakers in use

48. Condition: • Older breakers in use

In an overload condition they are rated for 50 operations at 6x (600%) rated current. During UL 489 testing, the device must survive short-circuit testing and continue to provide future overload protection.

From Eaton (Cutler Hammer) literature: UL489, requires that a breaker must safely clear its maximum current, which is the short circuit current rating of the breaker, twice and still be functional. Schneider (Square-D) uses this same criteria. And per IEEE 3.35 Circuit breaker useful life: it is prudent to replace any MCCB that has interrupted, at most, two faults at rated maximum current.

**Task:** Upgrade

**Time:** As soon as practical

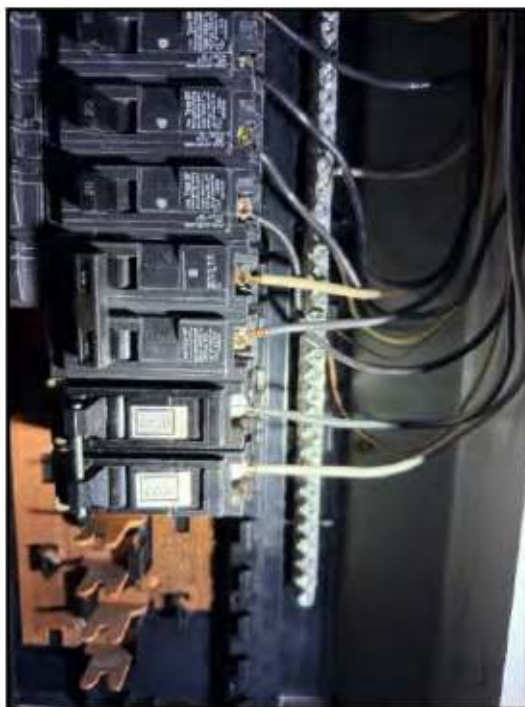
130. White wires connected to breakers not...

49. **Condition:** • White wires connected to breakers not identified as hot/live/ungrounded

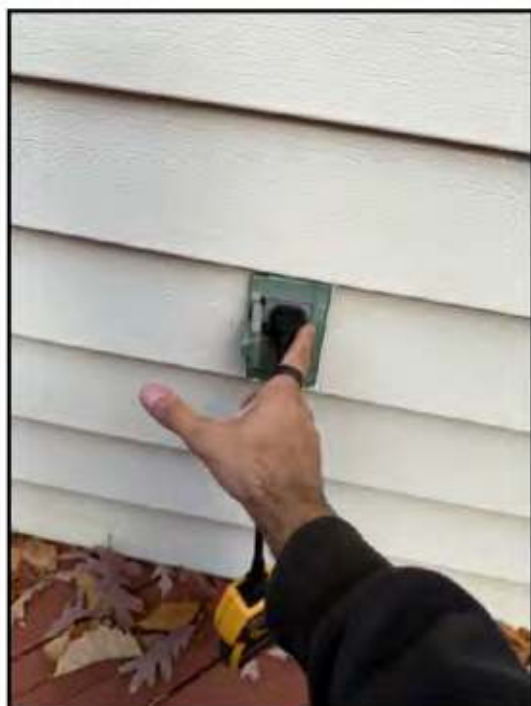
131. Loose

50. Condition: • [Loose](#)

Implication(s): Electric shock | Fire hazard

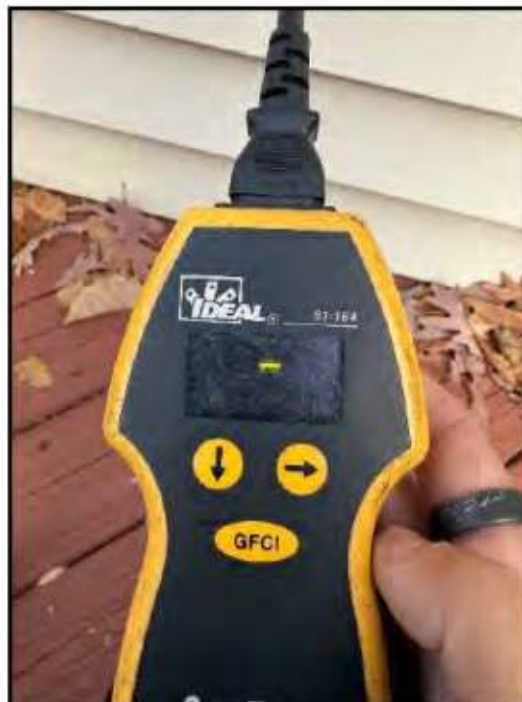
136. GFCI/GFI needed (Ground Fault Circuit...

51. Condition: • [GFCI/GFI needed \(Ground Fault Circuit Interrupter\)](#)

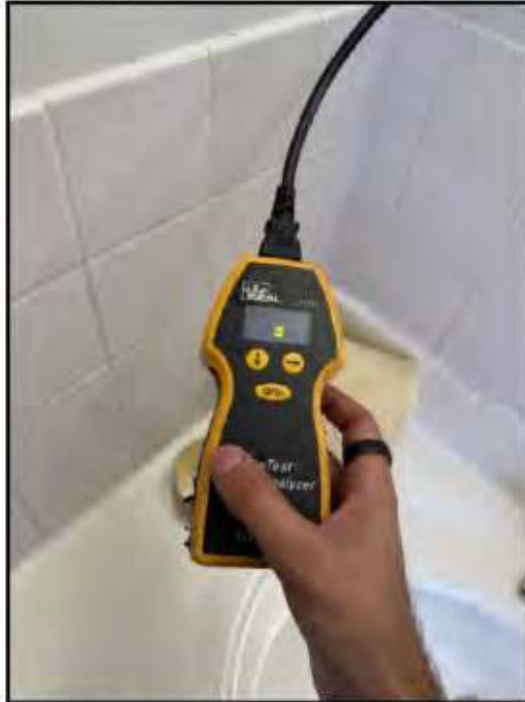
137. GFCI/GFI needed (Ground Fault Circuit...

52. Condition: • [GFCI/GFI needed \(Ground Fault Circuit Interrupter\)](#)

Implication(s): Electric shock

Location: Second Floor Bathroom

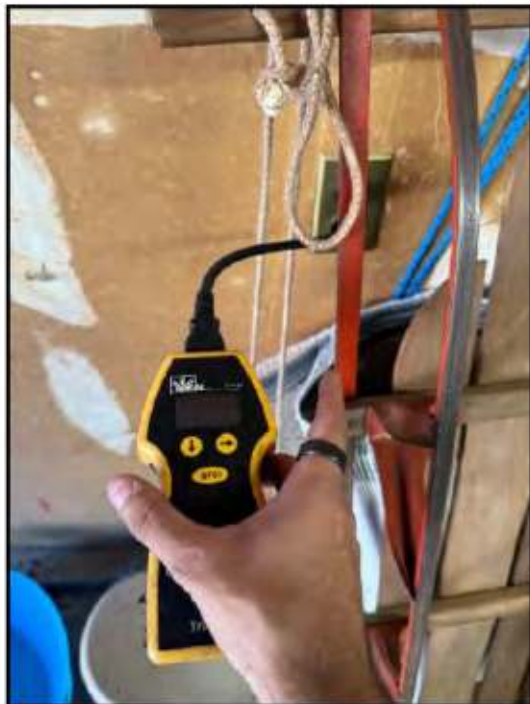
138. Loose connections

54. Condition: • Loose connections

Implication(s): Electric shock, Fire hazard

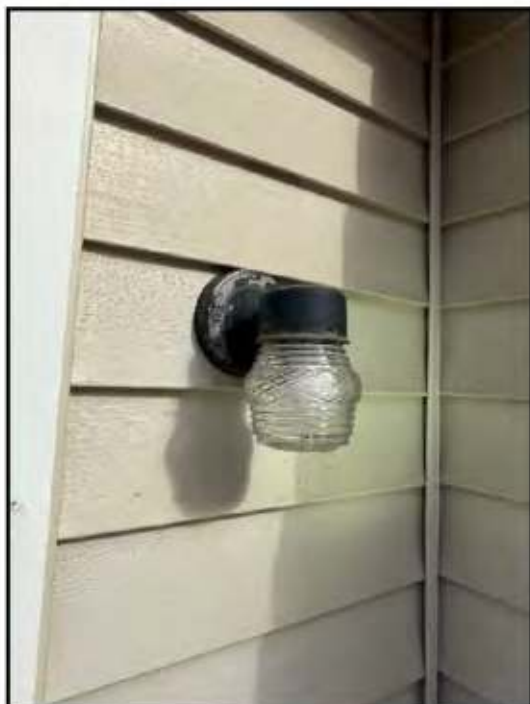
140. Loose

**DISTRIBUTION SYSTEM \ Lights**55. Condition: • [Loose](#)

Implication(s): Electric shock | Fire hazard

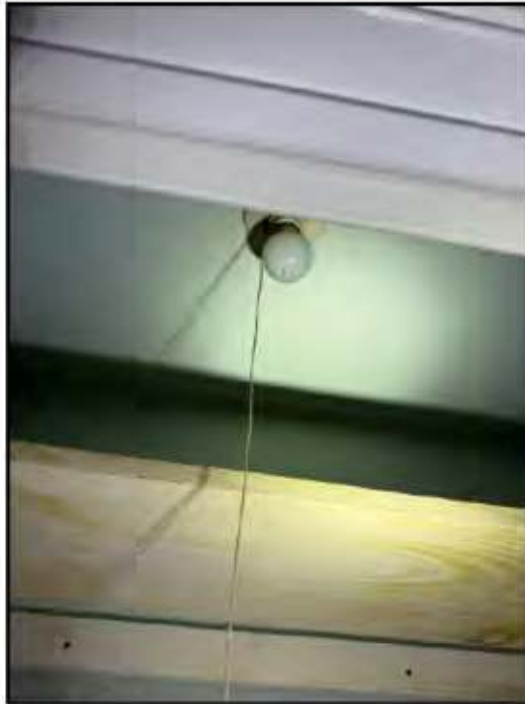
**56. Condition:** • Too close to combustibles

**Implication(s):** Fire hazard

**Location:** Closets

Recommend using LED bulbs when light fixtures are installed close to combustibles

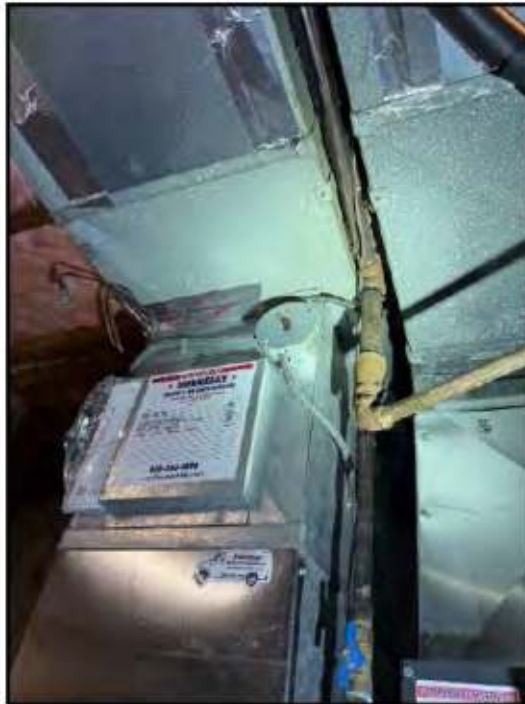
144. Furnace shut off switch must be marked with...

57. Condition: • Furnace shut off switch must be marked with a RED cover plate

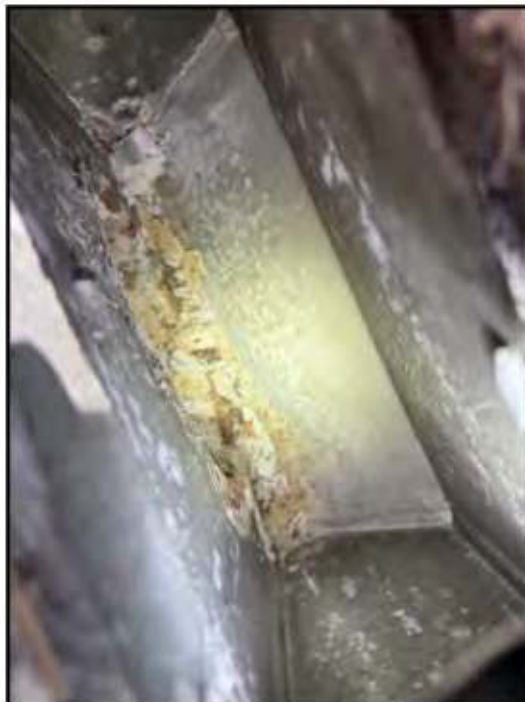
145. Dirty

58. Condition: • [Dirty](#)

Debris from old vinyl flooring was found inside, possibly containing asbestos.

Implication(s): Increased heating and cooling costs | Reduced comfort
