# Your Inspection Report

Tuesday, November 5, 2024

Leonardo Betancor, CMI, 24GI00182600, HOI.0001093

Smart Choice Inspections LLC  
173 Ridge Road, Suite H1  
Cedar Grove, NJ 07009

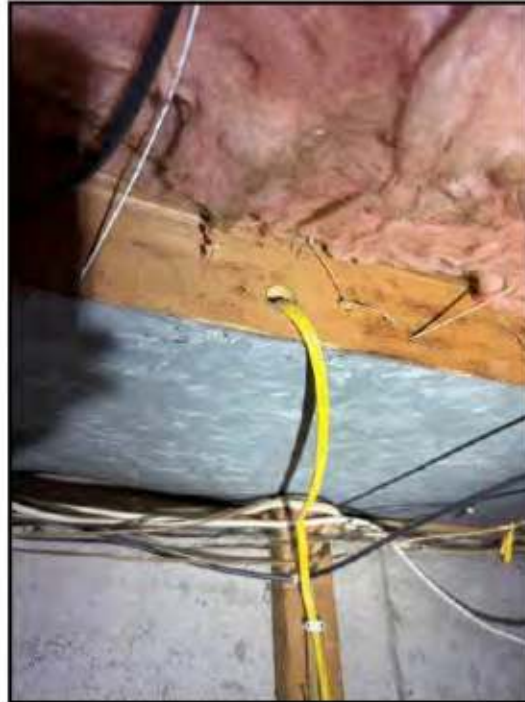
146. Return chase or plenum contain pipes, wires...

**59. Condition:** • Return chase or plenum contain pipes, wires or vents

**Implication(s):** Material deterioration | Damage to wire

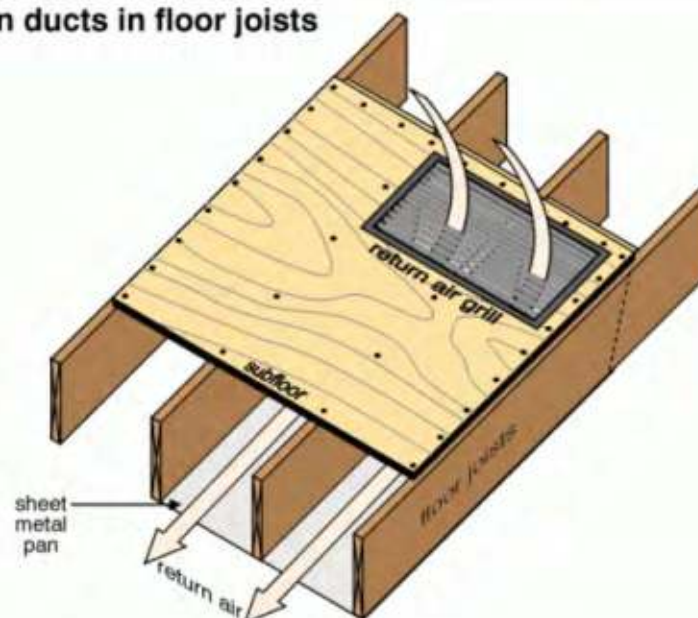
147. Building cavities used as return or supply...

**60. Condition:** • Building cavities used as return or supply ducts

A cavity space used as a return-air pathway will pull pollutants into the building from unknown sources. Another issue with using cavity spaces as return-air pathways is fire safety.

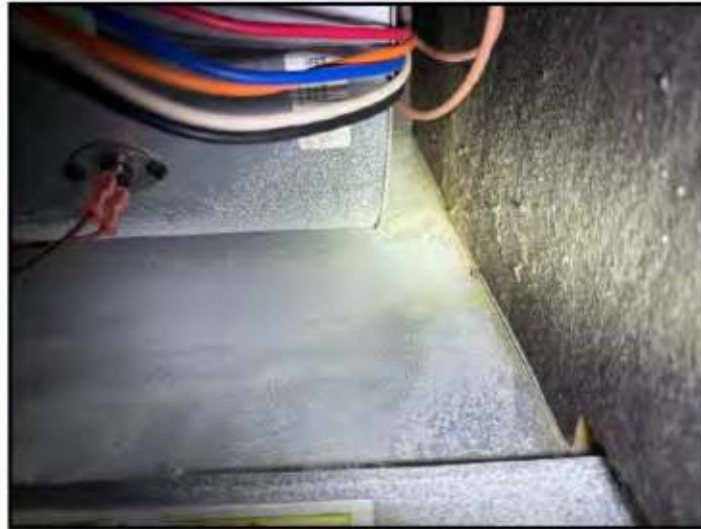
61. Condition: • Rust / corrosion

148. Rust / corrosion

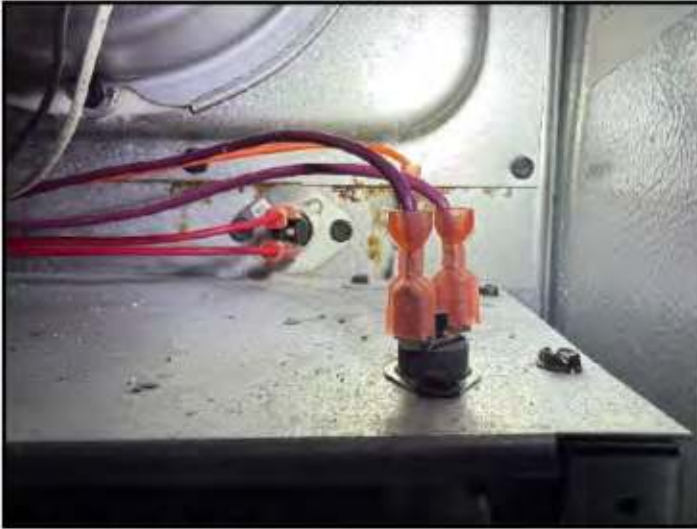
62. Condition: • [Rust, dirty, obstructed](#)

Implication(s): Equipment not operating properly | Hazardous combustion products entering home

149. Rust, dirty, obstructed

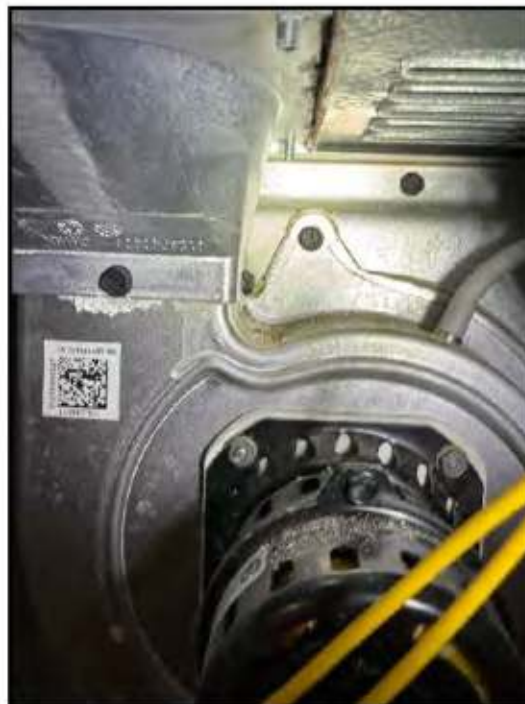
151. Rust, dirty, obstructed

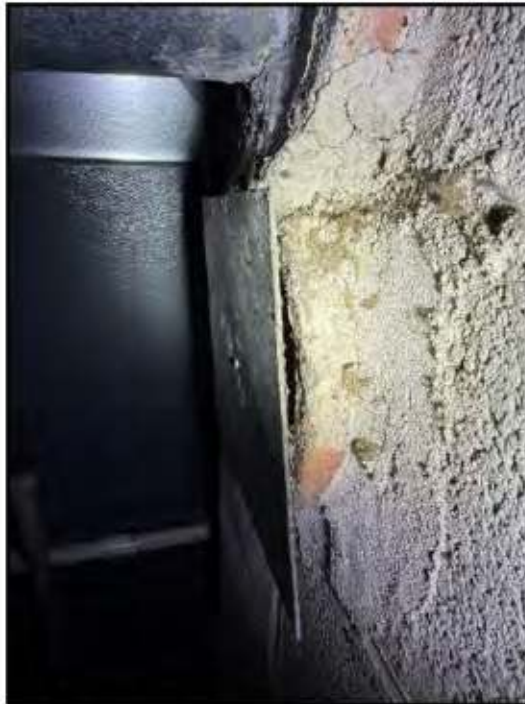
63. Condition: • [Abandoned openings for flue connections](#)

Implication(s): Hazardous combustion products entering home

152. Abandoned openings for flue connections

Recommend sealing opening properly

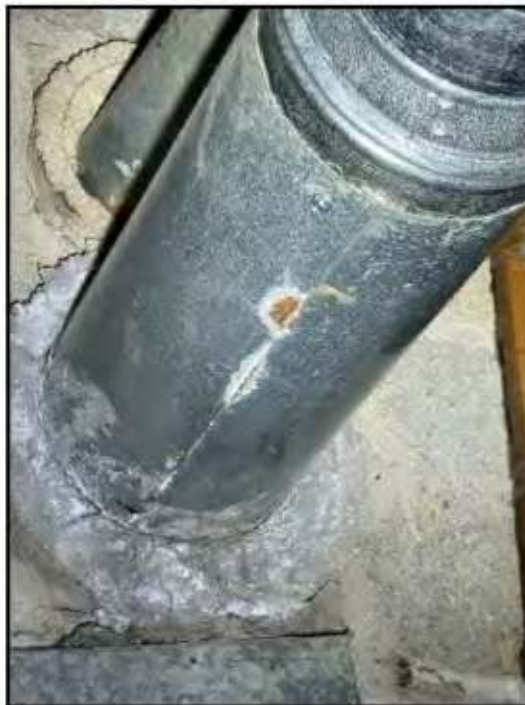
64. Condition: • Corrosion

153. Corrosion

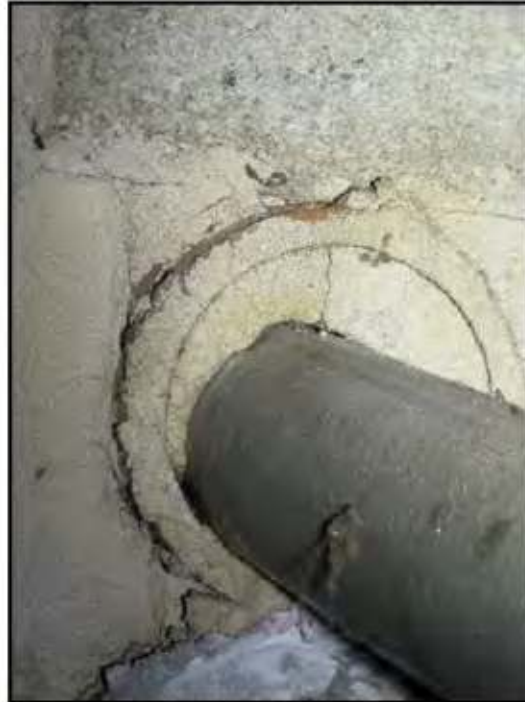
65. Condition: • Unsealed openings

Implication(s): Hazardous combustion products entering home

154. Unsealed openings

Task: Recommend sealing around vent connector using high temperature furnace cement

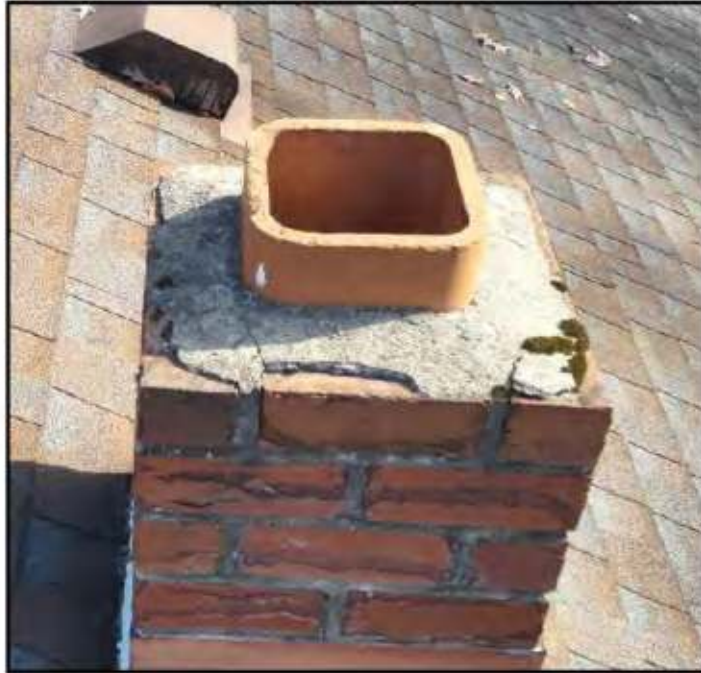
66. Condition: • [Cracked](#)

Implication(s): Chance of water damage to structure, finishes and contents | Shortened life expectancy of material

155. Cracked

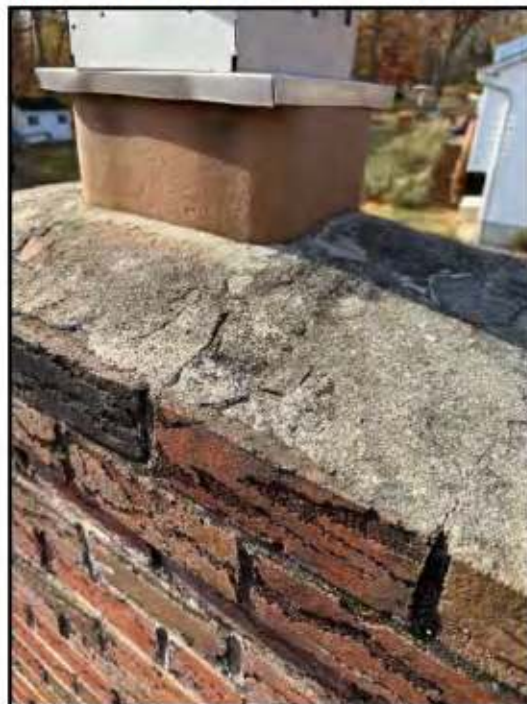
67. Condition: • [Cracked](#)

Implication(s): Chance of water damage to structure, finishes and contents | Shortened life expectancy of material

156. Cracked

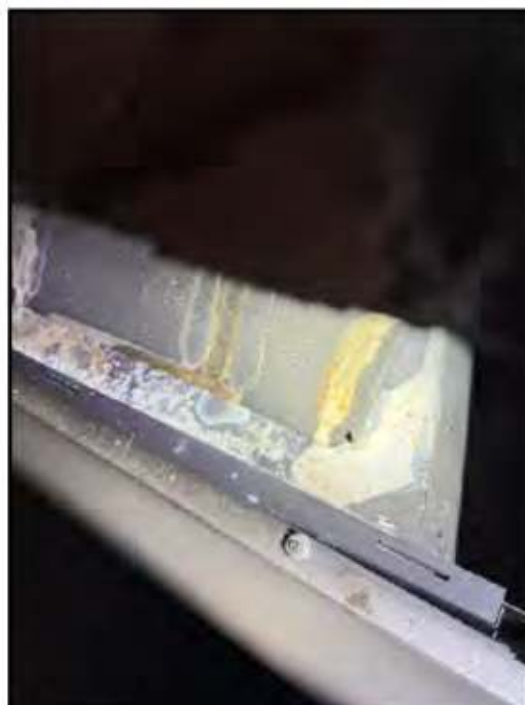
158.

69. Condition: • Water appears to be entering gas fireplace

Task: Further evaluation

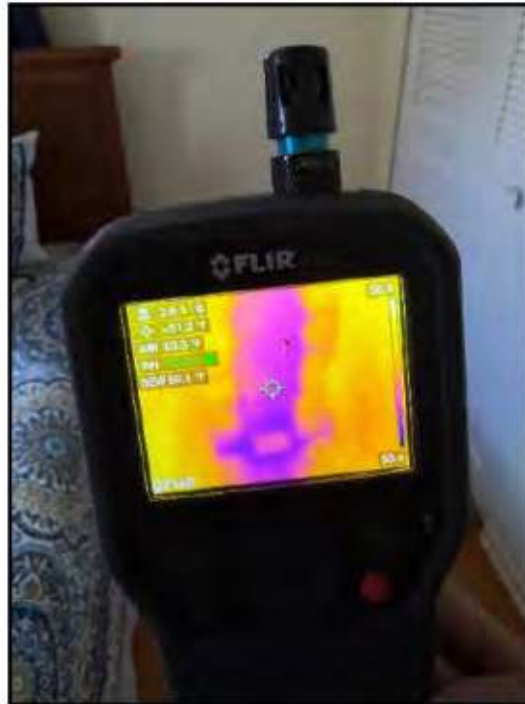
**70. Condition:** • Leaky joints

The entire wall cavity became cold when the AC unit was running, leading us to believe there may be possible leaks within the wall.

**Implication(s):** Weakened efficiency

160. Leaky joints

**Task:** Recommend sealing the ductwork with mastic or UL 181 foil tape in order to promote better airflow and stop potential or current leakage.

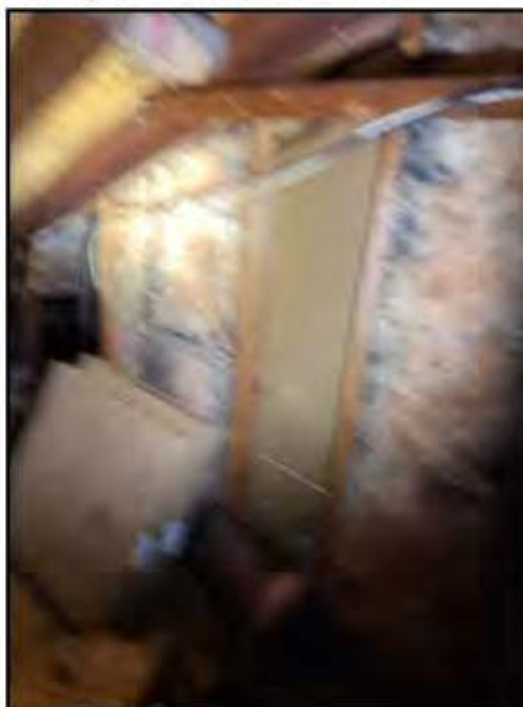
71. Condition: • [Gaps or voids](#)

Implication(s): Increased heating and cooling costs | Reduced comfort

161. *Gaps or voids*

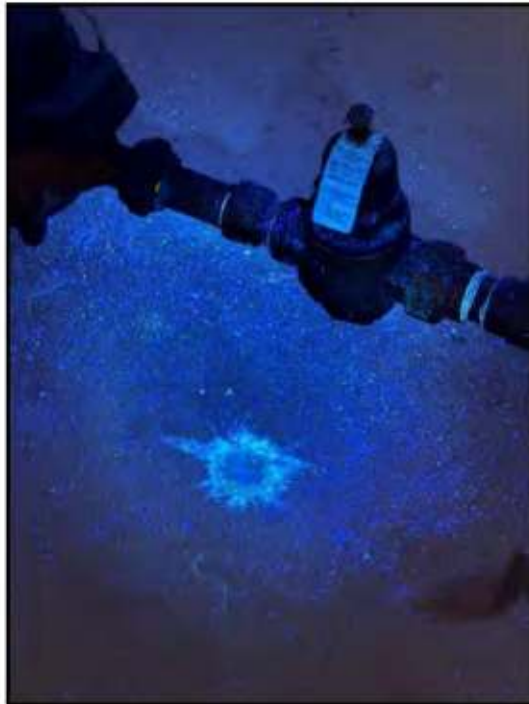
72. Condition: • [Leak](#)

Implication(s): Chance of water damage to structure, finishes and contents | Damage to equipment

163. Leak

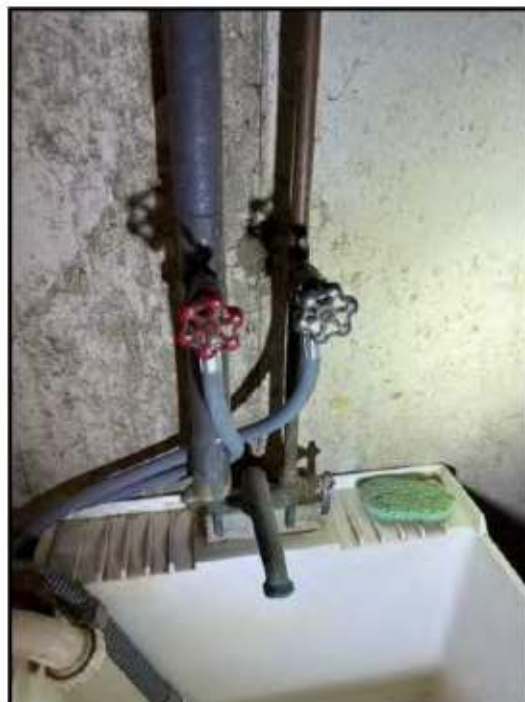
73. Condition: • [Inoperable](#)

Implication(s): Equipment not operating properly

165. Inoperable

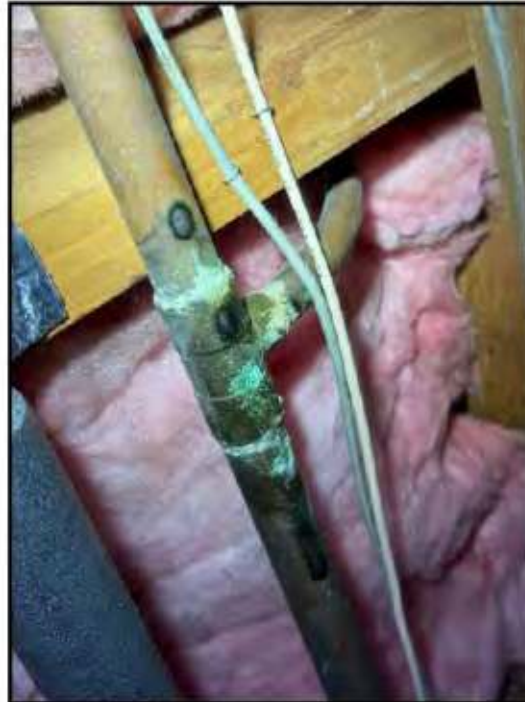
**74. Condition:** • Corrosion

**Implication(s):** Chance of water damage to structure, finishes and contents | Leakage | Reduced system life expectancy

166. Corrosion

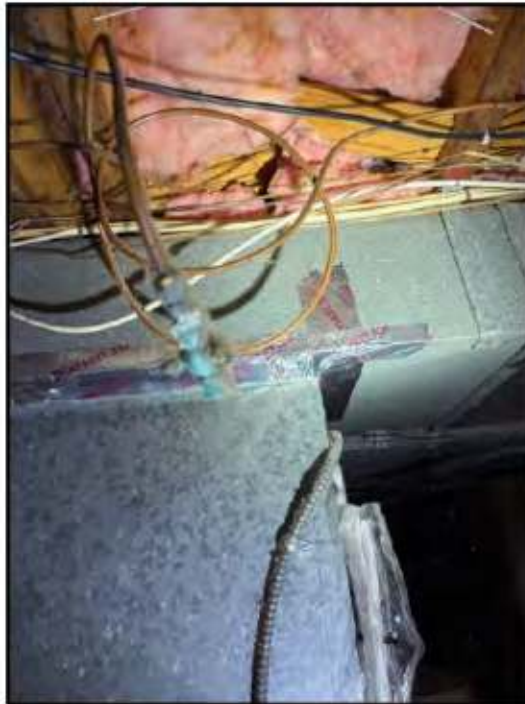
**75. Condition:** • Corrosion

**Implication(s):** Chance of water damage to structure, finishes and contents | Leakage | Reduced system life expectancy

167. Corrosion

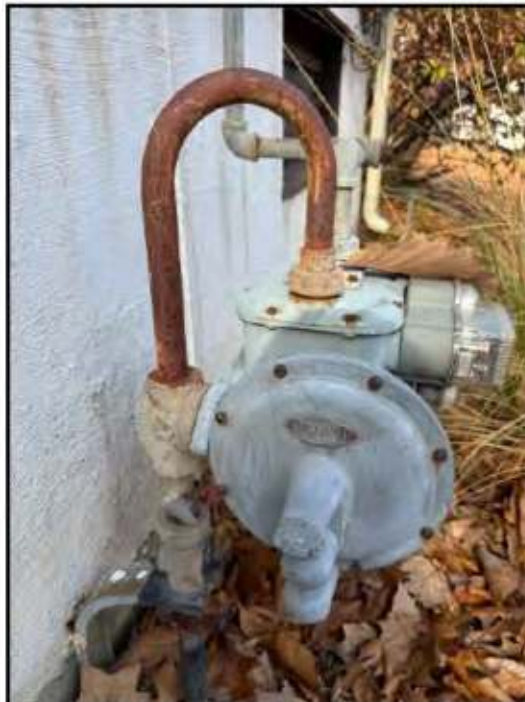
76. Condition: • [Rust](#)

Implication(s): Material deterioration | Fire hazard

168. Rust

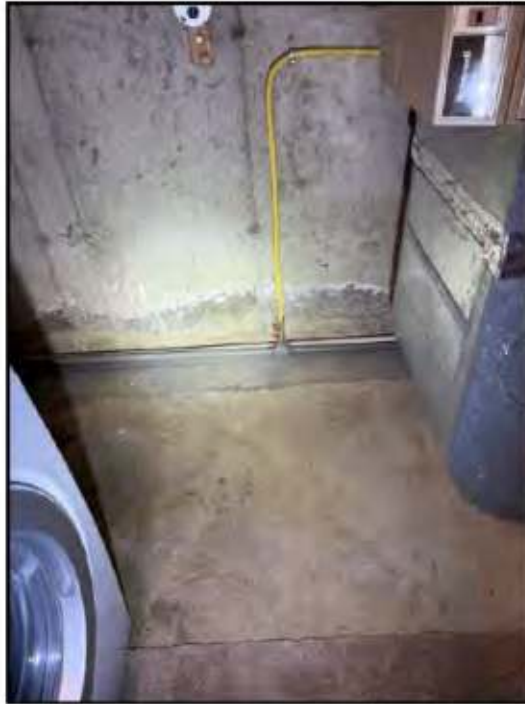
**77. Condition:** • Piping not protected from corrosion**Location:** Basement

169. Piping not protected from corrosion

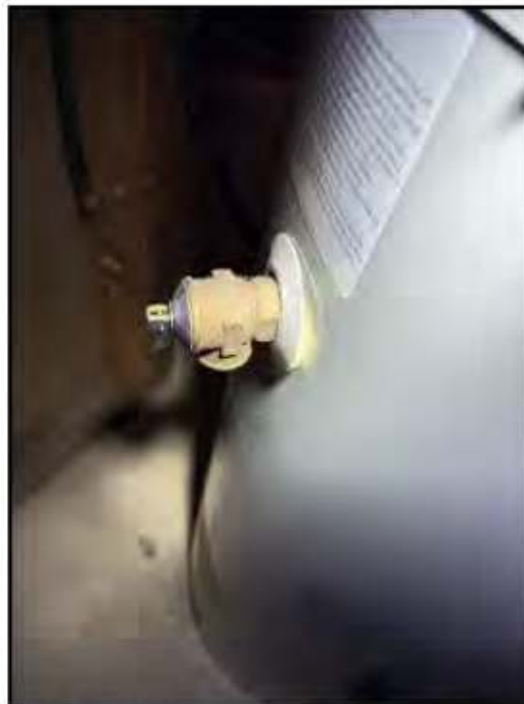
**WATER HEATER \ Temperature/pressure relief (TPR) valve****78. Condition:** • [Discharge tube missing](#)**Implication(s):** Scalding

170. Discharge tube missing

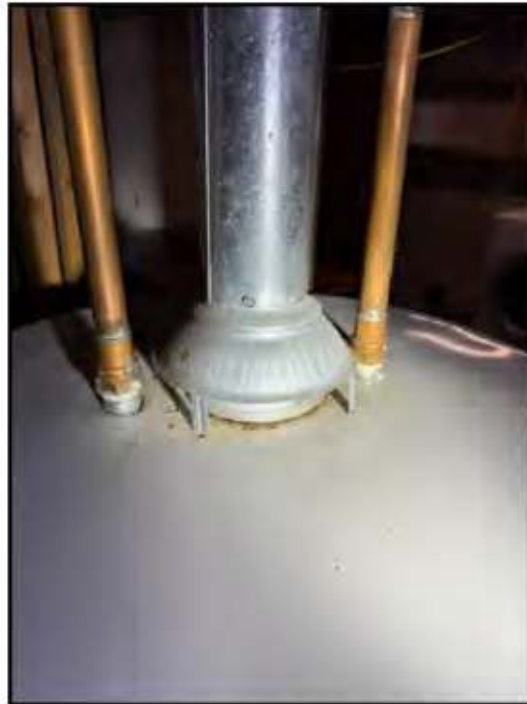
79. Condition: • [Vent connector too small, too big for water heater](#)

**Implication(s):** Equipment not operating properly | Hazardous combustion products entering home

the vent connector diameter should match the size of the flue collar

if the vent connector is too large or too small, condensation or spillage could result

171. Vent connector too small, too big for water...

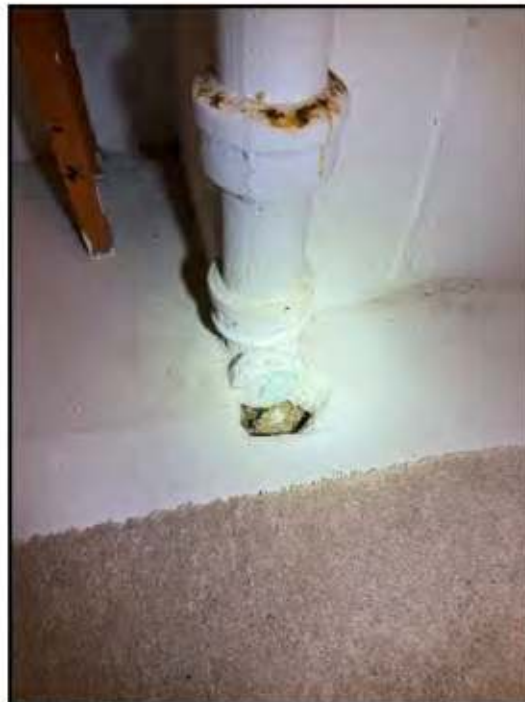
80. Condition: • Clean-outs missing or inaccessible

Implication(s): Increased maintenance costs | Difficult to service

172. Clean-outs missing or inaccessible

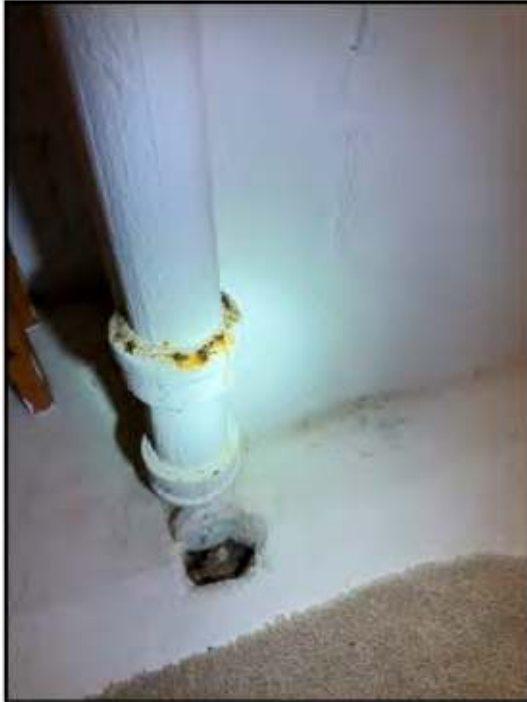
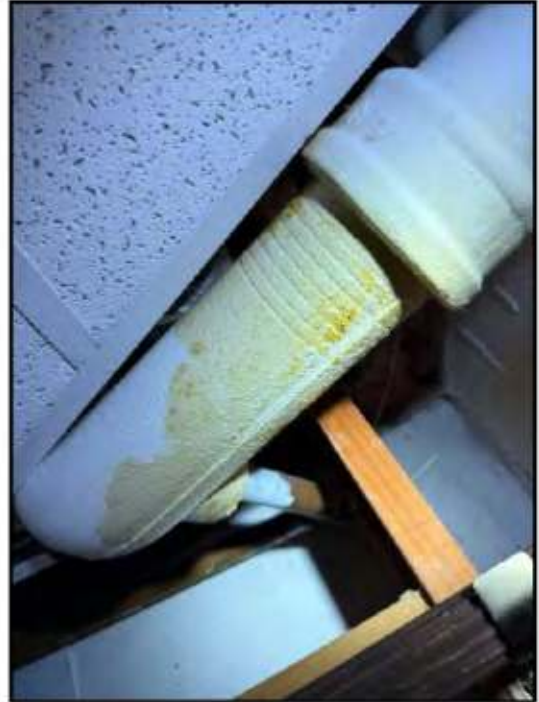
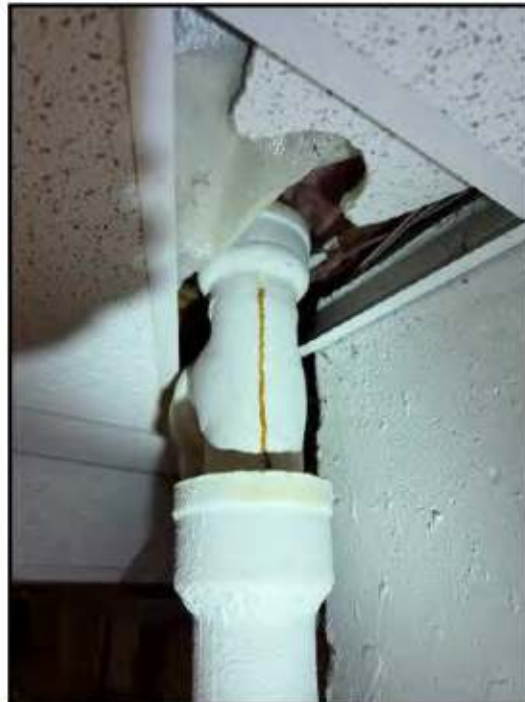
81. Condition: • Possible leakage

Task: Monitor

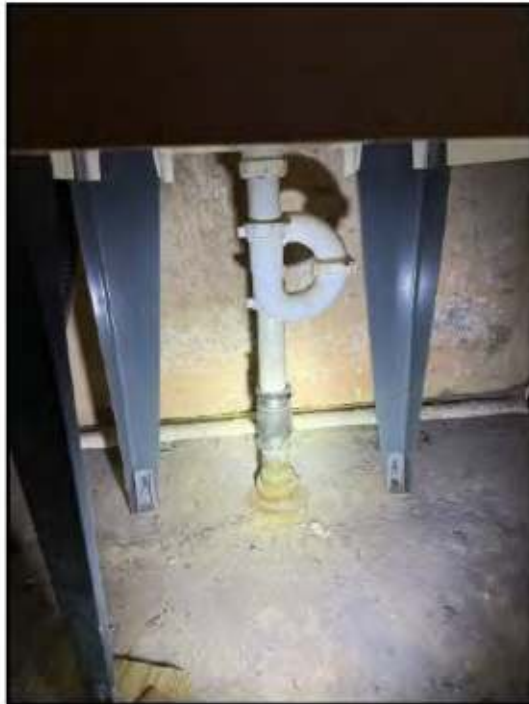
**WASTE PLUMBING \ Traps - Installation****82. Condition:** • [Nonstandard shape or material](#)

**Implication(s):** Reduced operability | Fixtures slow to drain

176. Nonstandard shape or material

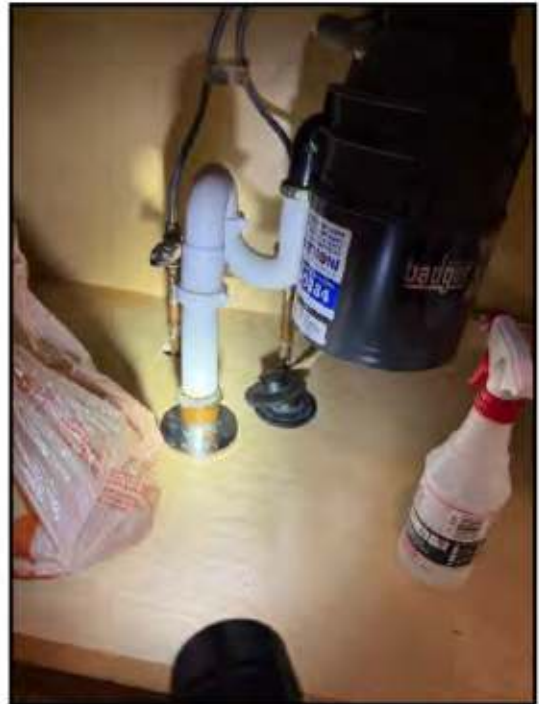
177. Nonstandard shape or material

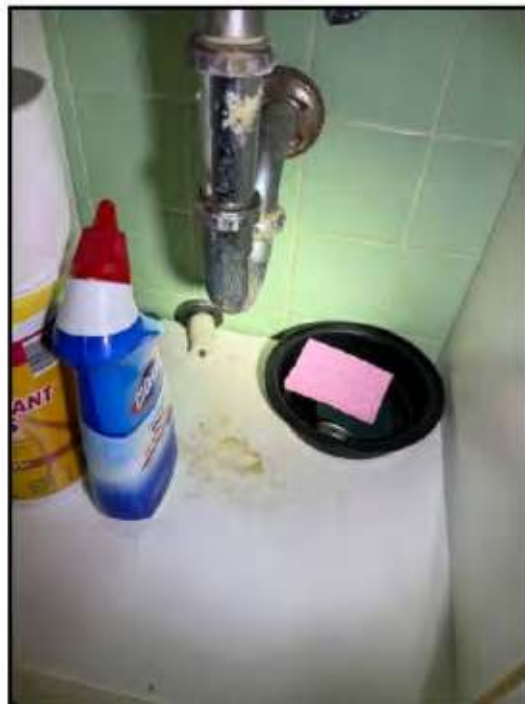
83. Condition: • Possible leakage stains

178. Possible leakage stains

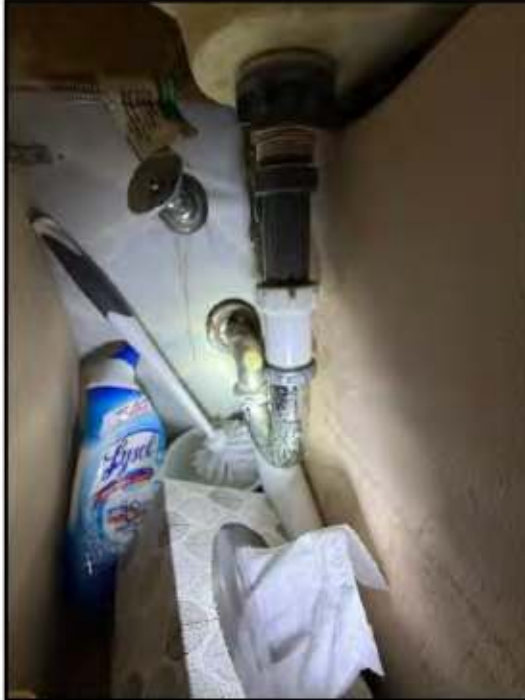
**84. Condition:** • Corrosion

**Implication(s):** Chance of water damage to structure, finishes and contents

179. Corrosion

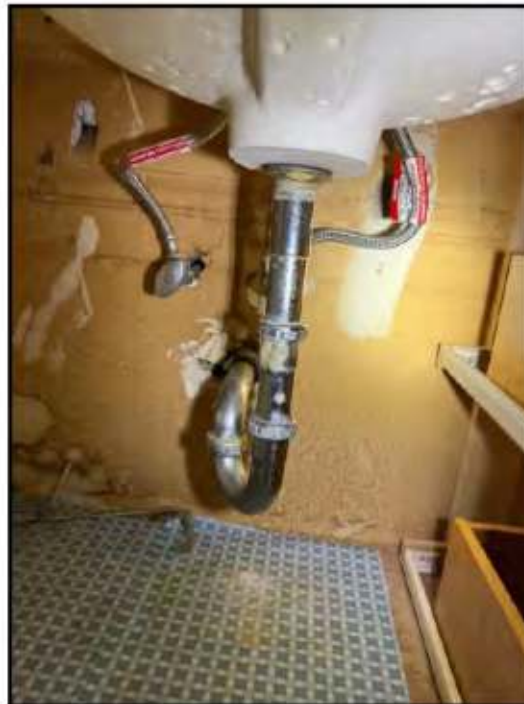
181. Corrosion

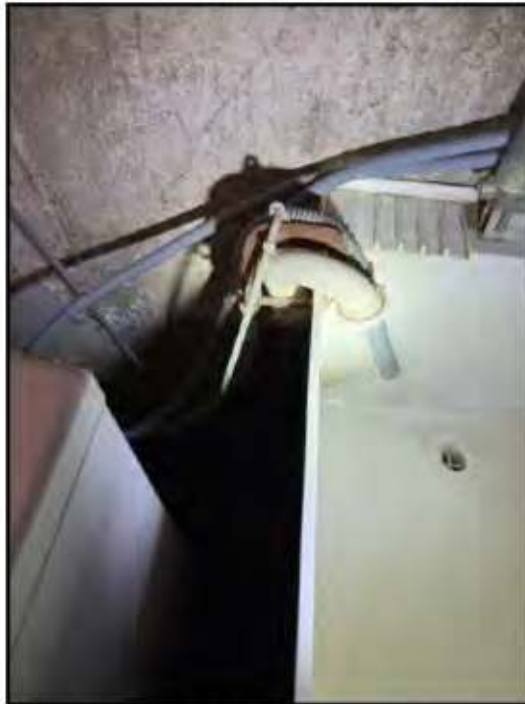
**85. Condition:** • Discharges into sewer

**Implication(s):** Chance of water damage to structure, finishes and contents

182. Discharges into sewer

**Task:** Discharge pipe be routed towards the exterior and extended 10 feet away from the foundation.

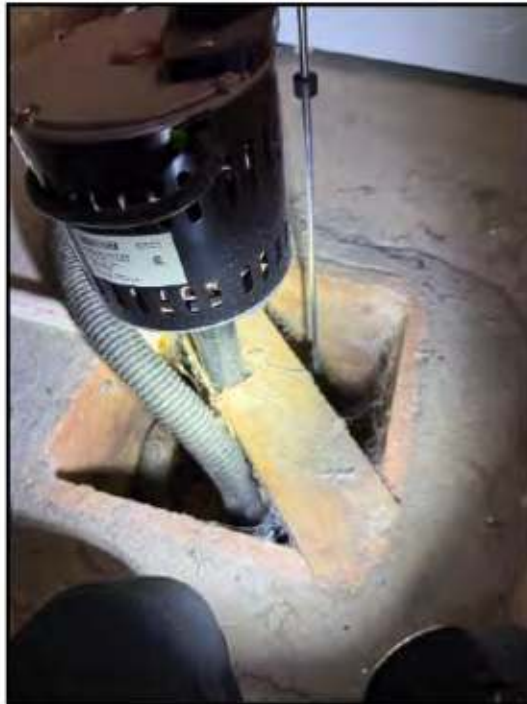
**86. Condition:** • Questionable installation

A section of chimney flue liner has been repurposed as a makeshift sump pump basin. This approach was sometimes used in the 1950s-1970s but is not as effective as a modern sump basin. The sump pump in this setup is intended to remove any water that rises from the water table beneath the slab, helping to reduce water pressure under the foundation. It appears that a French drain may have been installed along portions of the basement perimeter (although we cannot confirm if perforated pipe is present, as it is not visible), but it does not connect to this sump basin, which limits the drainage system's effectiveness.

183. Questionable installation

For optimal performance, it is recommended to replace this flue liner with a properly sized polyethylene basin (16x22 inches) and connect it directly to the French drain piping. This setup would improve water collection and ensure efficient drainage. Additionally, the sump pump discharge should be directed to an exterior point at least 6-10 feet away from the home, rather than into the sewer system, to prevent rainwater from overloading the sewer infrastructure.

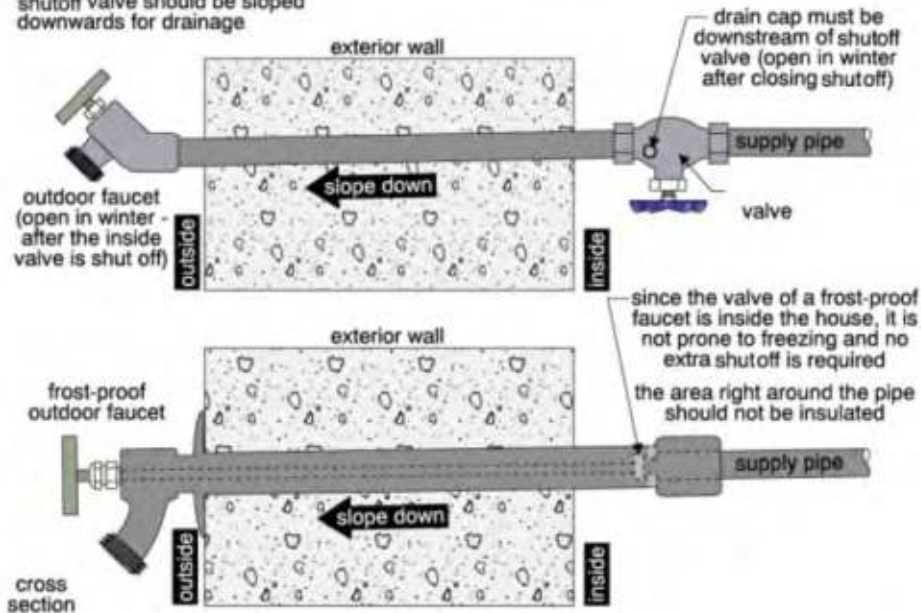
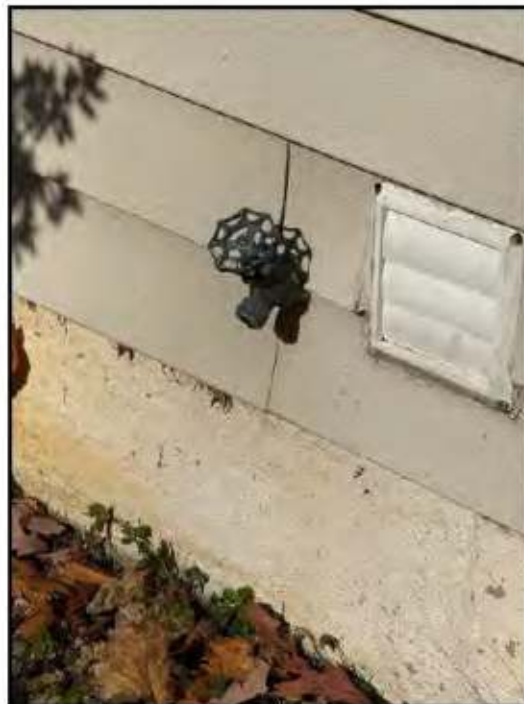
186. Not Frost Free

88. Condition: • Not Frost Free

Implication(s): Chance of water damage to structure, finishes and contents

piping/faucets downstream of the shutoff valve should be sloped downwards for drainage

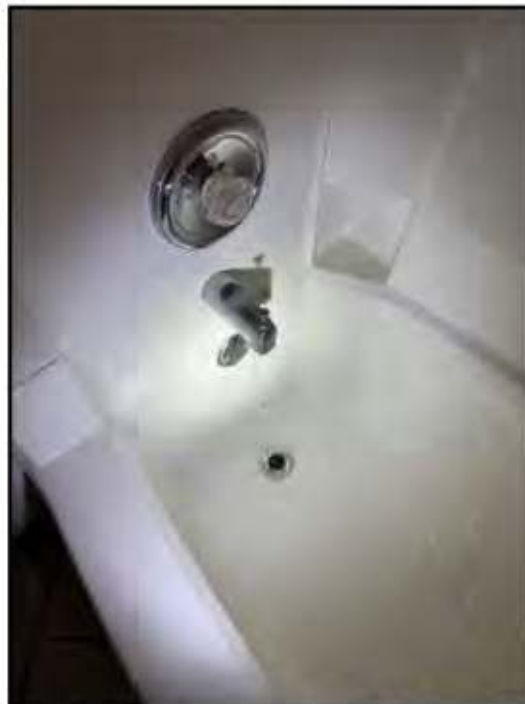
187. Loose shower valves/mixer piping

89. Condition: • Loose shower valves/mixer piping

Over time, even well-secured plumbing components can loosen, emphasizing the importance of proper installation and regular maintenance. The plumbing should have been properly secured before the wall covering was installed. Continuous movement of unsecured plumbing can loosen or damage components, increasing the risk of a hidden leak that could go unnoticed until significant damage occurs. If not addressed, this can lead to water damage, mold growth, and costly repairs, compromising the integrity of the structure and surrounding materials, whether behind tile or plastic surrounds.

**Implication(s):** Chance of water damage to structure, finishes and contents. Equipment failure.

**Location:** Second Floor Bathroom

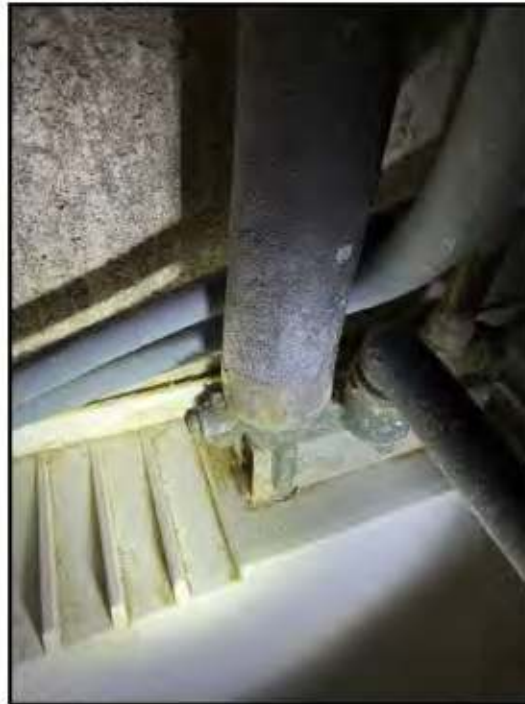
188. *Damage*

**90. Condition:** • Damage

**Location:** Laundry Area

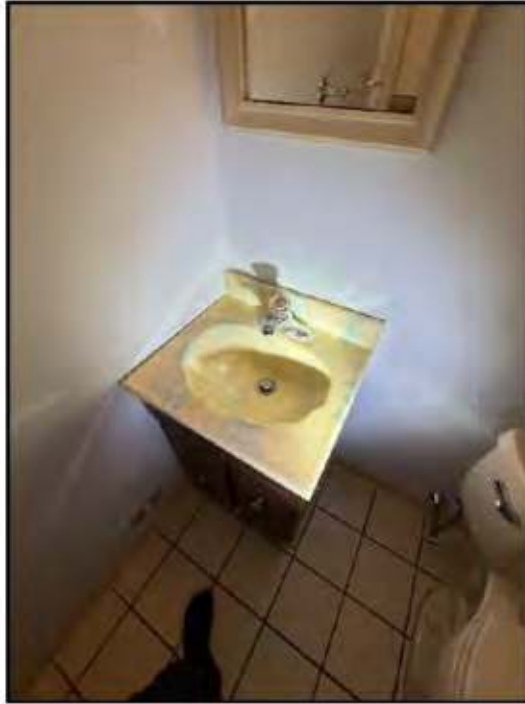
189. Loose

91. Condition: • [Loose](#)

**Implication(s):** Chance of water damage to structure, finishes and contents | Damage or physical injury due to falling materials | Sewage entering the building

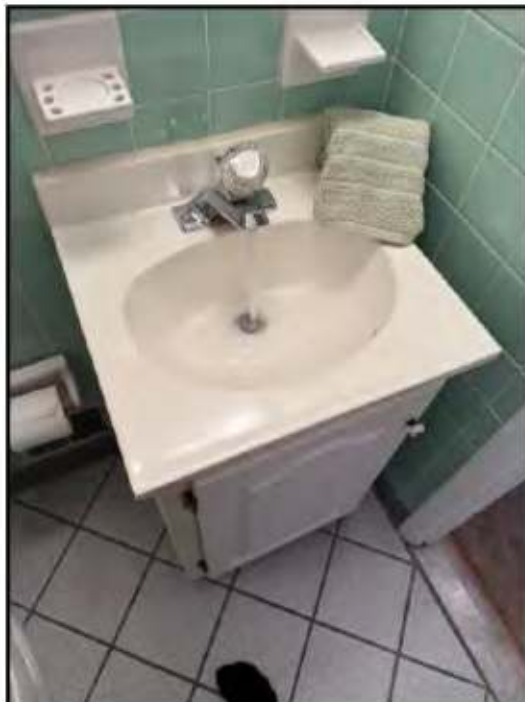
190. Loose

92. Condition: • [Loose](#)

Implication(s): Chance of water damage to structure, finishes and contents | Damage or physical injury due to falling materials | Sewage entering the building

Location: Second Floor Bathroom

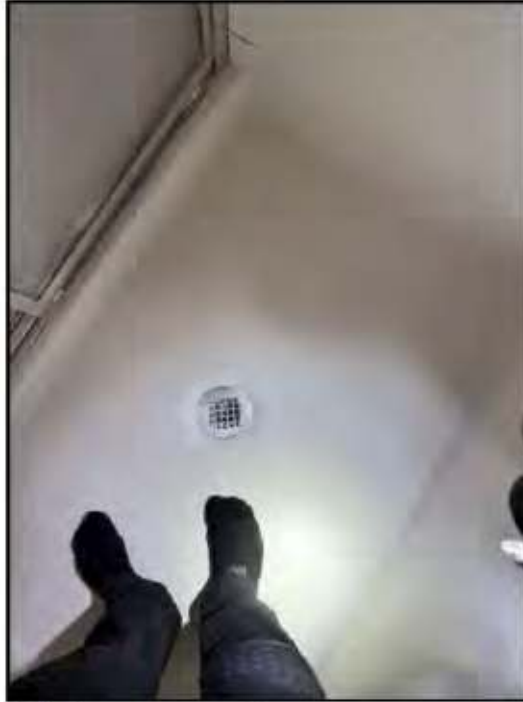
**191.** *Loose or unstable*

**93. Condition:** • Loose or unstable

Vinyl shower pans should be supported by adding sand mix underneath them during installation. Constant movement of the shower pan during use can loosen the plumbing.

**Location:** Second Floor Bathroom

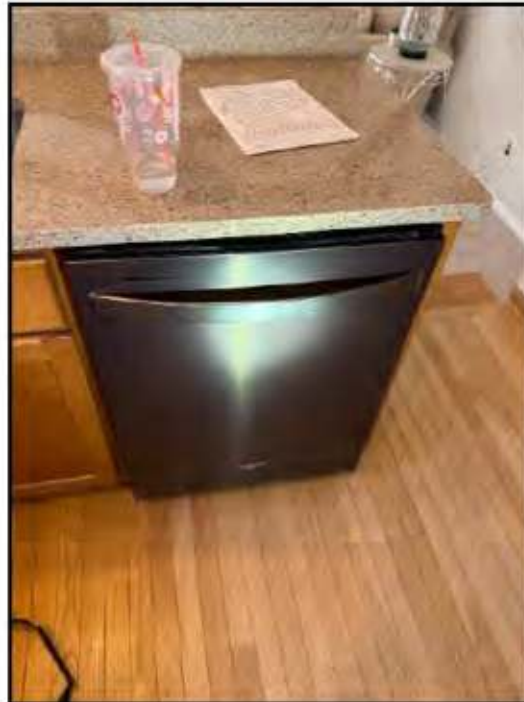
192. Dishwasher

Due to the sewer main clog, we decided not to test the dishwasher.

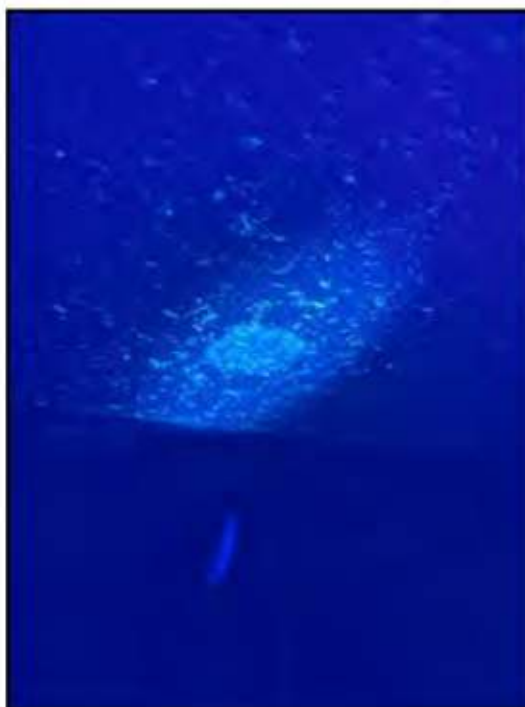
193. *Water stains*

95. Condition: • Water stains

Implication(s): Chance of water damage to structure, finishes and contents

Location: Basement

## Task: Monitor

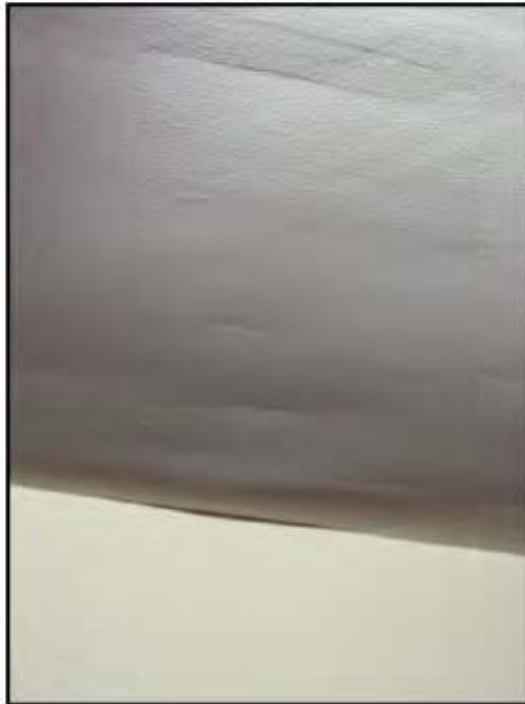
194. *Sag*

96. Condition: • [Sag](#)

Implication(s): Chance of movement

Location: Various

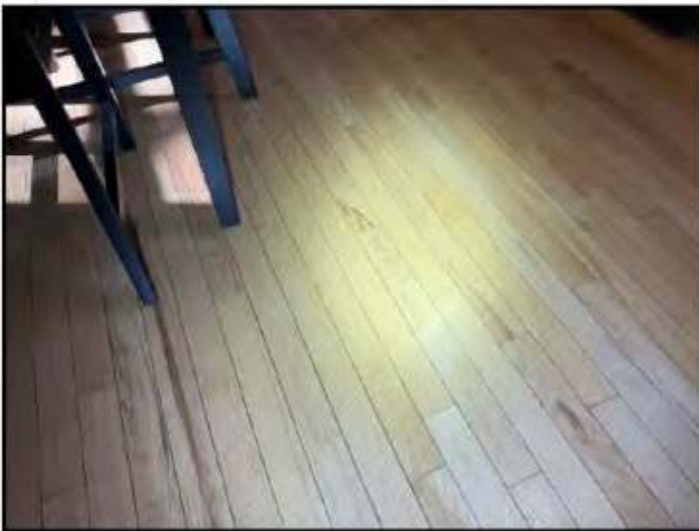
195. *Wear*

98. Condition: • Wear

Implication(s): Material deterioration

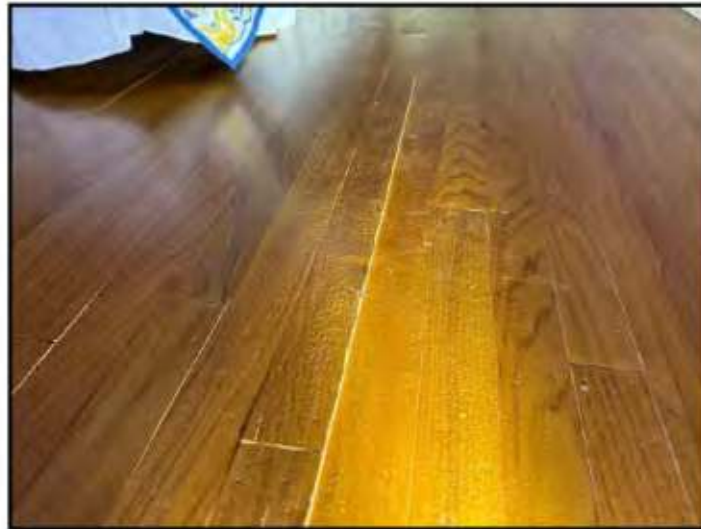
197. Buckled

100. Condition: • [Buckled](#)

Implication(s): Trip or fall hazard

Location: Second Floor

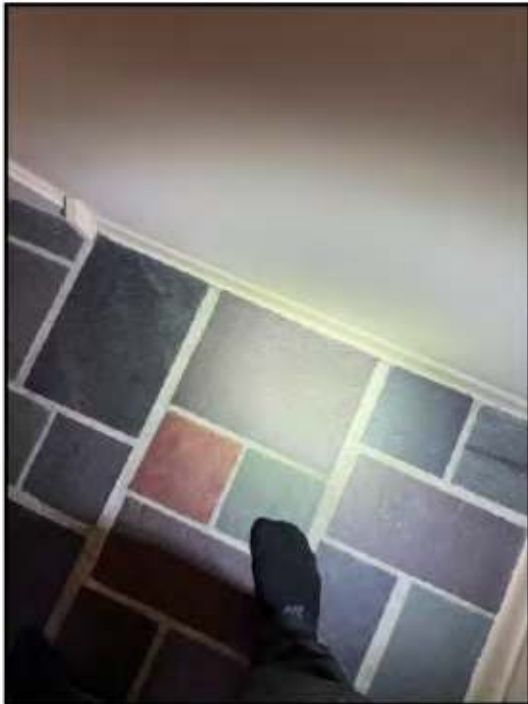
198. Tiles cracked

101. Condition: • [Tiles cracked](#)

Implication(s): Trip or fall hazard

Location: Foyer

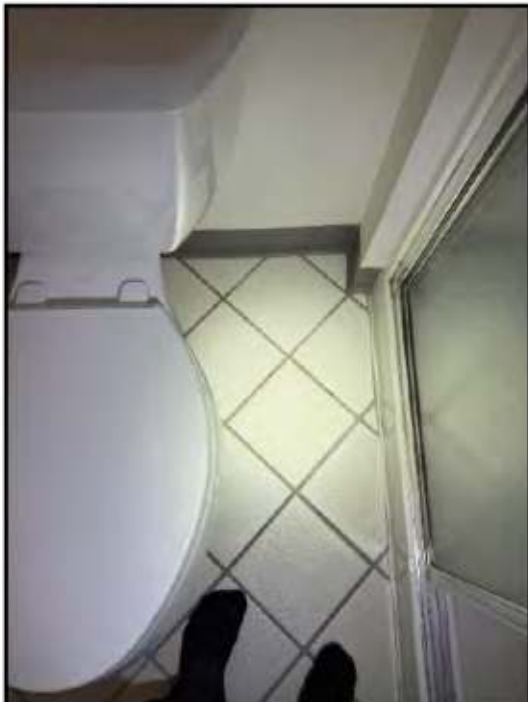
200. Tiles cracked

102. Condition: • [Tiles cracked](#)

Implication(s): Trip or fall hazard

Location: Bathroom

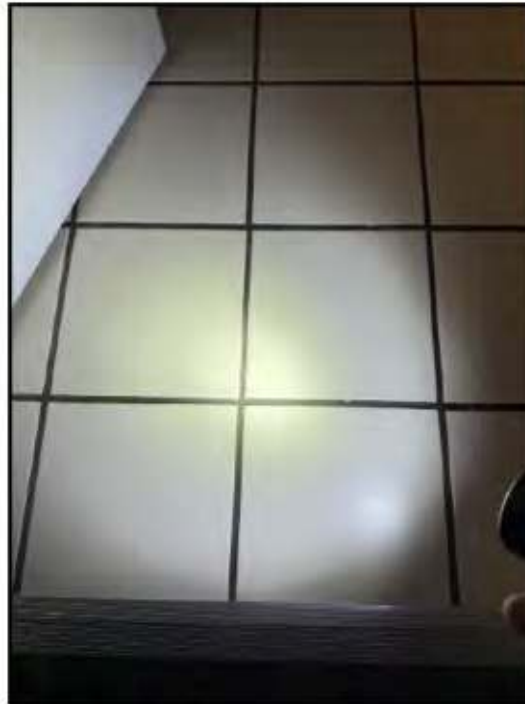
202. Tiles loose

103. Condition: • [Tiles loose](#)

Implication(s): Slip hazard

Location: First Floor Hallway Bathroom

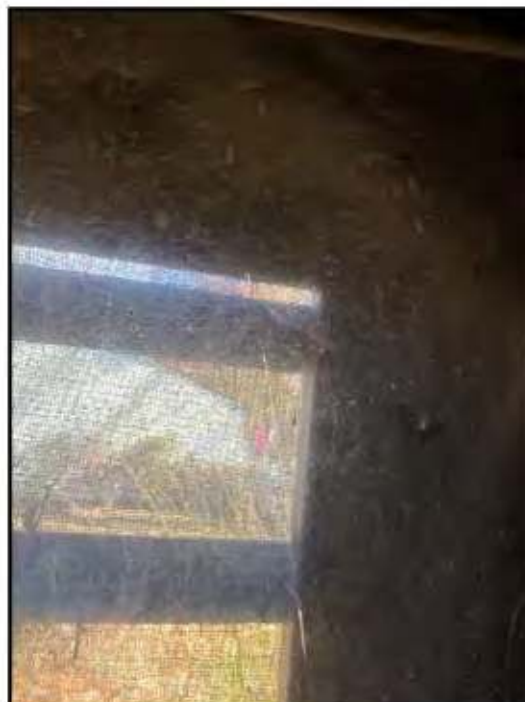
203. Cracked

104. Condition: • [Cracked](#)

Implication(s): Physical injury

Location: Basement

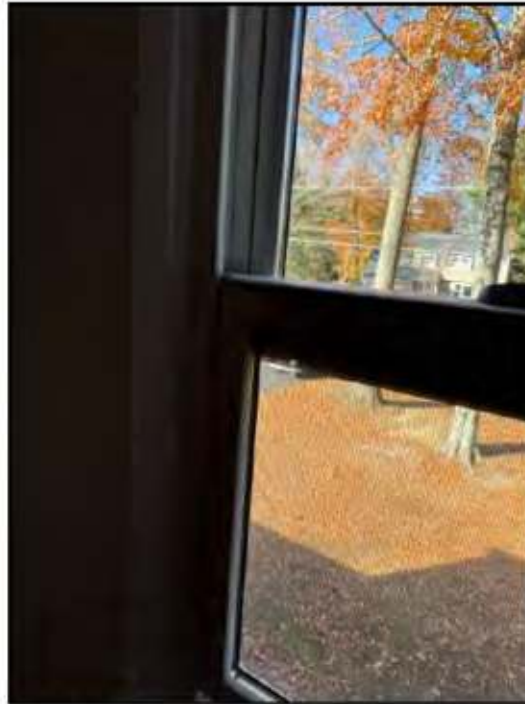
204. *Loose fit*

105. Condition: • [Loose fit](#)

Implication(s): Chance of damage to finishes and structure

Location: Second Floor

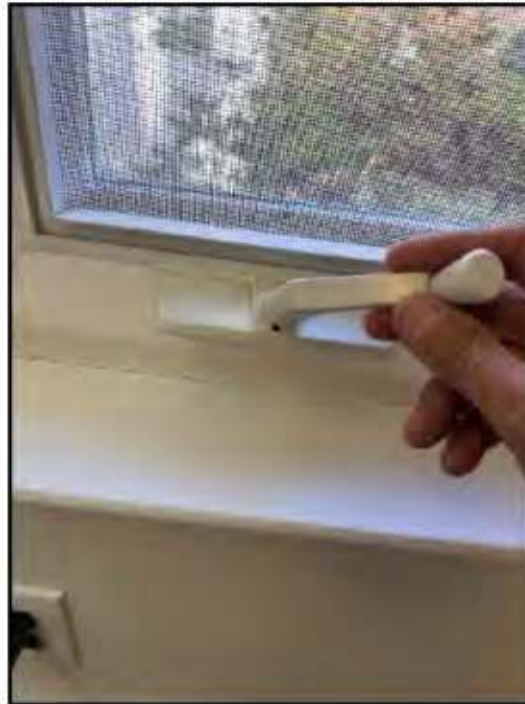
205. Loose

106. Condition: • [Loose](#)

Implication(s): Equipment failure

Location: First Floor

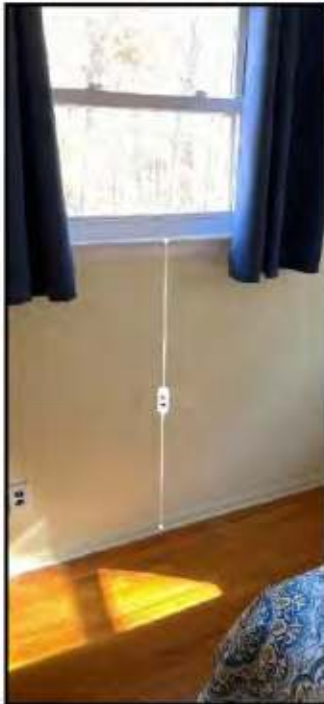
206. Ineffective

### 107. Condition: • Ineffective

- (1) minimum egress window per bedroom
- It must provide an unobstructed opening with a minimum area of 5.7 sq. ft. (This requirement drops to 5 sq. ft. for grade floor or below grade openings).
- The height of the clear opening must be at least 24" and the width must be at least 20".
- The sill height must not be more than 44" above the floor.
- If the sill height is below grade, the window must have a window well.
- If required, the window well must be at least 9 sq. ft. in an area with a horizontal projection and a width of at least 36" each.
- Window wells deeper than 44" must have permanent steps or a ladder that do not impede the opening of the window.

**Location:** Most Bedrooms

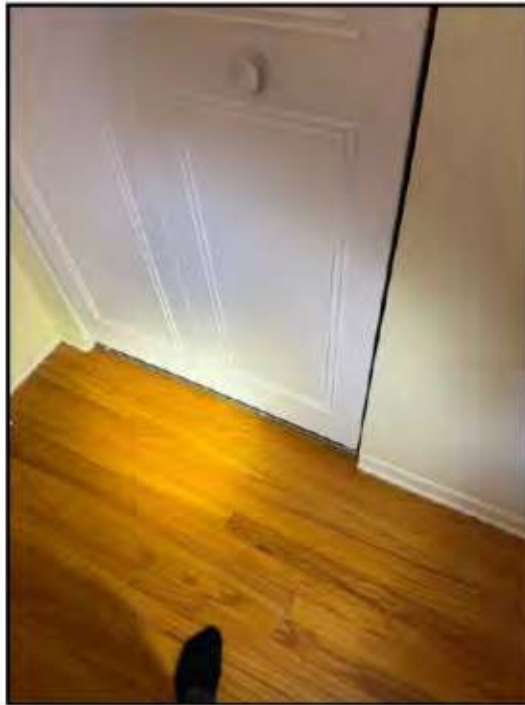
209. Stiff

108. Condition: • [Stiff](#)

Implication(s): Reduced operability

Location: Closet

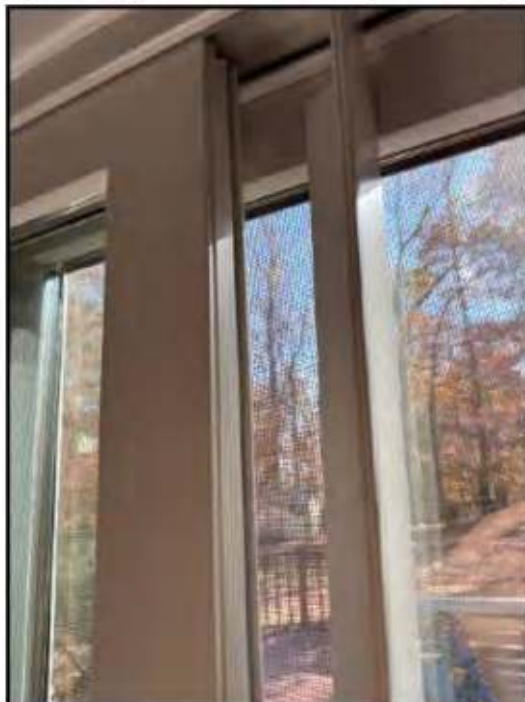
210. Weatherstripping missing or ineffective

109. Condition: • [Weatherstripping missing or ineffective](#)

Loose

Implication(s): Chance of water entering building | Increased heating and cooling costs | Reduced comfort

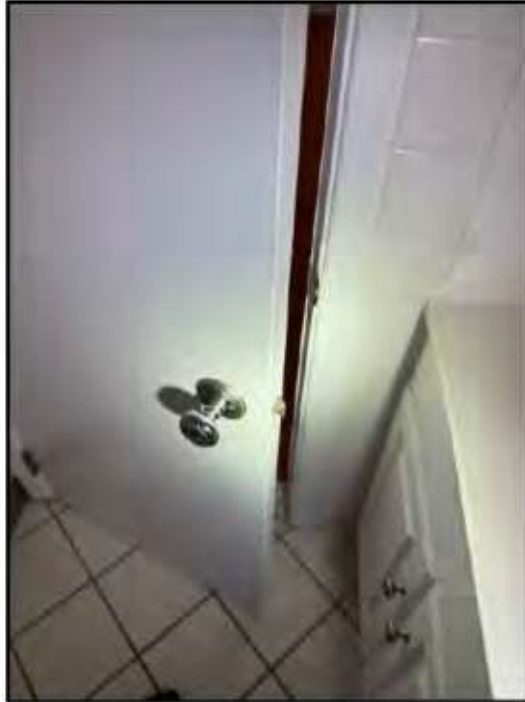
211. Does not latch properly

110. Condition: • Does not latch properly

Implication(s): System inoperative or difficult to operate

Location: Bathroom
