# Your Inspection Report

Tuesday, November 5, 2024

Leonardo Betancor, CMI, 24GI00182600, HOI.0001093

Smart Choice Inspections LLC  
173 Ridge Road, Suite H1  
Cedar Grove, NJ 07009

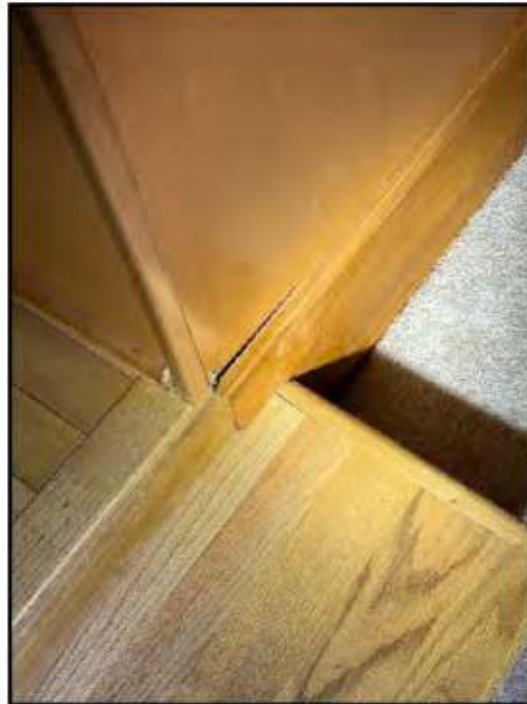
212. Loose

111. Condition: • [Loose](#)

Implication(s): Material deterioration

Location: Kitchen

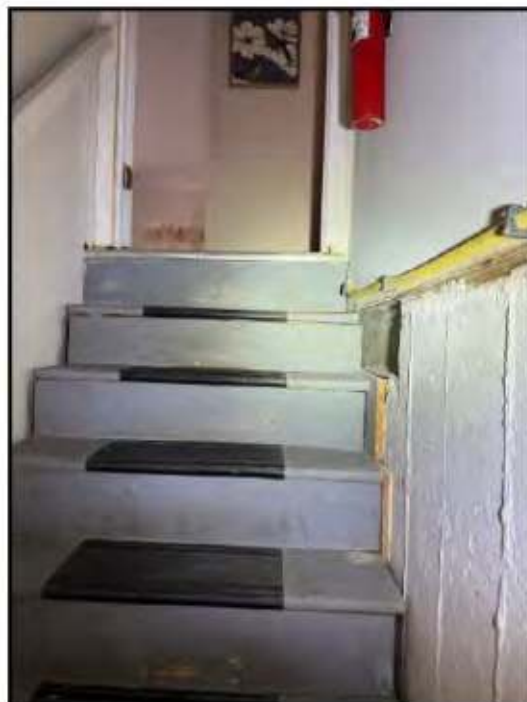
213. Sloped

112. Condition: • [Sloped](#)

Implication(s): Trip or fall hazard

Location: Basement

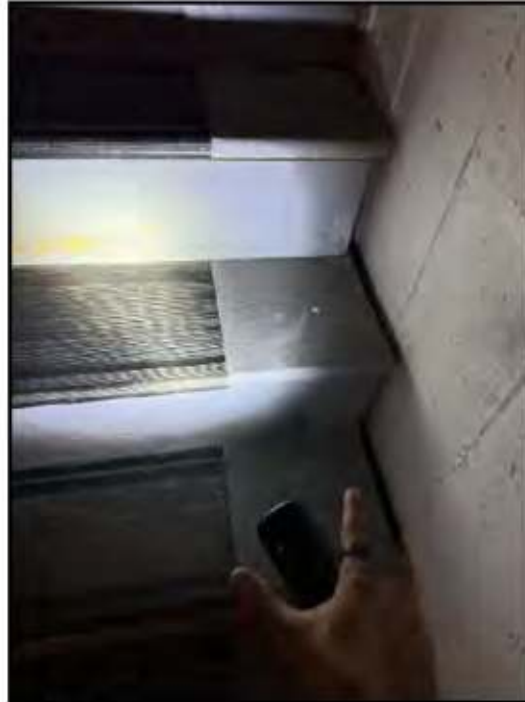
214. *Loose*

113. Condition: • [Loose](#)

Implication(s): Chance of movement

Location: Basement

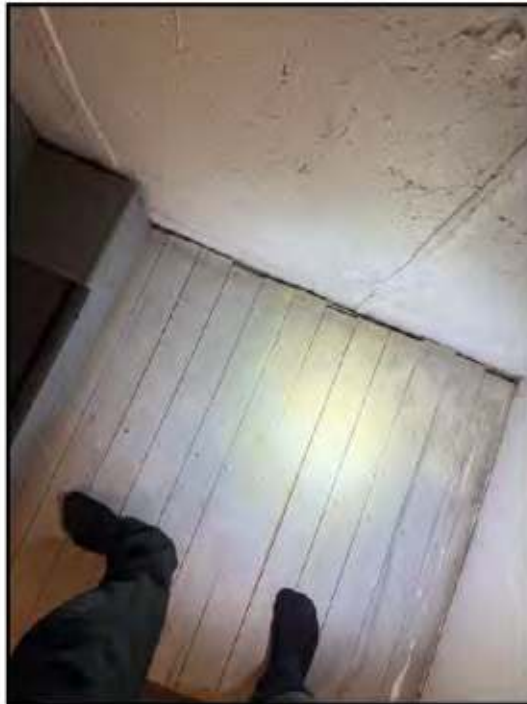
215.

114. Condition: • Loose

Location: Basement

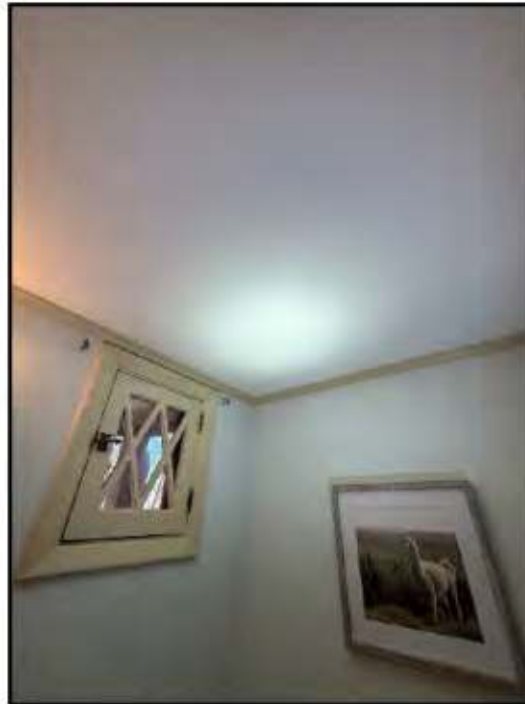
217. Missing

115. Condition: • [Missing](#)

Implication(s): Chance of condensation damage to finishes and/or structure

Location: First Floor Hallway Bathroom

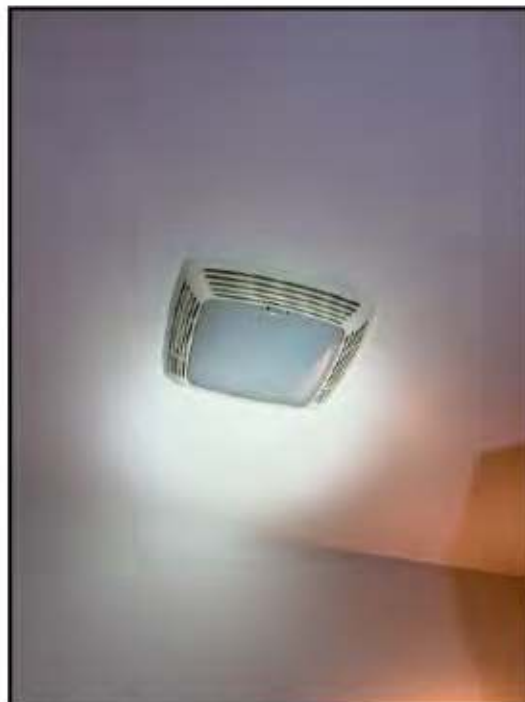
218. Light inoperative

**116. Condition:** • Light inoperative  
**Location:** Bathroom

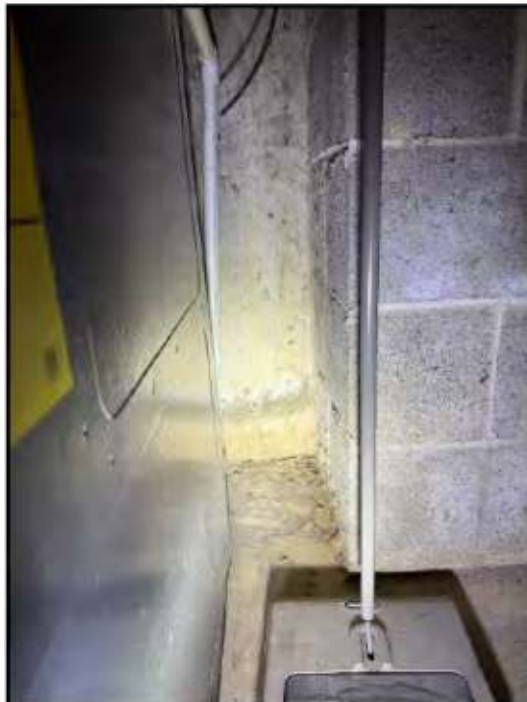
117. Condition: • [Efflorescence](#)

Implication(s): Chance of water damage to structure, finishes and contents

219. Efflorescence

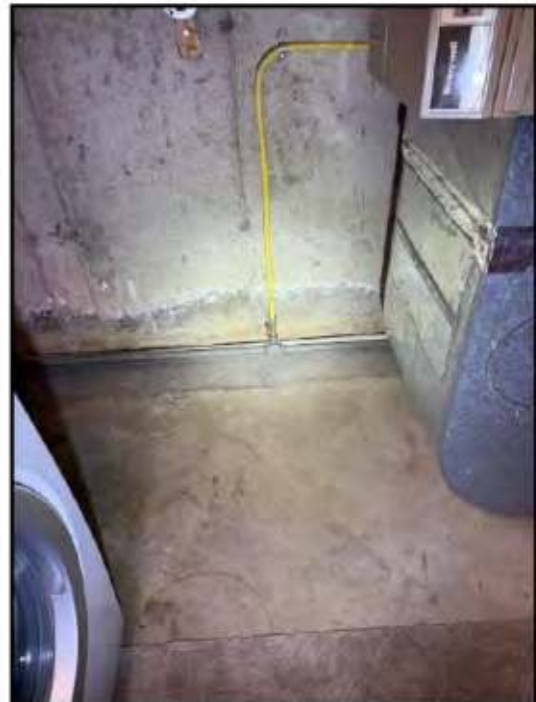
220. Efflorescence

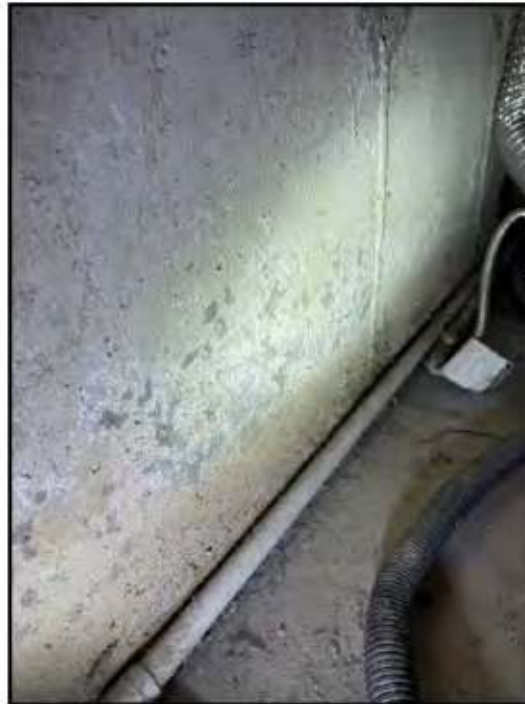
221. Efflorescence

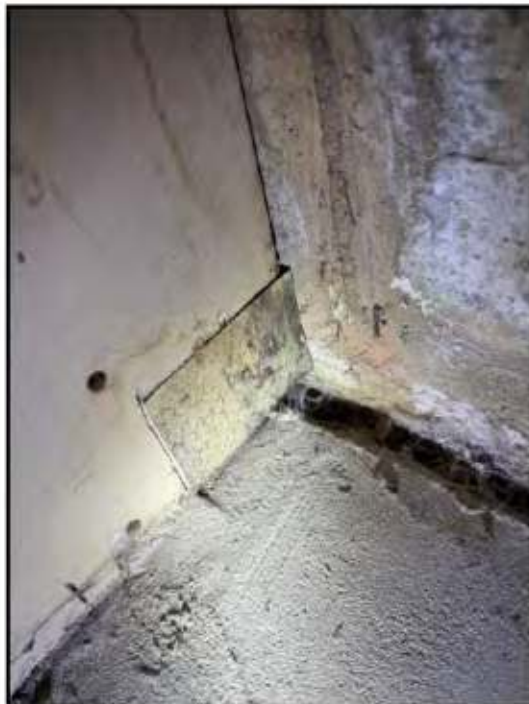
118. Condition: • **Mold**

Implication(s): Chance of water damage to structure, finishes and contents | Contaminants may enter building air

222. Mold

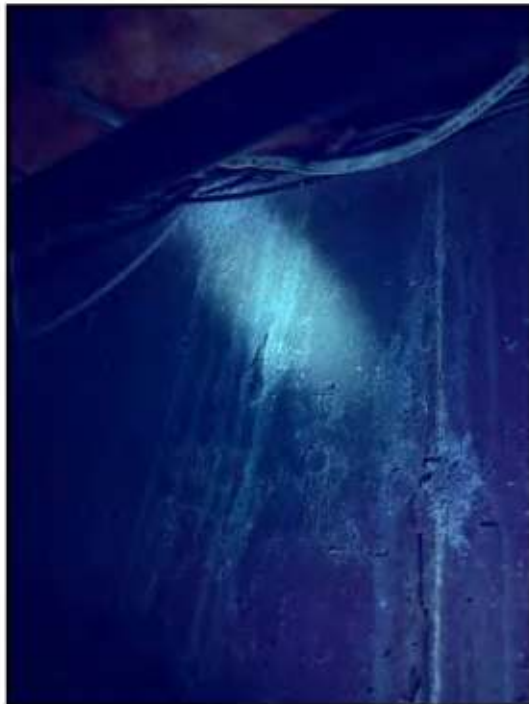
119. Condition: • [Water marks](#)

Implication(s): Chance of water damage to structure, finishes and contents

224. Water marks

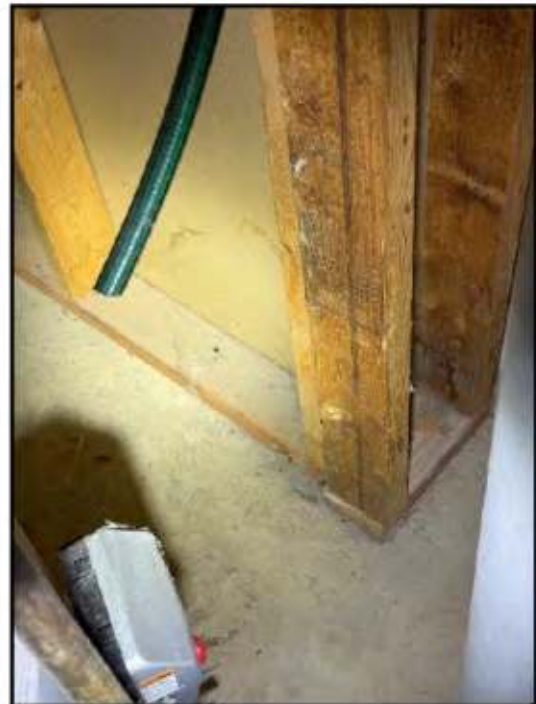
225. Water marks

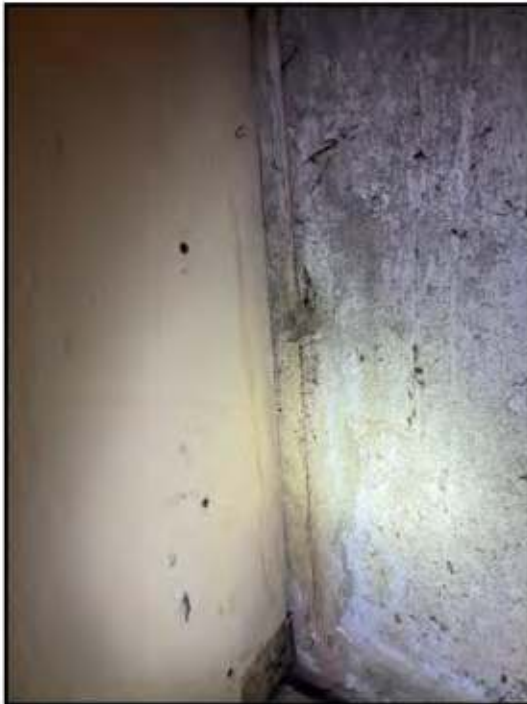
226. Water marks

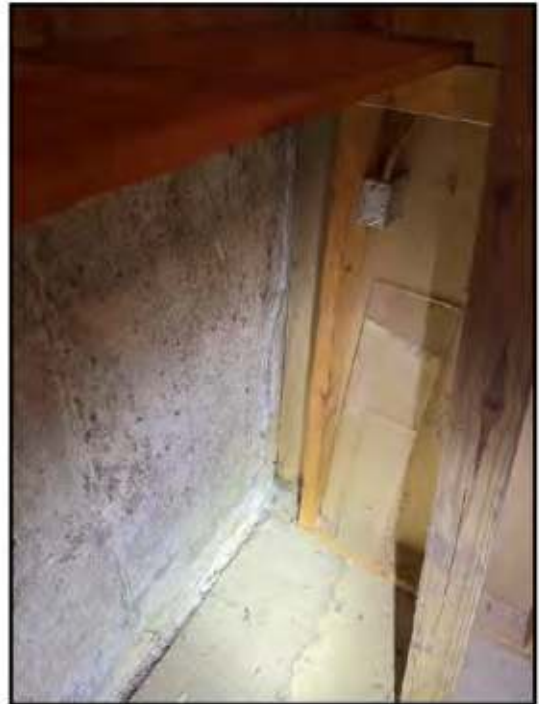
227. Water marks

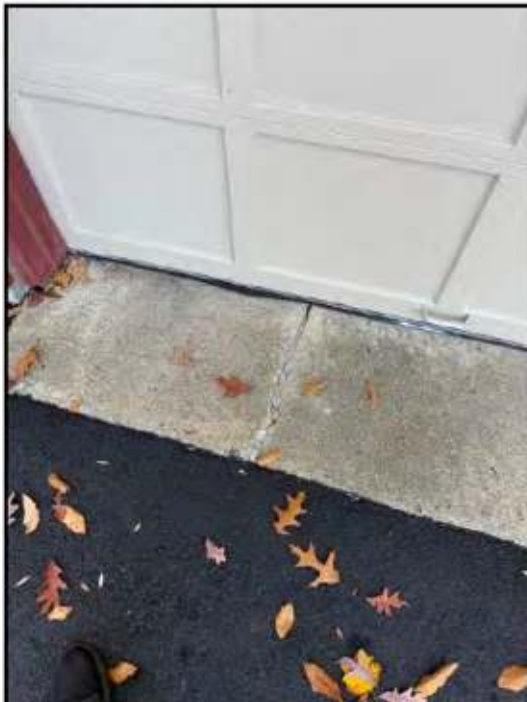
120. Condition: • [Cracked](#)

Implication(s): Uneven floors

228. Cracked

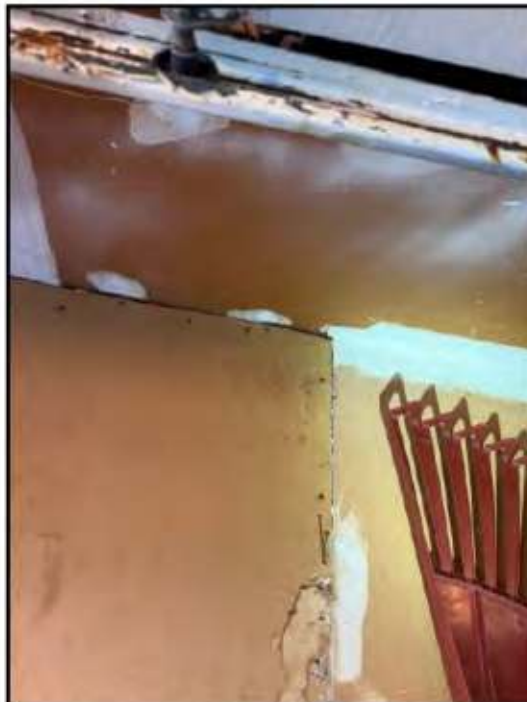
121. Condition: • Missing sections of fire rated wall/ceiling assembly

Implication(s): Hazardous combustion products entering home

230. Missing sections of fire rated wall/ceiling...

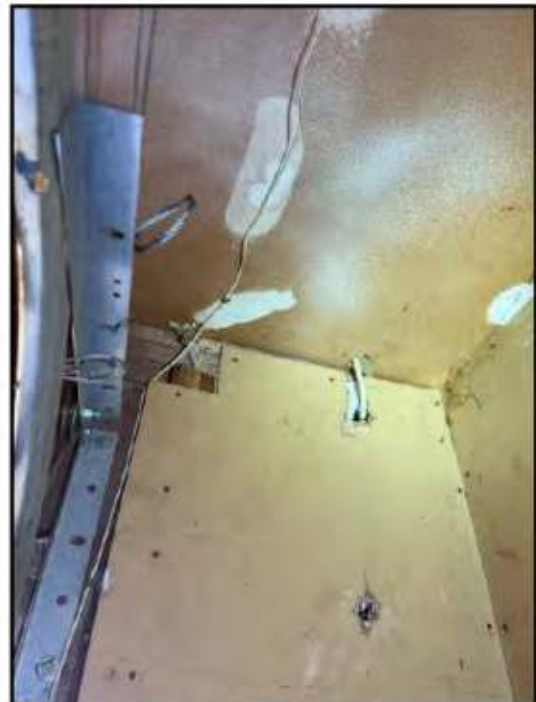
231. Missing sections of fire rated wall/ceiling...

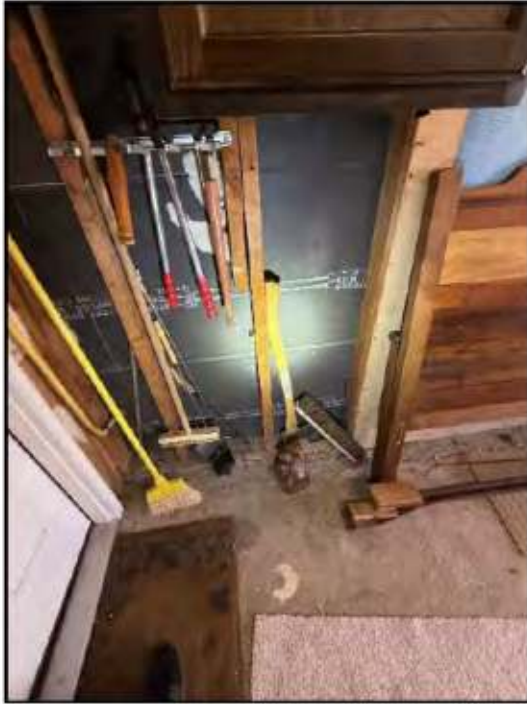
232. Missing sections of fire rated wall/ceiling...

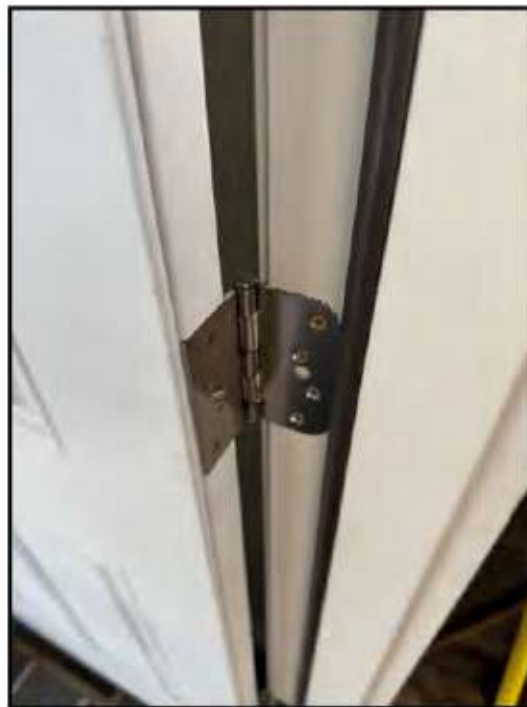
122. Condition: • [No self closer](#)

Implication(s): Hazardous combustion products entering home

234. No self closer

Recommend installing self-closing hinges.

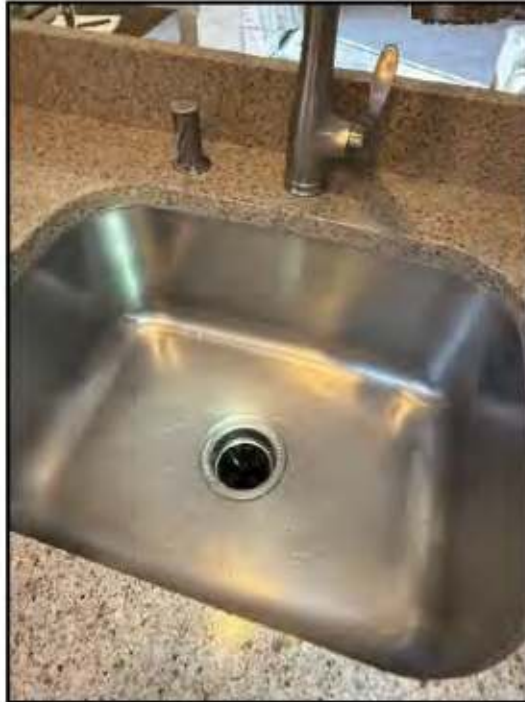
123. Condition: • Switch/button exposed on sink/countertop

235. Switch/button exposed on sink/countertop

Garbage disposal should not be operated with a switch above countertop but instead should be activated with a safety top cover or hidden switch inside cabinet

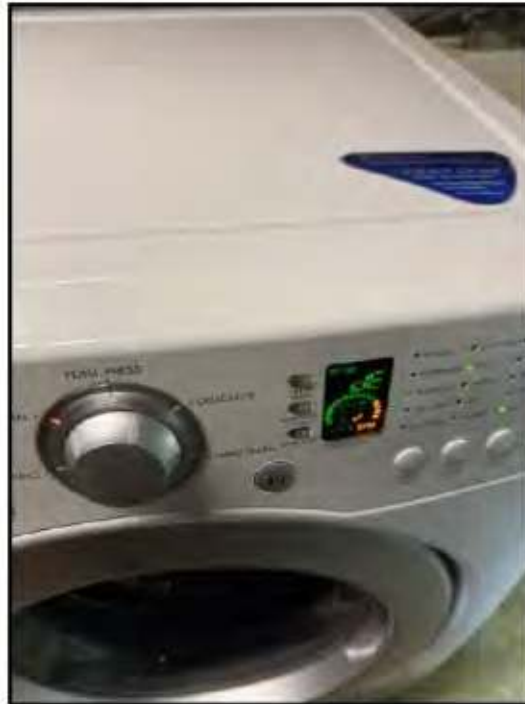
124. **Condition:** • Inoperative

**Implication(s):** Equipment inoperative

236. Inoperative

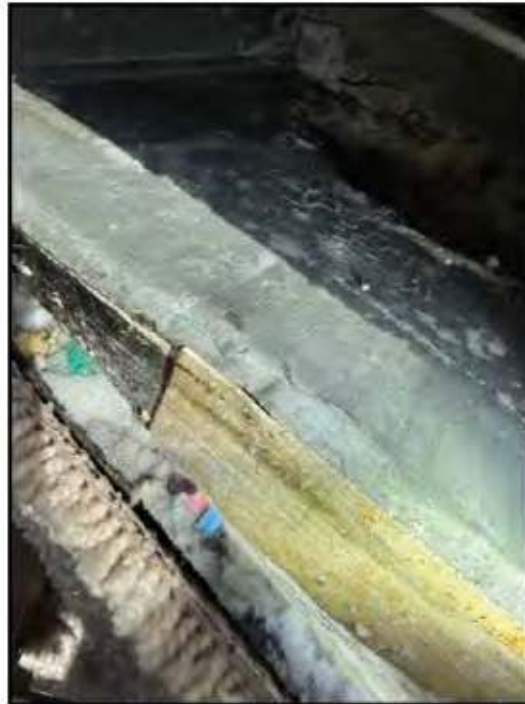
### 125. Condition: • Possible asbestos containing materials

Nine-inch vinyl tiles containing probable asbestos fibers were observed under the ground floor carpet. It is recommended to have a licensed asbestos removal company remove these tiles, as particles from damaged asbestos can cause lung cancer.

**Implication(s):** Health hazard

237. Possible asbestos containing materials

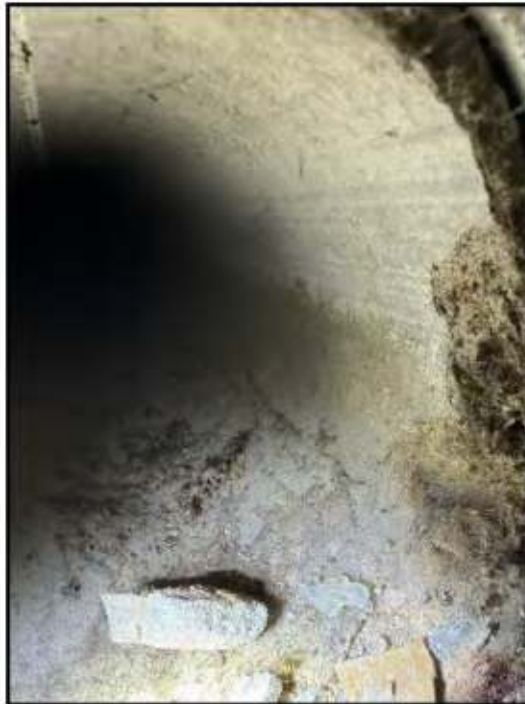
**126. Condition:** • Possible asbestos containing materials

In-slab ducts were discovered in the fireplace room, which appear to be constructed from transite-a material commonly known to contain asbestos fibers. A sample from the ducts has been sent for lab testing to confirm the presence of asbestos. Once results are available, further assessment by a licensed asbestos professional is recommended if asbestos is confirmed, to determine the best course of action for safe management or removal.

**Implication(s):** Health hazard

238. Possible asbestos containing materials

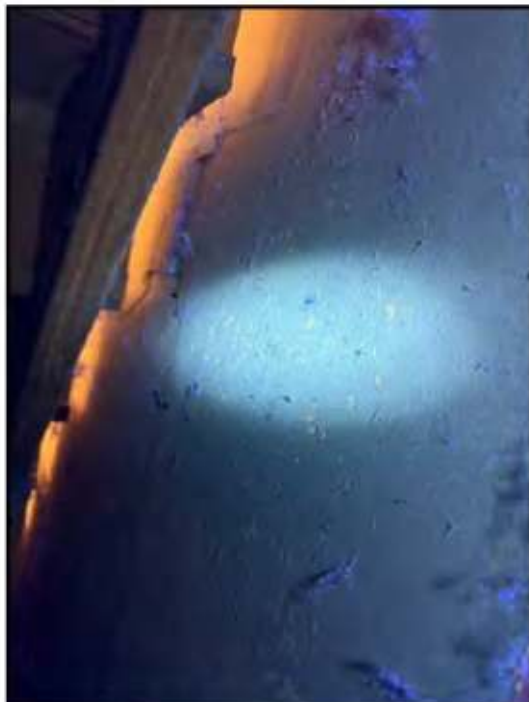
127. Condition: • Mold

Implication(s): Health hazard

239. Mold

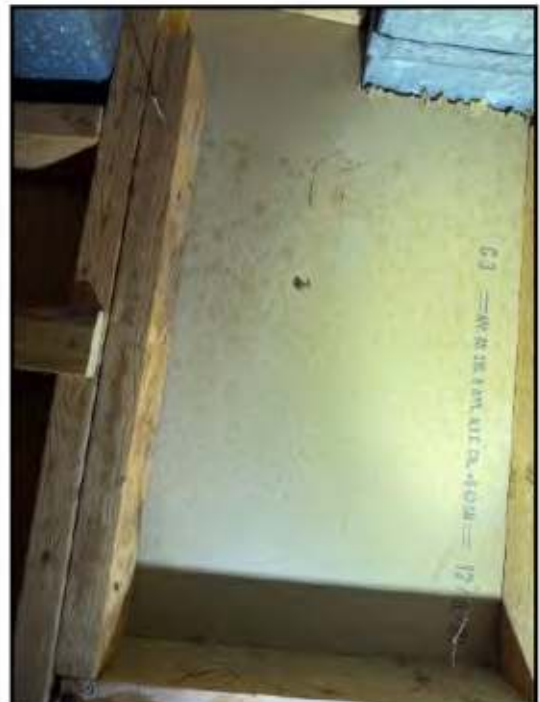
240. Mold

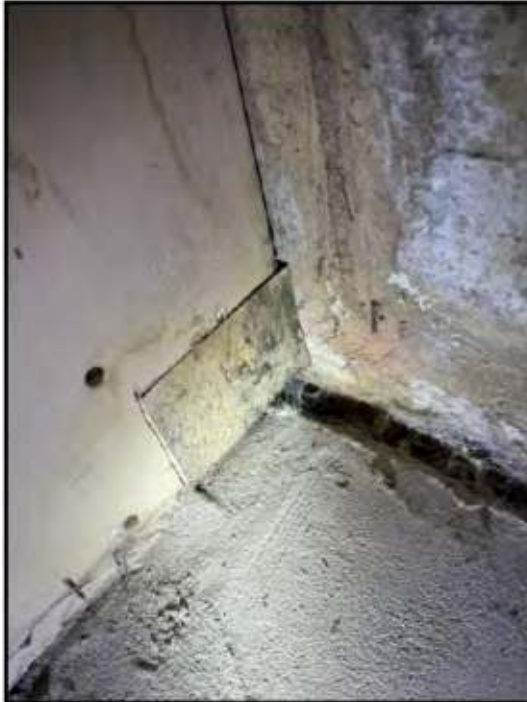
241. Mold

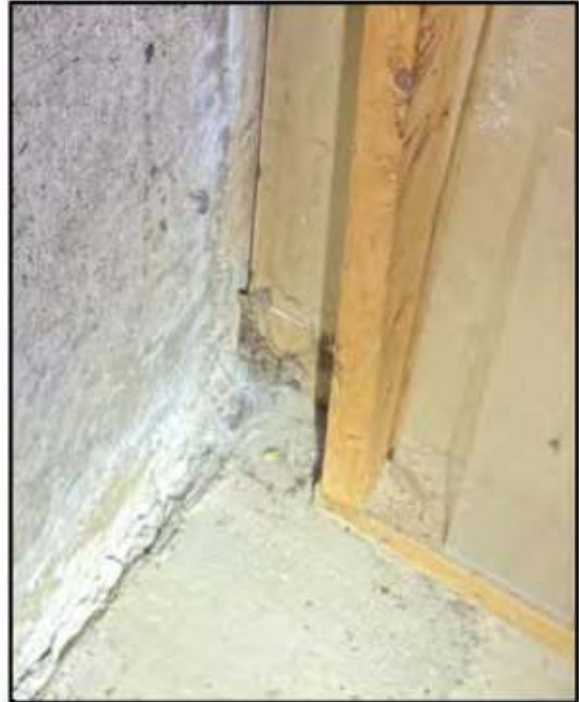
242. Mold

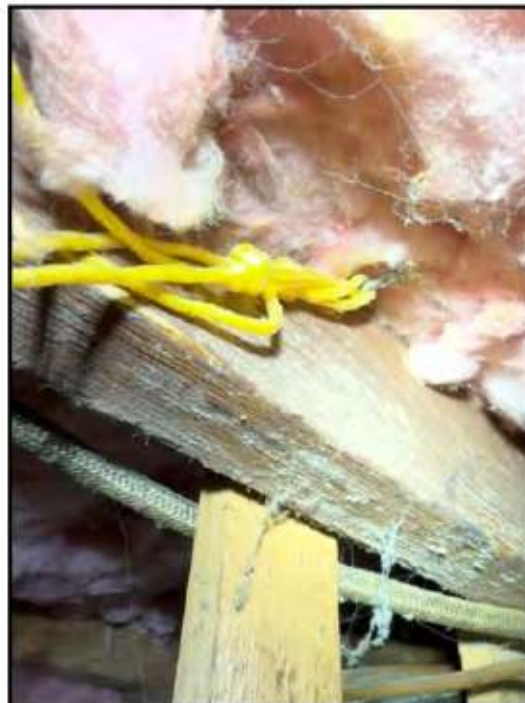
243. Mold

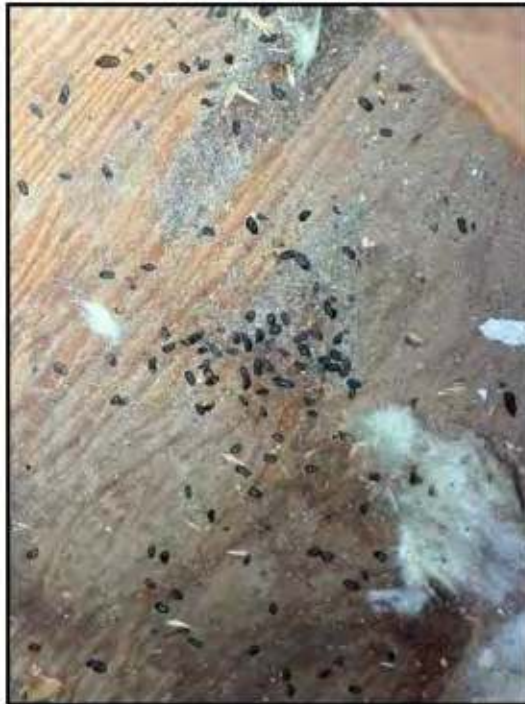
128. Condition: • Mice droppings

244. *Mice droppings*
